June 17, 2021

Version 5

**2021 Odyssey: Popping or Crackling from the Speakers; No Sound from the Audio System; Network Loss Message and/or Display Issues**Supersedes 20-049, dated February 18, 2021, to revise the information highlighted in **yellow**.**AFFECTED VEHICLES**

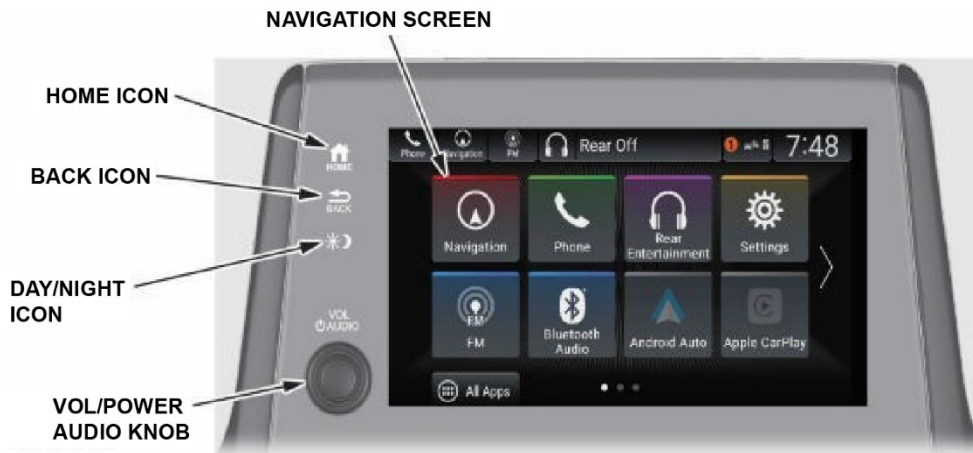
1. Turn the ignition to ON.
2. Press and hold the VOL/Power AUDIO knob, **Day/Night** icon, and **HOME** icon at the same time. Then, release them when you see the **Dealer Diagnostics** screen.

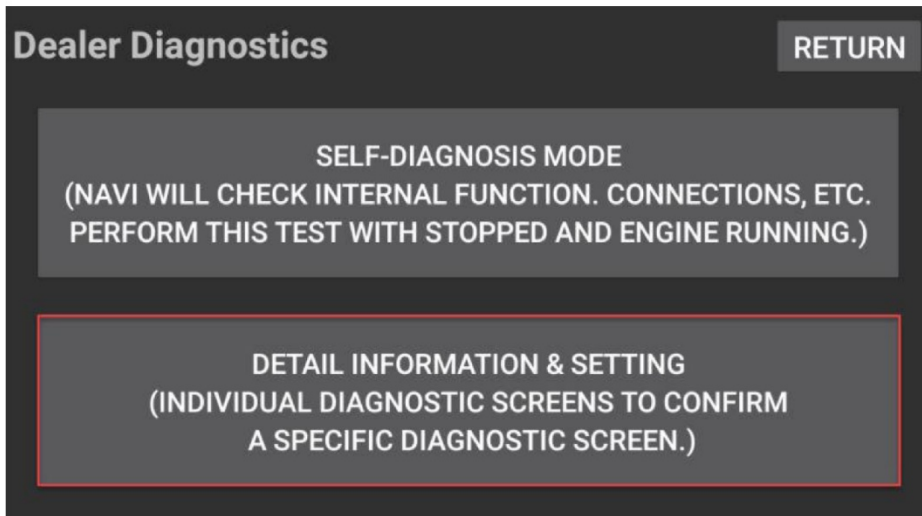
3. Select **DETAIL INFORMATION & SETTING**.

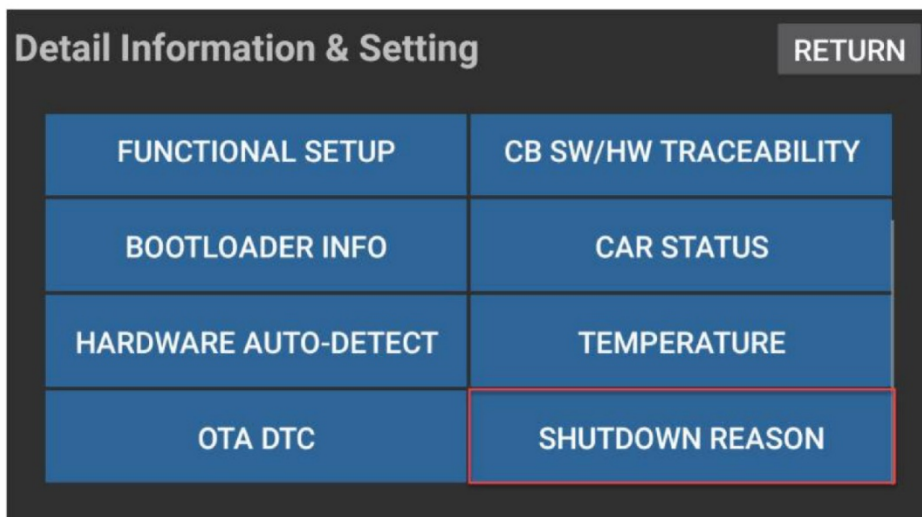
4. Scroll down the menu, and select **SHUTDOWN REASON**.

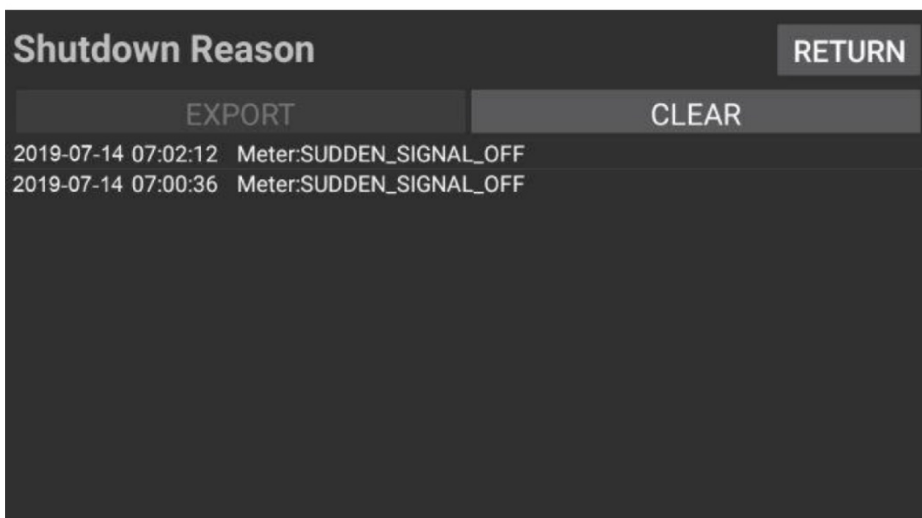
In this example, the cause of the failure can be identified as **Meter:SUDDEN\_SIGNAL\_OFF**.

Write down any failures; they will be collected on the warranty claim. Then, clear the data.

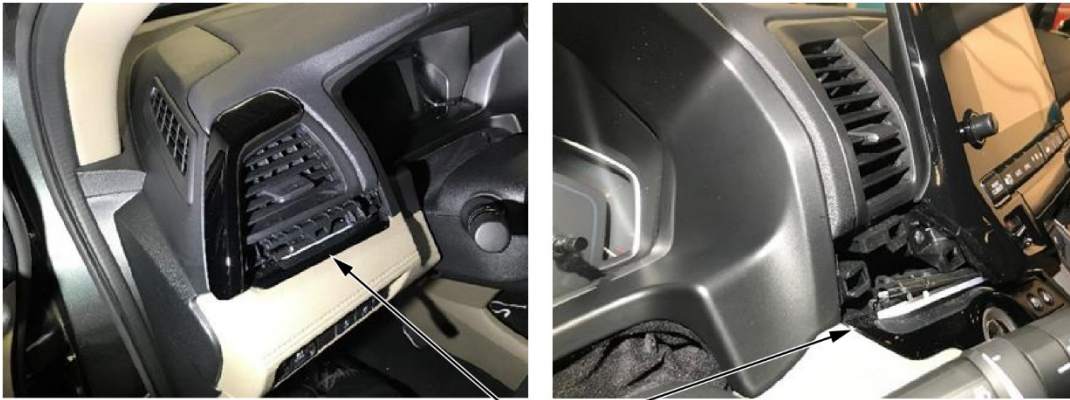
LOWER VENT COVERS

1. Remove the lower vent covers.

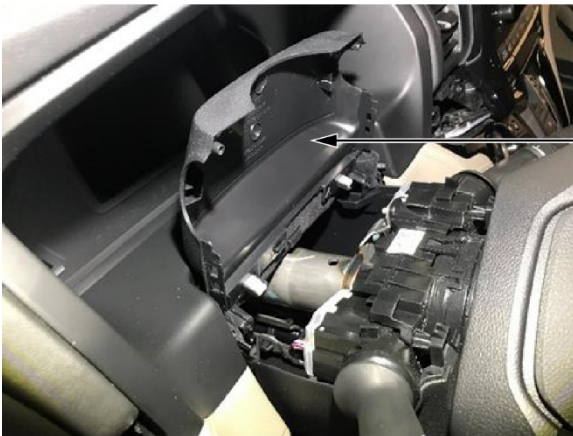
UPPER  
COLUMN  
COVER

2. Loosen the upper column cover.

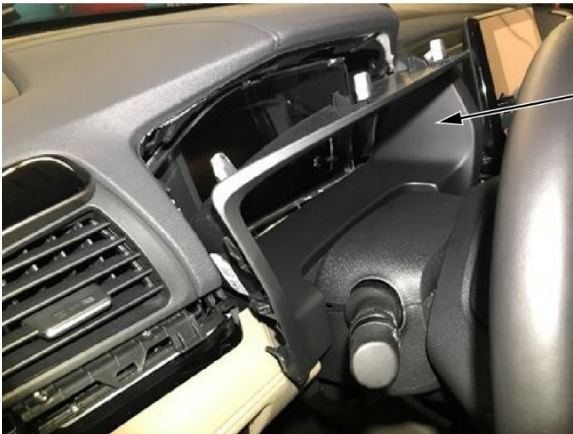
METER  
BEZEL

3. Disengage the clips around the meter bezel. Then, remove it with the upper column cover as one piece.

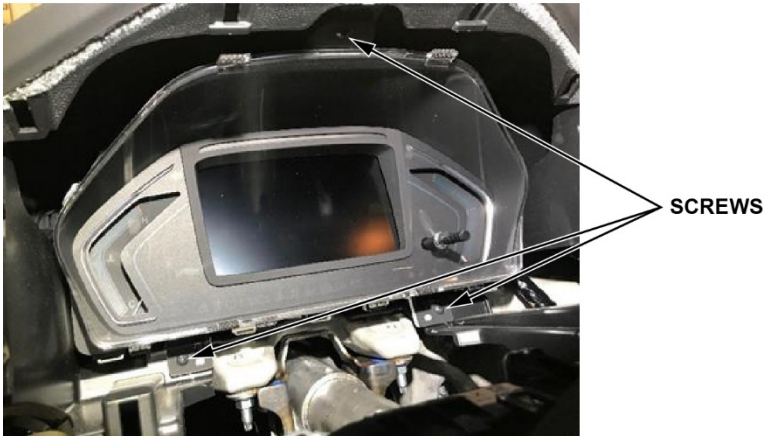
4. Remove the three screws holding the gauge control module.

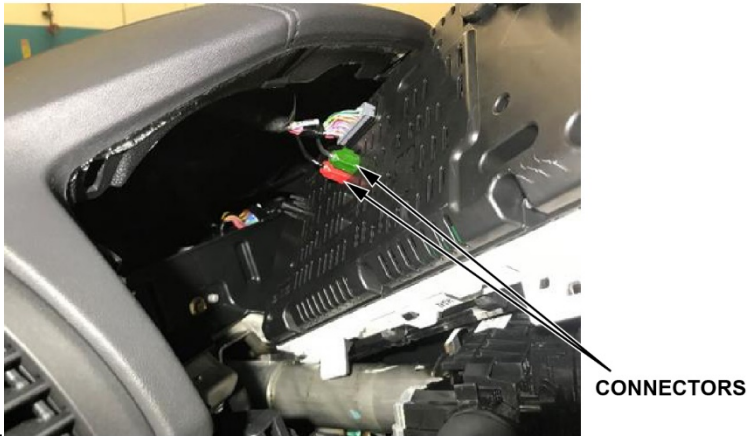
5. Turn the gauge control module to access the rear connectors. Then, using the straight FAKRA tool, disconnect the red and green FAKRA connectors, and remove them from the gauge control module. Do not pull on the units or MOST feeders while the FAKRA connectors are connected to help prevent communication issues.

NOTE: For more information on using the FAKRA tools, see the job aid, *Using the MOST Connector Tools*.

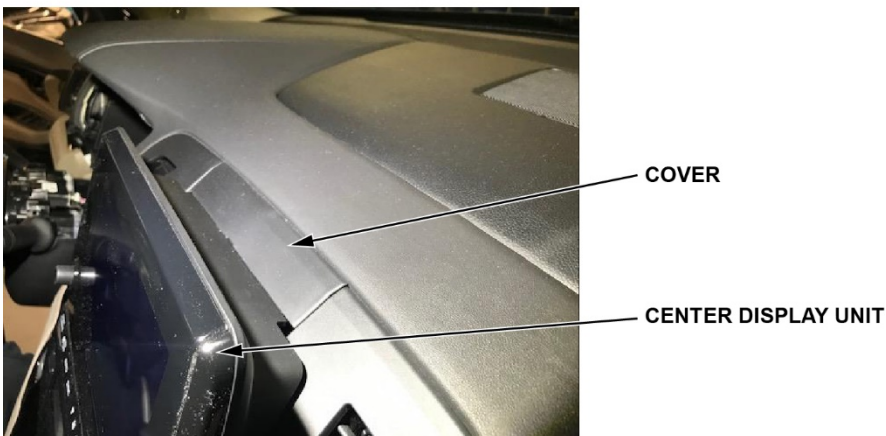
6. Remove the cover above the center display unit.

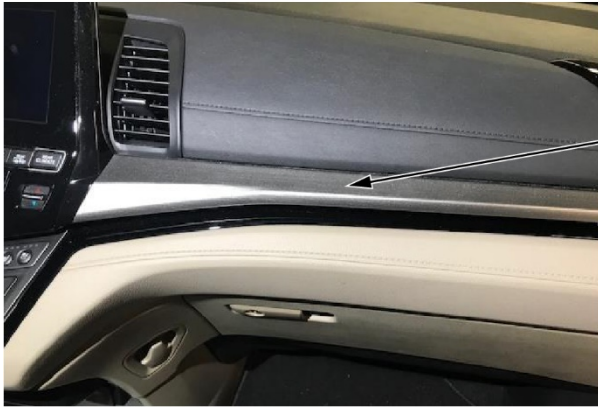
CENTER  
DASH TRIM

7. Remove the center dash trim.

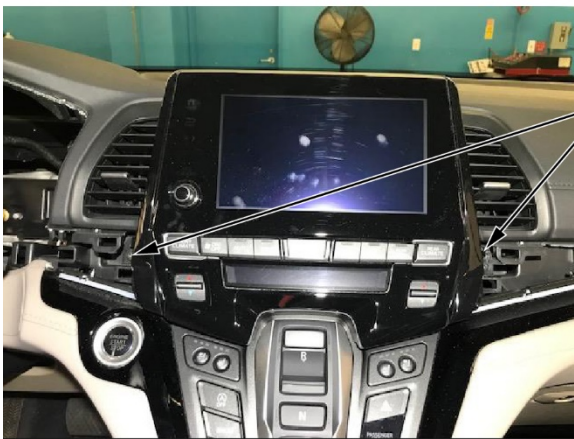
SCREWS

8. Remove the two screws.

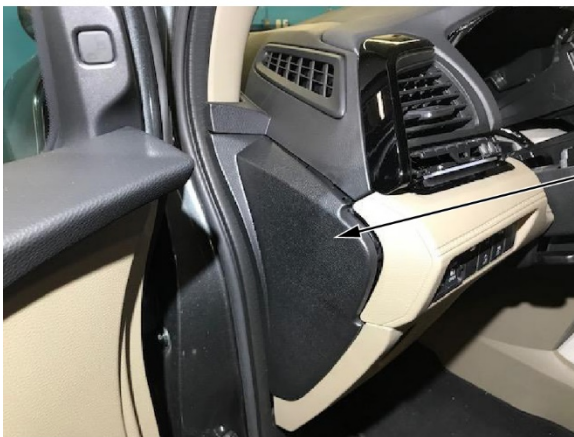
SIDE  
COVER

9. Remove the side cover.

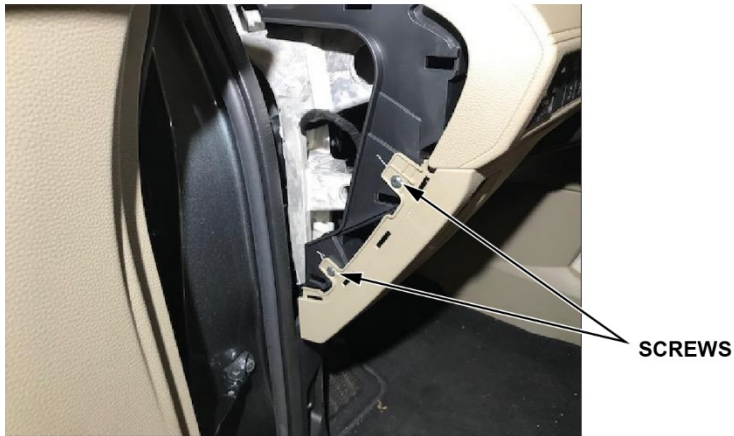
10. Remove the two screws.

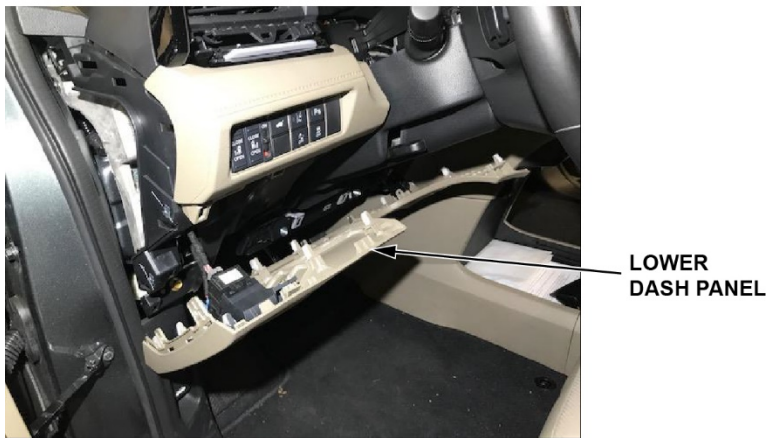
11. Remove the lower dash panel.

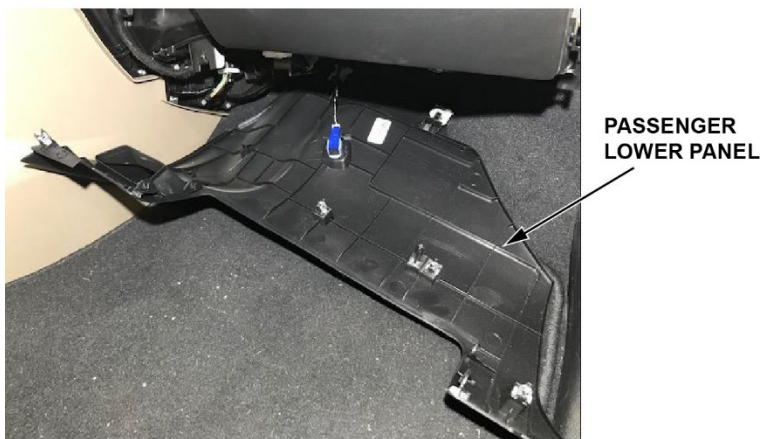
12. Remove the passenger lower panel.

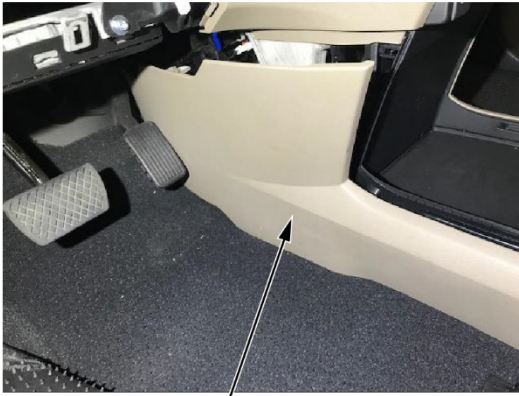
**DRIVER LOWER  
CONSOLE PANEL**

13. Remove the driver lower console panel and the passenger lower console panel.

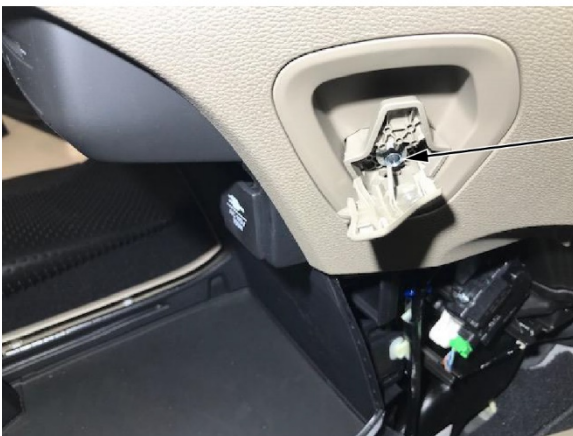
**BOLT**

14. Pull back the cover, and remove the bolt.

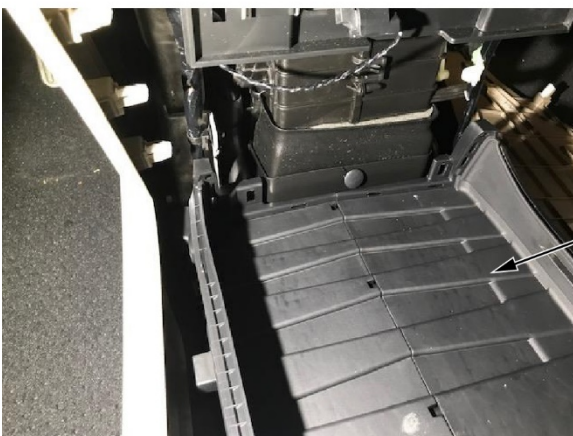
**RUBBER  
LINER**

15. Remove the rubber liner, and pull back the lower console cover.

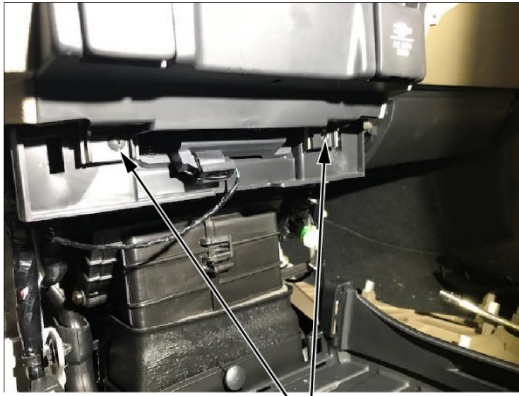
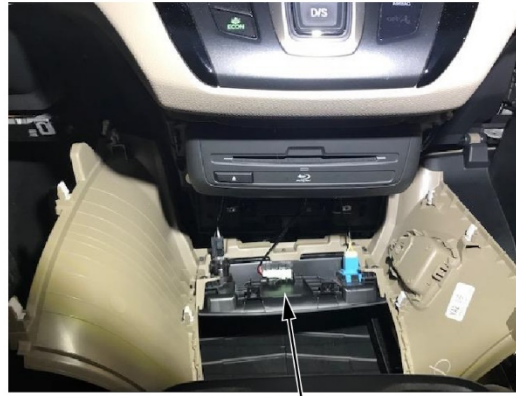
16. Remove the two screws from the dashboard center pocket, then pull back the panel.

**SCREWS**

**DASHBOARD CENTER POCKET**

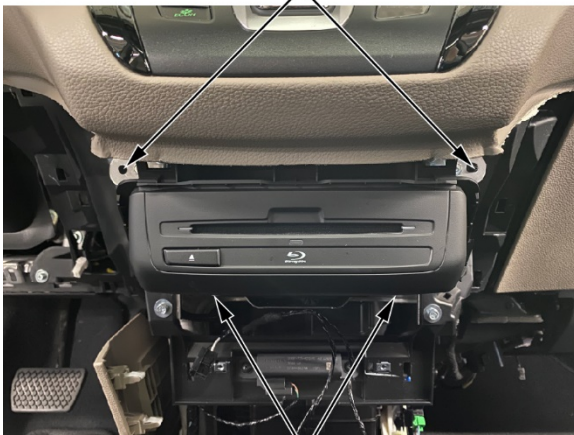
17. Remove the two upper screws, and loosen the two lower screws.

NOTE: Some models will have a CD player, DVD player or center pocket.

**SCREWS**  
Remove.

**SCREWS**  
Loosen.

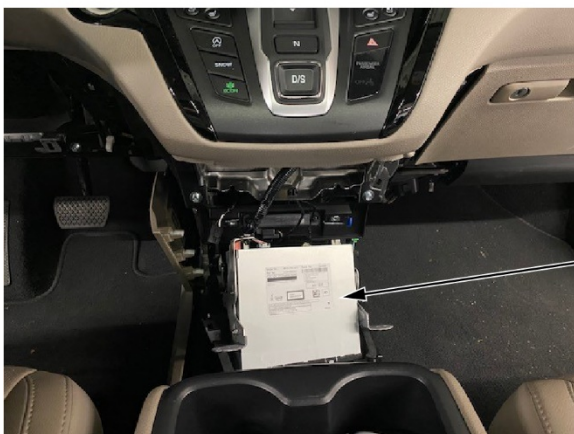
**DVD PLAYER,  
CD PLAYER or  
CENTER POCKET**

18. Remove the DVD player, CD player or center pocket to gain access to the two 8 mm bolts holding the infotainment unit.

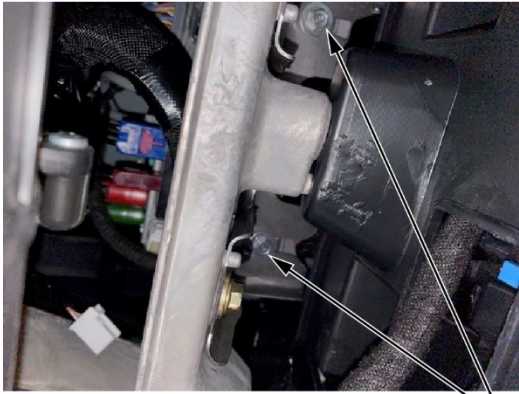
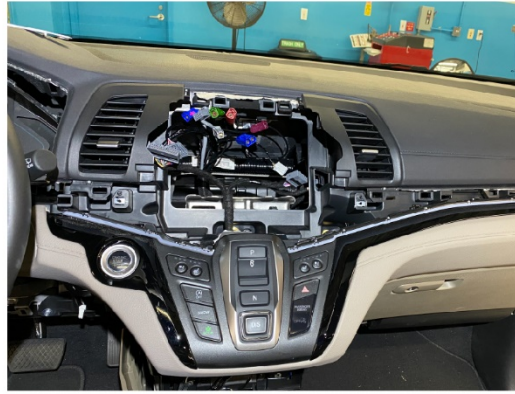
**BOLTS**

19. While looking upward from underneath where the DVD player, CD player, or center pocket was removed, loosen the two 8 mm bolts holding the infotainment unit, then remove the unit.

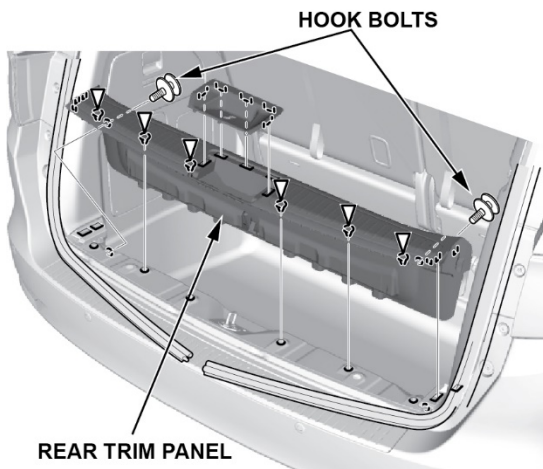
20. In the rear cargo area, remove the rear trim panel.

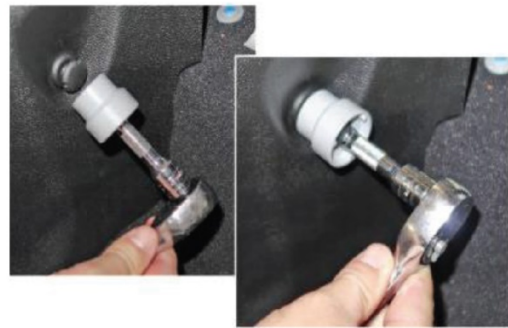
If necessary, use Special Tool 07AAA-SEPA100 to loosen the hook bolts.

21. On the right rear quarter panel, remove the hook bolts. If needed, use Cargo Cap Screw Socket (T/N 07AAA-SEPA100) to loosen the bolts.

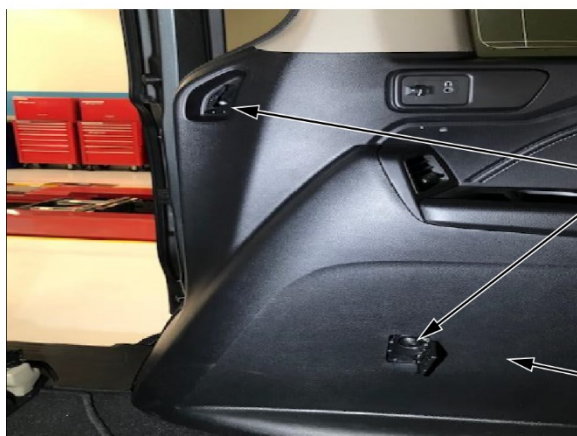
22. Remove the covers then remove the two screws from the passenger side inner rear quarter panel.

**SCREWS**

**PASSENGER SIDE  
INNER REAR  
QUARTER PANEL**

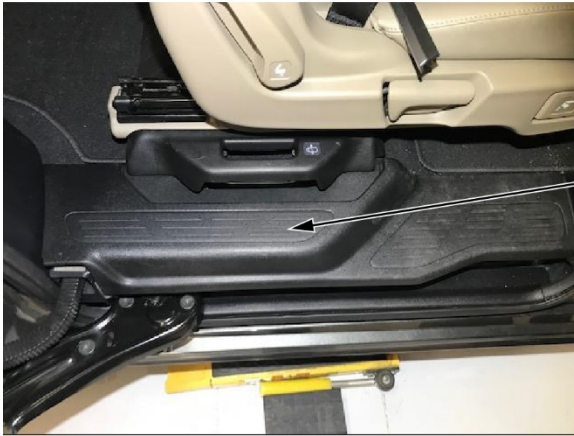
**LOWER PASSENGER  
SLIDING DOOR TRIM**

23. Remove the lower passenger sliding door trim.

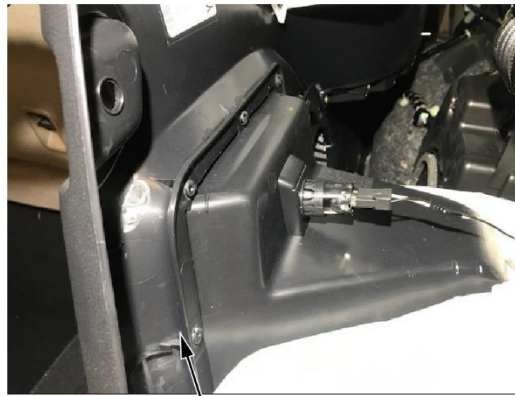
**RIGHT QUARTER INNER PANEL**

24. Remove the right quarter inner panel, then disconnect the connectors.

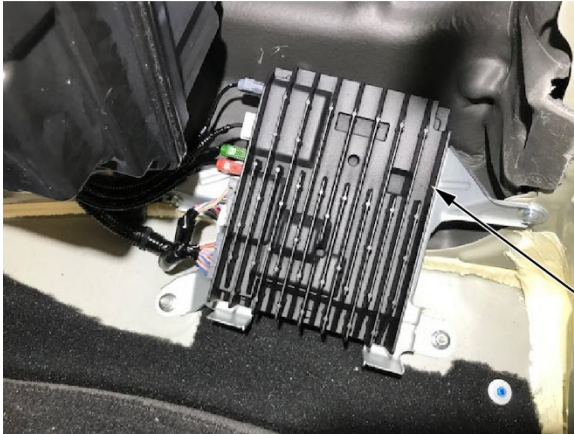
**STEREO AMPLIFIER OR  
TUNER-AMPLIFIER**

25. Disconnect the red and green FAKRA connectors from the stereo amplifier (Elite) or tuner-amplifier unit (EX, EX-L, Touring), gauge control module, and infotainment unit using the straight FAKRA puller. Do not pull on the units or MOST feeders while the FAKRA connectors are connected to help prevent communication issues.

NOTE: Disassemble the connectors one at a time to avoid swapping the green and red wires.

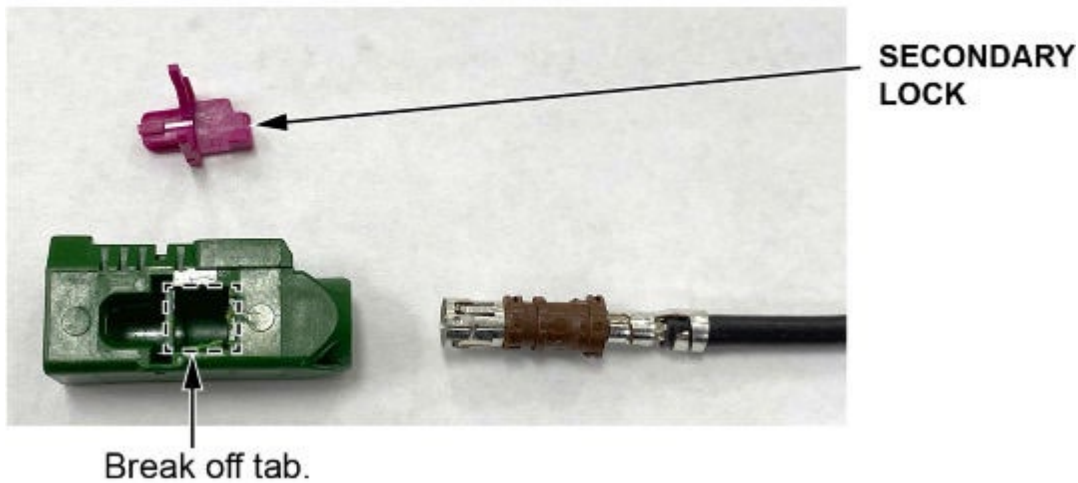
26. Using a small screwdriver, remove the secondary lock, then break off the tab as shown. Then, discard the housing and lock.

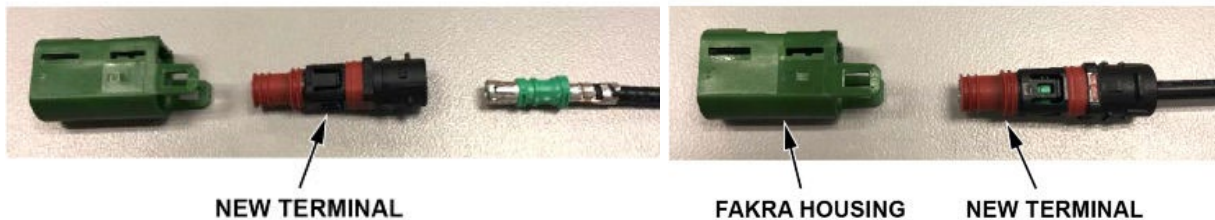
27. Pull and twist the housing counterclockwise to remove it from the wire.  
28. Select the correct color FAKRA housing, then slide the new terminal onto the wire until it clicks into place.

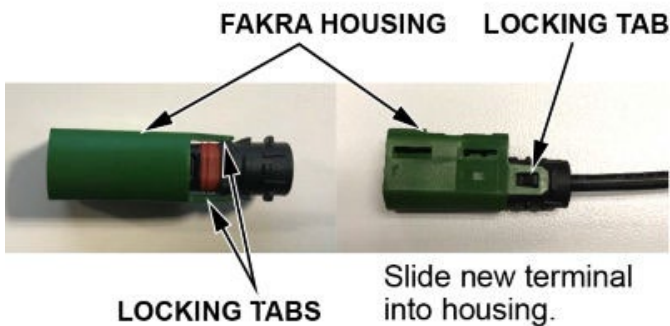
29. Line up the locking tabs on the FAKRA housing with the new terminal, then push the terminal into the housing until it clicks into place.

30. Repeat steps 26 thru 29 for the other connectors. Then, install the FAKRA connectors to the gauge control module, infotainment unit, and stereo amplifier or tuner-amplifier unit.

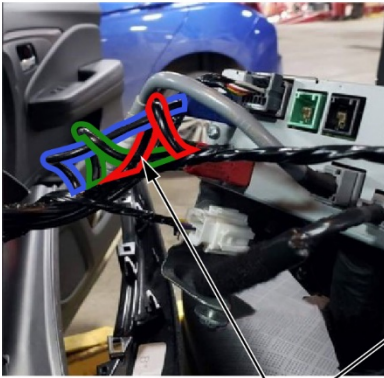
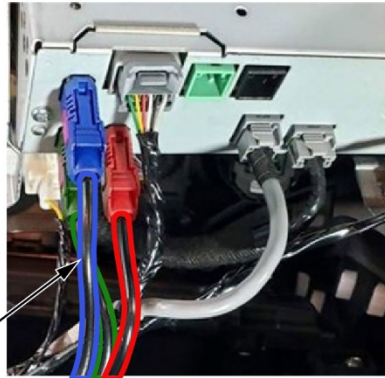
31. Install all of the removed parts in the reverse order. When installing units, make sure the harness is routed correctly. A mis-routed harness can put pressure on the wires and connectors causing connection issues. Do not pull on the units or MOST feeders while the FAKRA connectors are connected to help prevent communication issues.

**BEFORE**

**AFTER**

**HARNESS  
Reroute.**
