## Wiring Refrigerator to properly operate on 12 Volt

| <b>Bulletin Type:</b> | TSB 21-013 Supersedes<br>& replaces TSB 21-002 | <b>Publication Date:</b> | June 2021 |

| <b>Incident:</b> | Refer does not operate or sufficiently cool while on 12V |
| <b>Affected Units:</b> | 2021 Entegra 20T Ethos MHB- M1RT8051-8183<br>2021 Jayco 20T Swift MHB- M1RT4051-4147 |

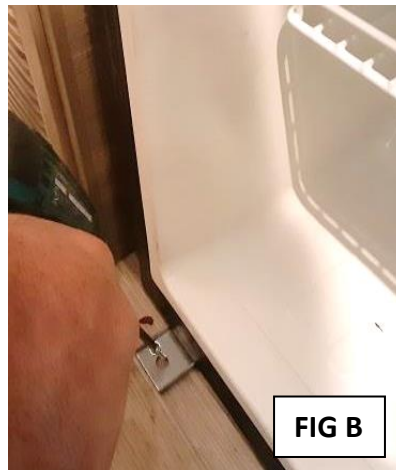
1. Remove the (2) screws from the bracket(s) that secure the refrigerator to the floor shown in Fig B. Set the screws aside for re-use.
2. Pull the refrigerator from the cabinet shown in Fig C .

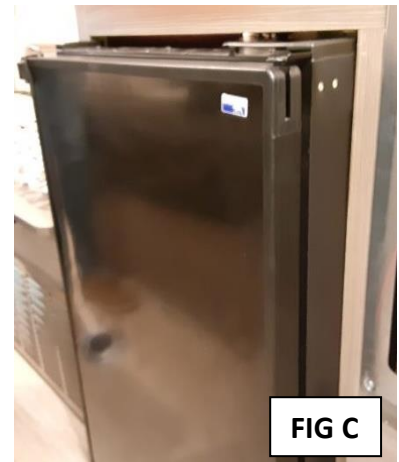
**NOTE:** When moving the refrigerator out, hold on the sides of the refrigerator. Avoid adding pressure or stress to trims and molding on the refrigerator.

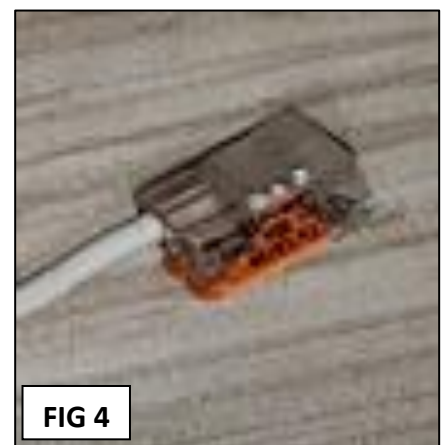
11. At the refer location, locate the ground wire connection (14 GA White to Black) Fig. 3.
12. Remove the installed 14 GA White wire and insert into a two conductor WAGO connector (capping off wiring not used).
13. Insert the 12 GA wire routed in step 7 into the two cavity WAGO connector shown in Fig 4).

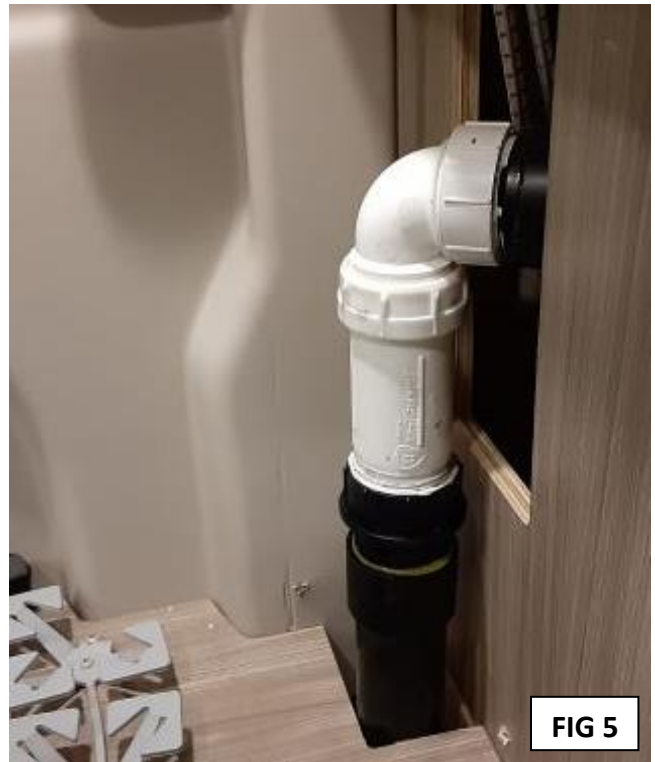
19. Remove the ABS pipe cover shown in Fig 5 on the side of the cabinet (between the cabinet and the seat base). You will need to remove (4) square head screws. This will expose the pipe and give you access behind the refrigerator.

20. Have one person push the refrigerator back into place while a second person gently shifts the pipe allowing the refrigerator to be pushed back into place.
