STAR ONLINE PUBLICATION

Case Number: S2123000030

Symptom/Vehicle Issue: Lumbar Adjustment Not Working

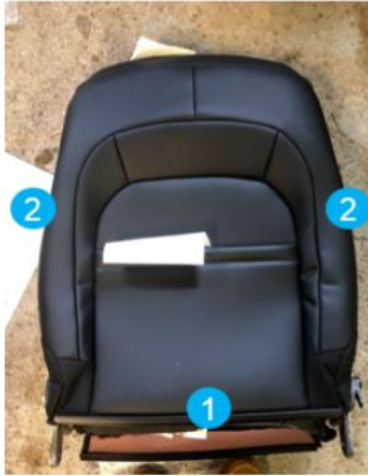
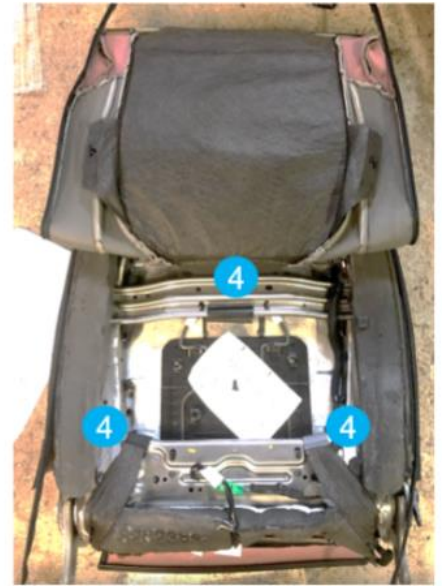
1. Open closeout Js
2. Unzip hidden zippers x2
3. Undo push pins to frame
4. Unclip J clips x3

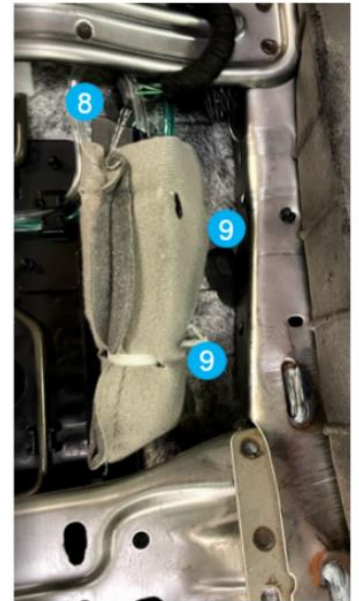
5. Unscrew lumbar screws x2
6. Unclip lumbar plastic bracket to frame x2
7. Unclip heater map wire
8. Unclip lumbar motor wire harness connector
9. Unclip lumbar motor clips to frame x2

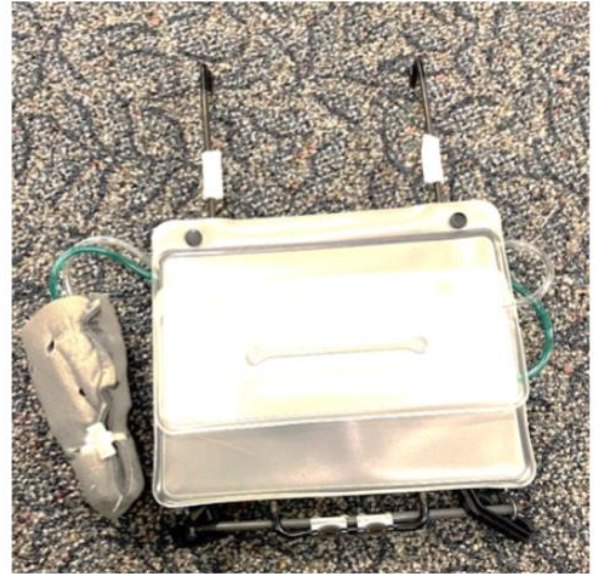
10. Flip over and lift trim/foam (SAB on OB side will not allow complete lift)
11. Unclip vent plenum from fan (if applicable)
12. Undo Z-bends and remove bad lumbar

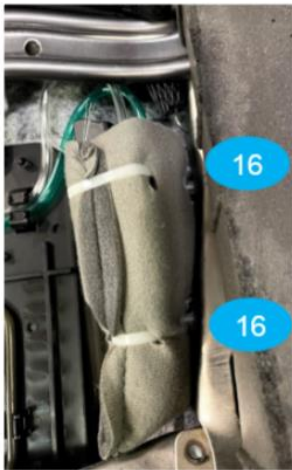
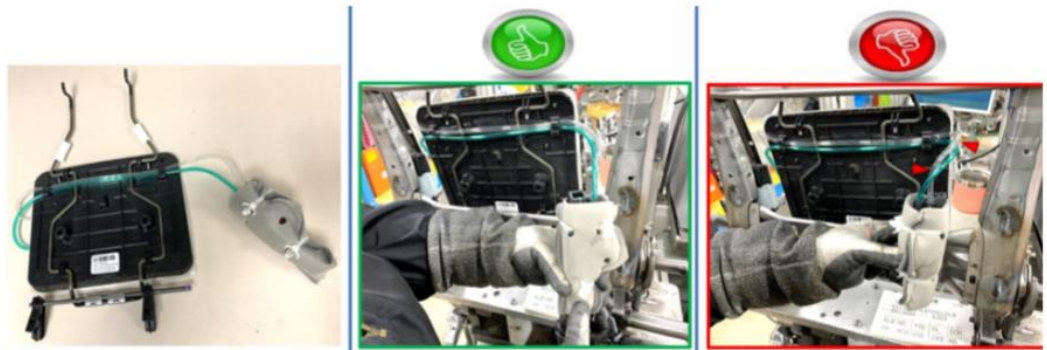
16. Clip lumbar motor clips to frame x2

INSTRUCTIONS/NOTES: Verify that the lumbar hose **IS NOT TWISTED / KINKED / PINCHED** when attaching the lumbar assembly to the frame.

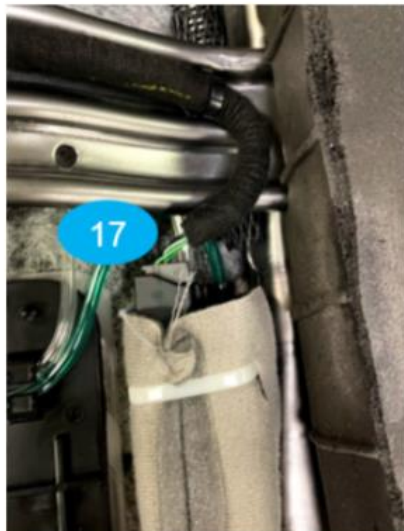
17. Clip lumbar motor wire harness connector

18. Screw in 2 screws 2.5±0.3Nm

19. Clip heater map wire
