## Mercedes-Benz

Campaign No. 2021050004, May, 2021

SUBJECT: **Model 907 Sprinter, Model Year 2019**  
**Update Incorrect VIN**

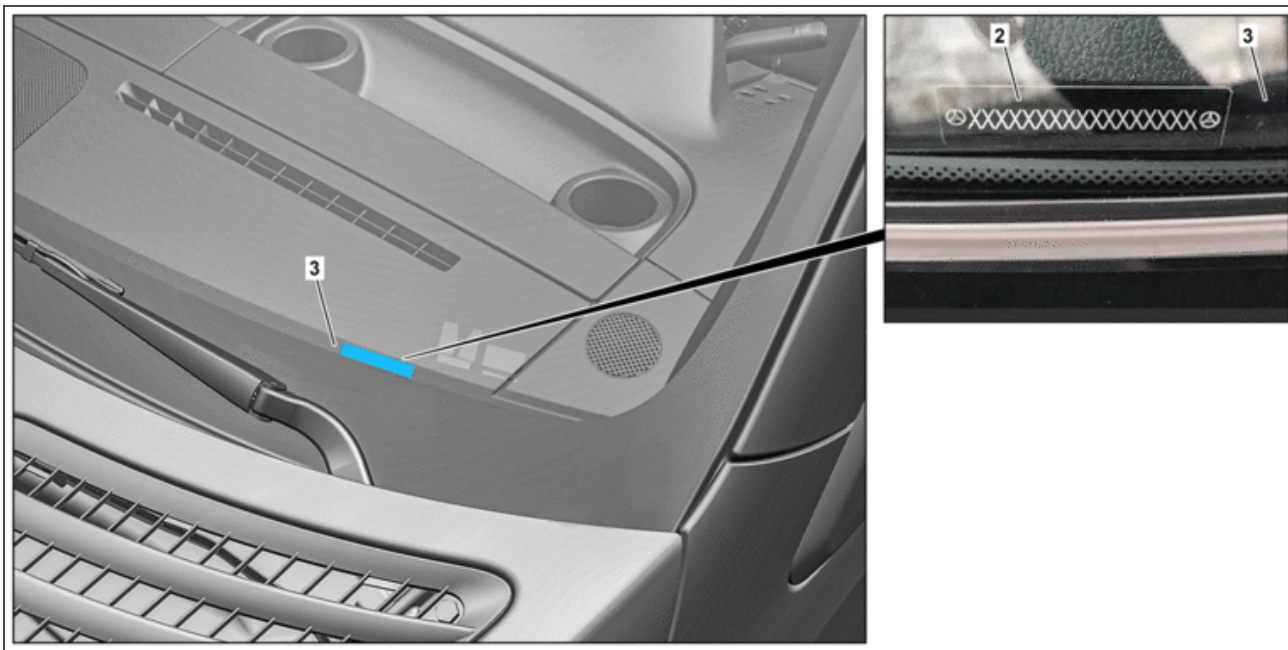
D60.00-A055-79

2 Information label

3 Instrument panel

| 3 | Replace information label (2). | <p>Bonding surface must be absolutely dry and free of dust and grease.<br/>This prevents any adhesion problems.</p> <p>Incorrect vehicle identification number:<br/><b>WDZPF0ED6KT016360</b><br/>Correct vehicle identification number:<br/><b>W1Z40FHYXKT016360</b></p> <p>Aid of helper required.<br/>Cleaner</p> | BR00.45-Z-1025-04A |

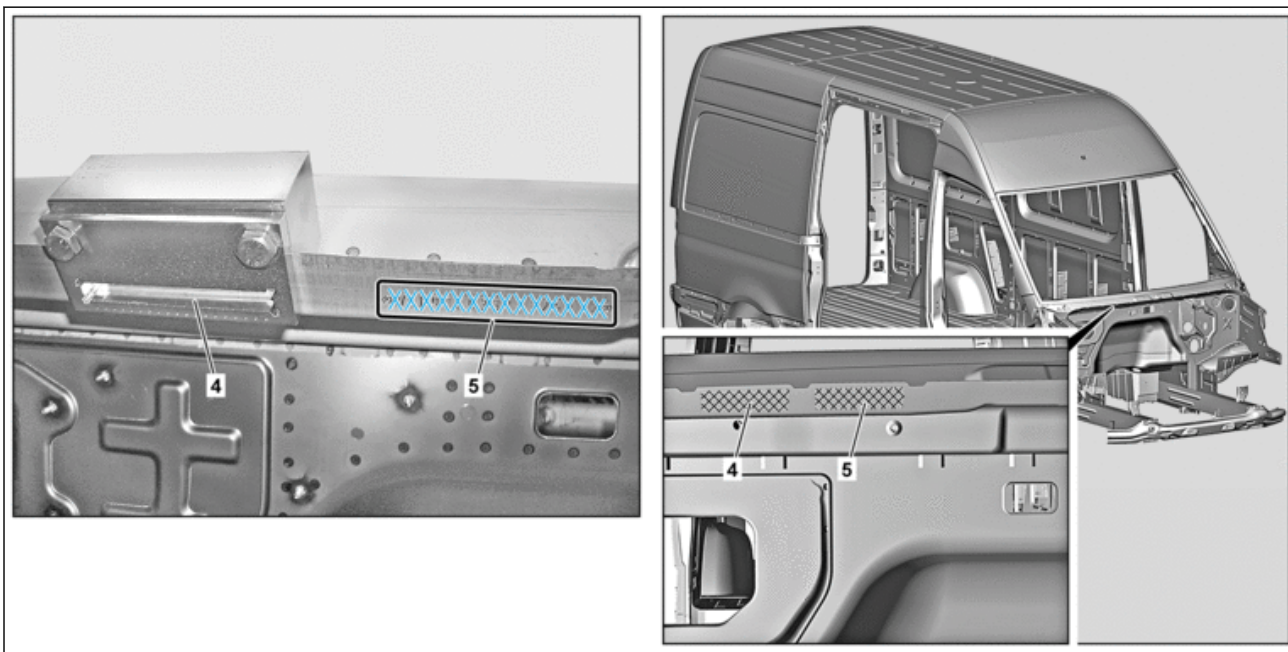
D60.00-A056-79

4 Reserve field for vehicle identification number

5 Standard field for vehicle identification number

| 5 | Remove engine compartment seal in area of reserve field (4). | | |
| 6<br> | Stamp correct vehicle identification number into reserve field (4). | <br>Cross out incorrect vehicle identification number in standard field (5).<br><br>Incorrect vehicle identification number:<br><b>WDZPF0ED6KT016360</b><br>Correct vehicle identification number:<br><b>W1Z40FHYXKT016360</b><br> Stamping guide<br> Star marking punch<br> Letter marking punch<br> Letter marking punch<br> Die stamp numbers | AR60.00-D-0800TS<br><br><br><br><br><br><br><br><br><br><br>906 589 10 63 00<br>000 589 02 39 00<br>000 589 00 39 00<br>000 589 03 39 00<br>000 589 01 39 00 |
