# AfterSales Diagnostic Sheet

**MAS002589**

## Hood locks checklist

**Section:** 09.23 - 1 FRONT LID OPENING BUTTON

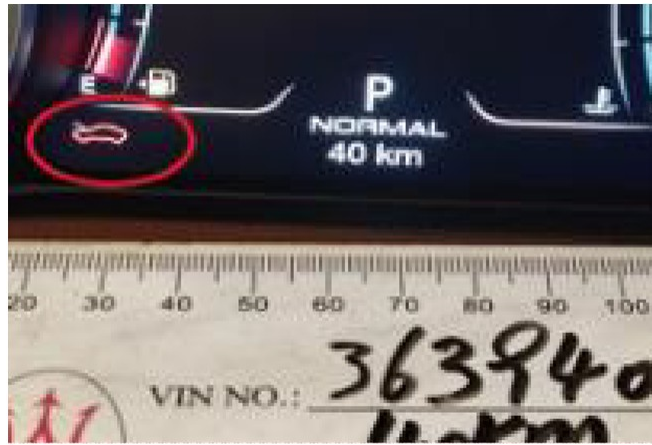
- a) Attach a photo of the open hood warning light on the IPC as in Figure 1 to the BOL.

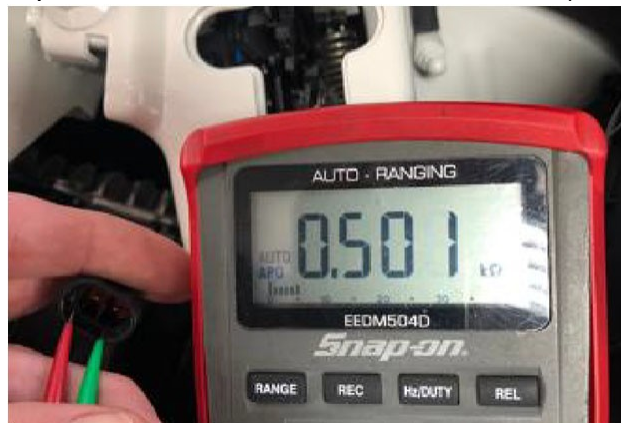
Figure 2

- b) Attach the DTC and parameters report of the car in pdf format to the BOL.
- c) With open hood lock(s), measure their internal resistance as shown in figure 2. (open lock -> expected value between 494 and 504 Ohm).

- e) If the resistance values are not correct, the locks must be replaced.
- f) With defective locks removed from the vehicle, verify if the internal resistance values in open and closed positions comply with the specifications indicated above.

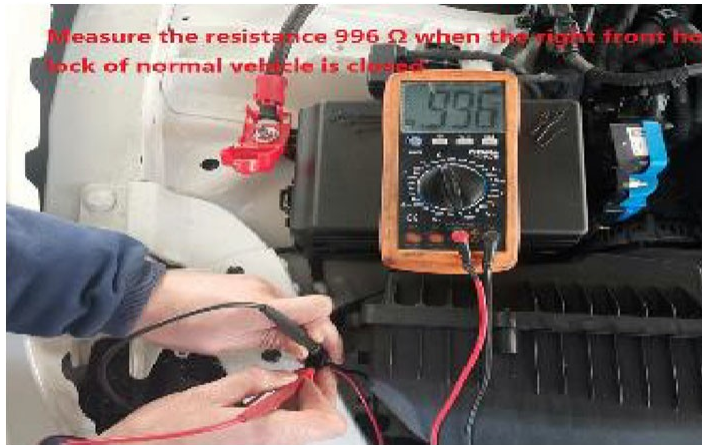
Figure 3

- d) With closed hood locks, measure their internal resistance as shown in figure 3 (closed lock -> expected value between 988 and 1008 Ohm).

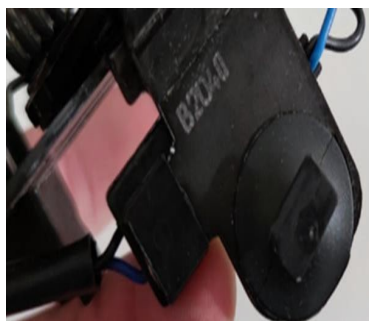
Figure 4

- g) Attach to the BOL photos of the lock's ID data as shown below in figure 4.
