## SS 284 TBB 2021 DD5 low dash heat

C2 with DD5 Engine

Lack and or low heat in the drivers area

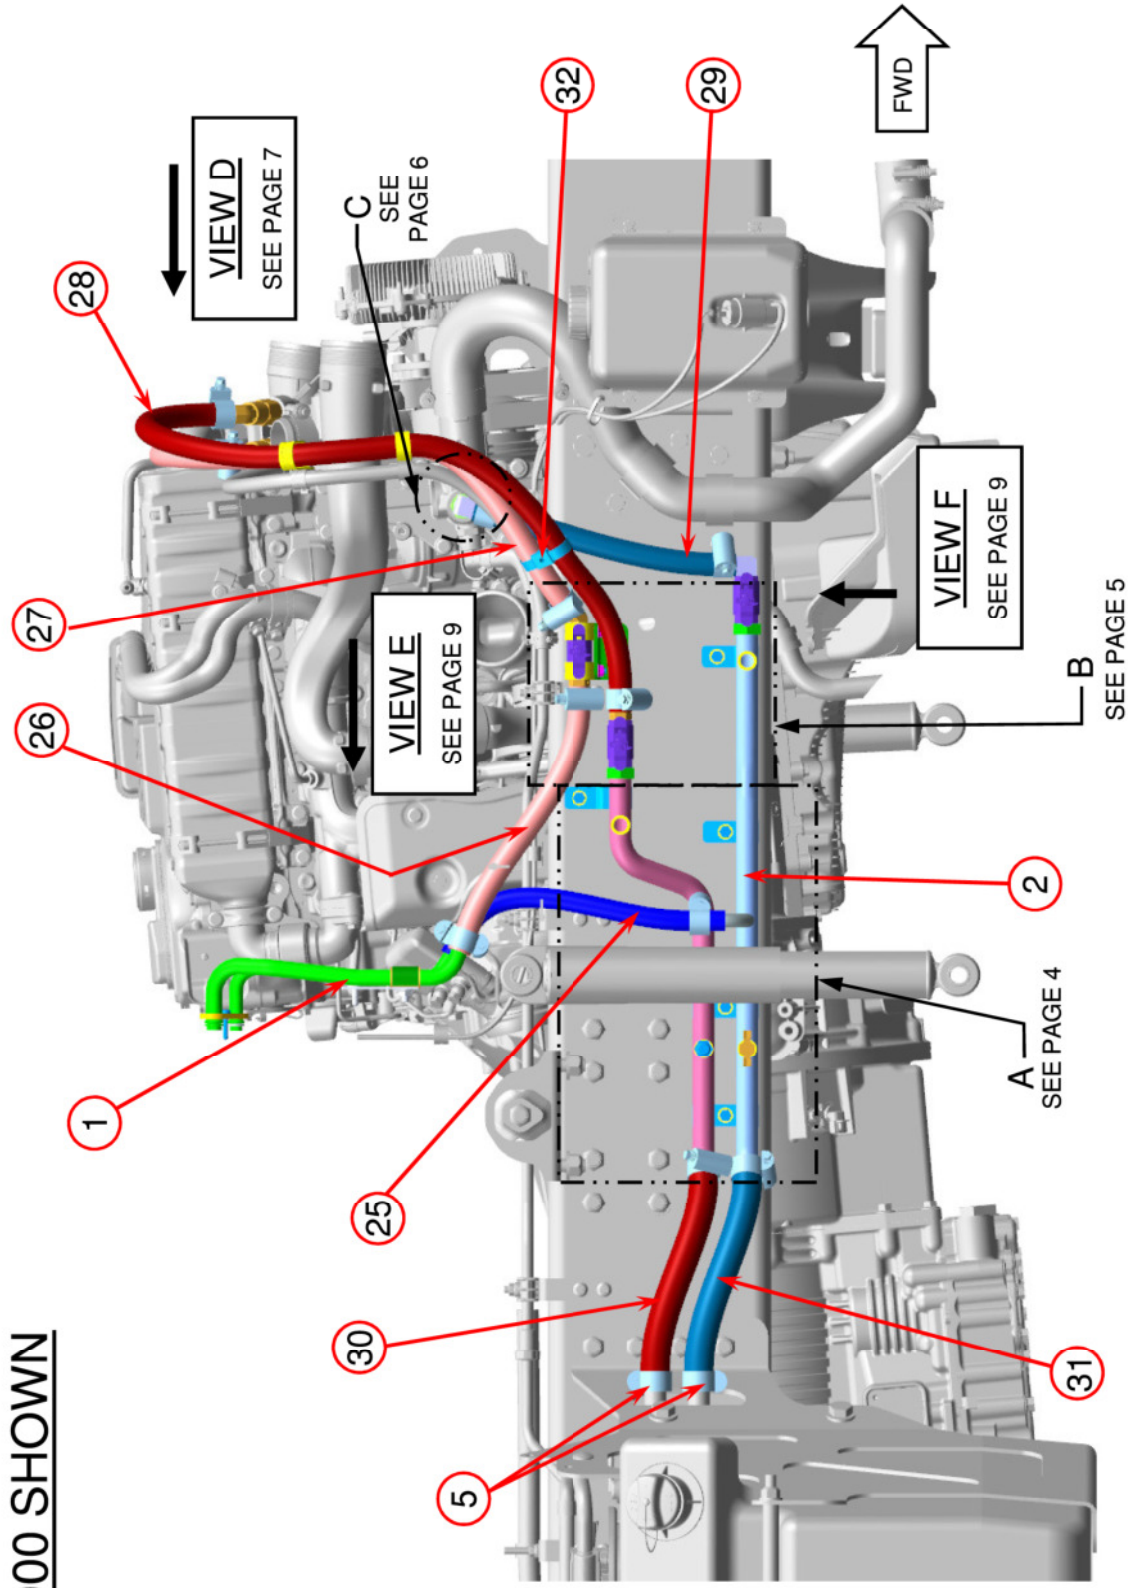
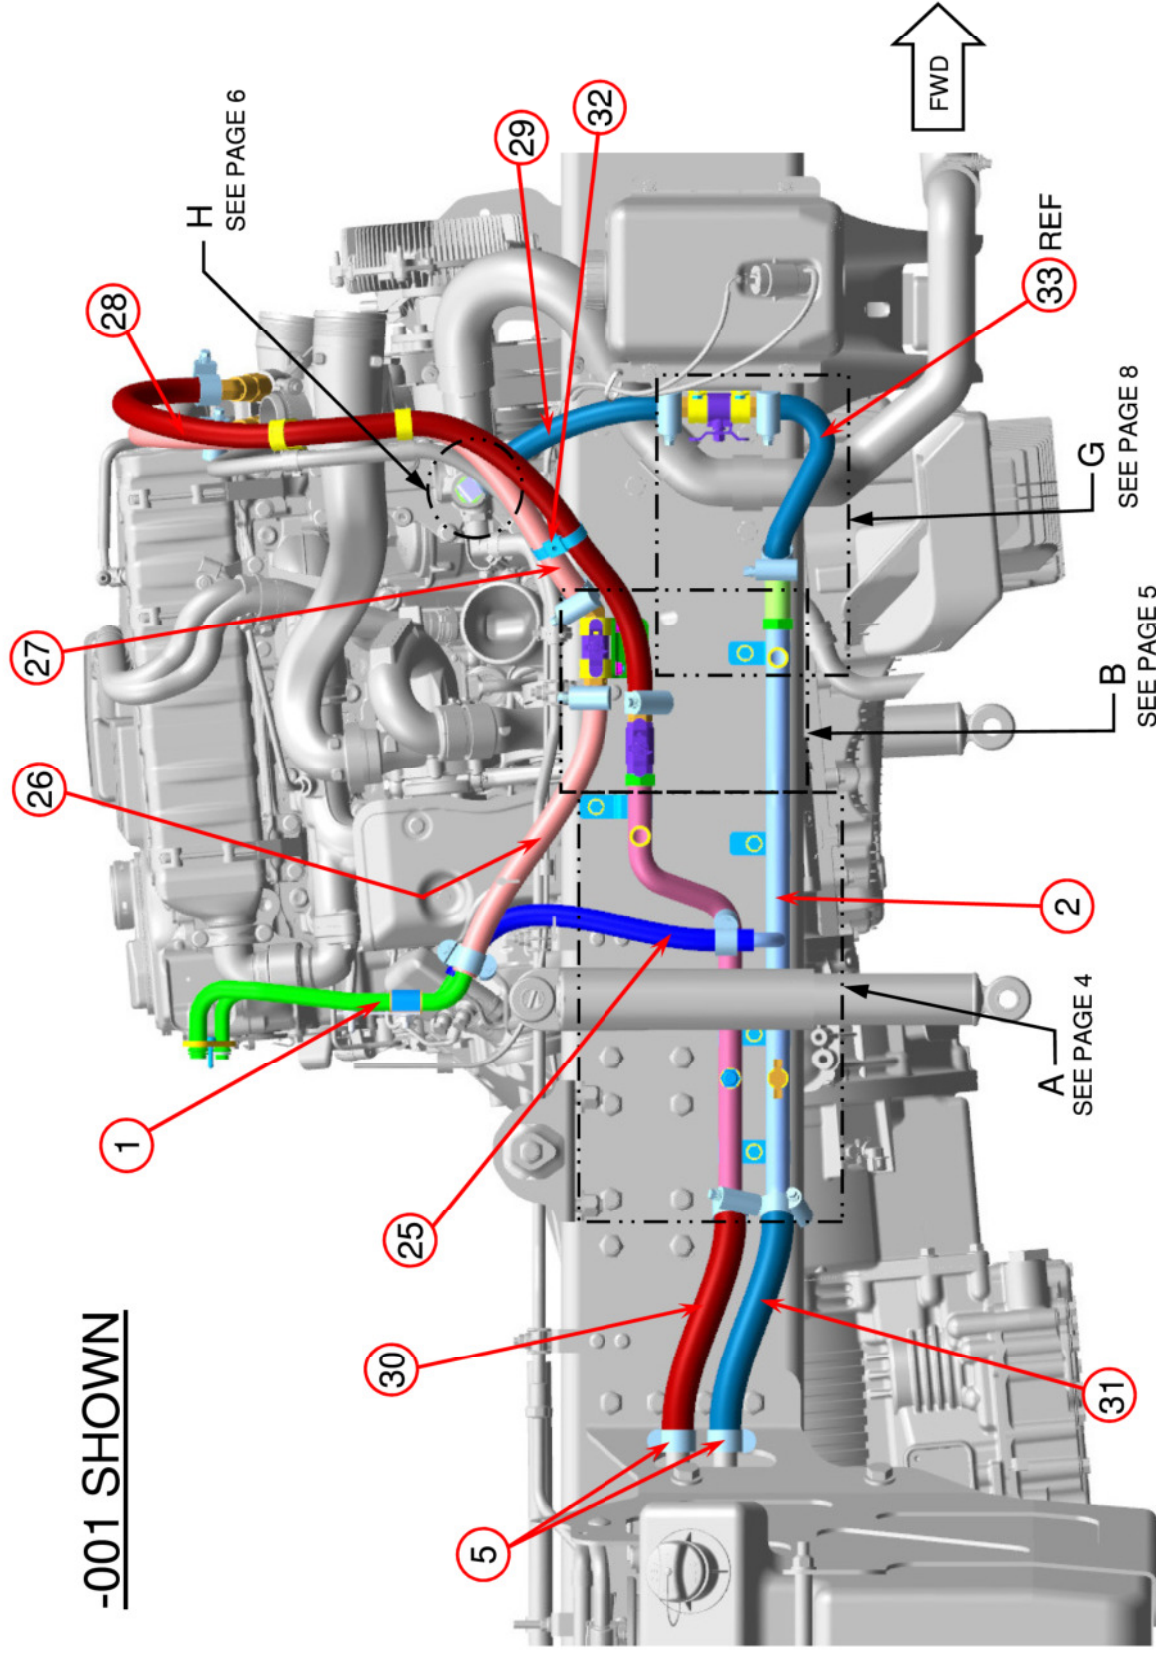
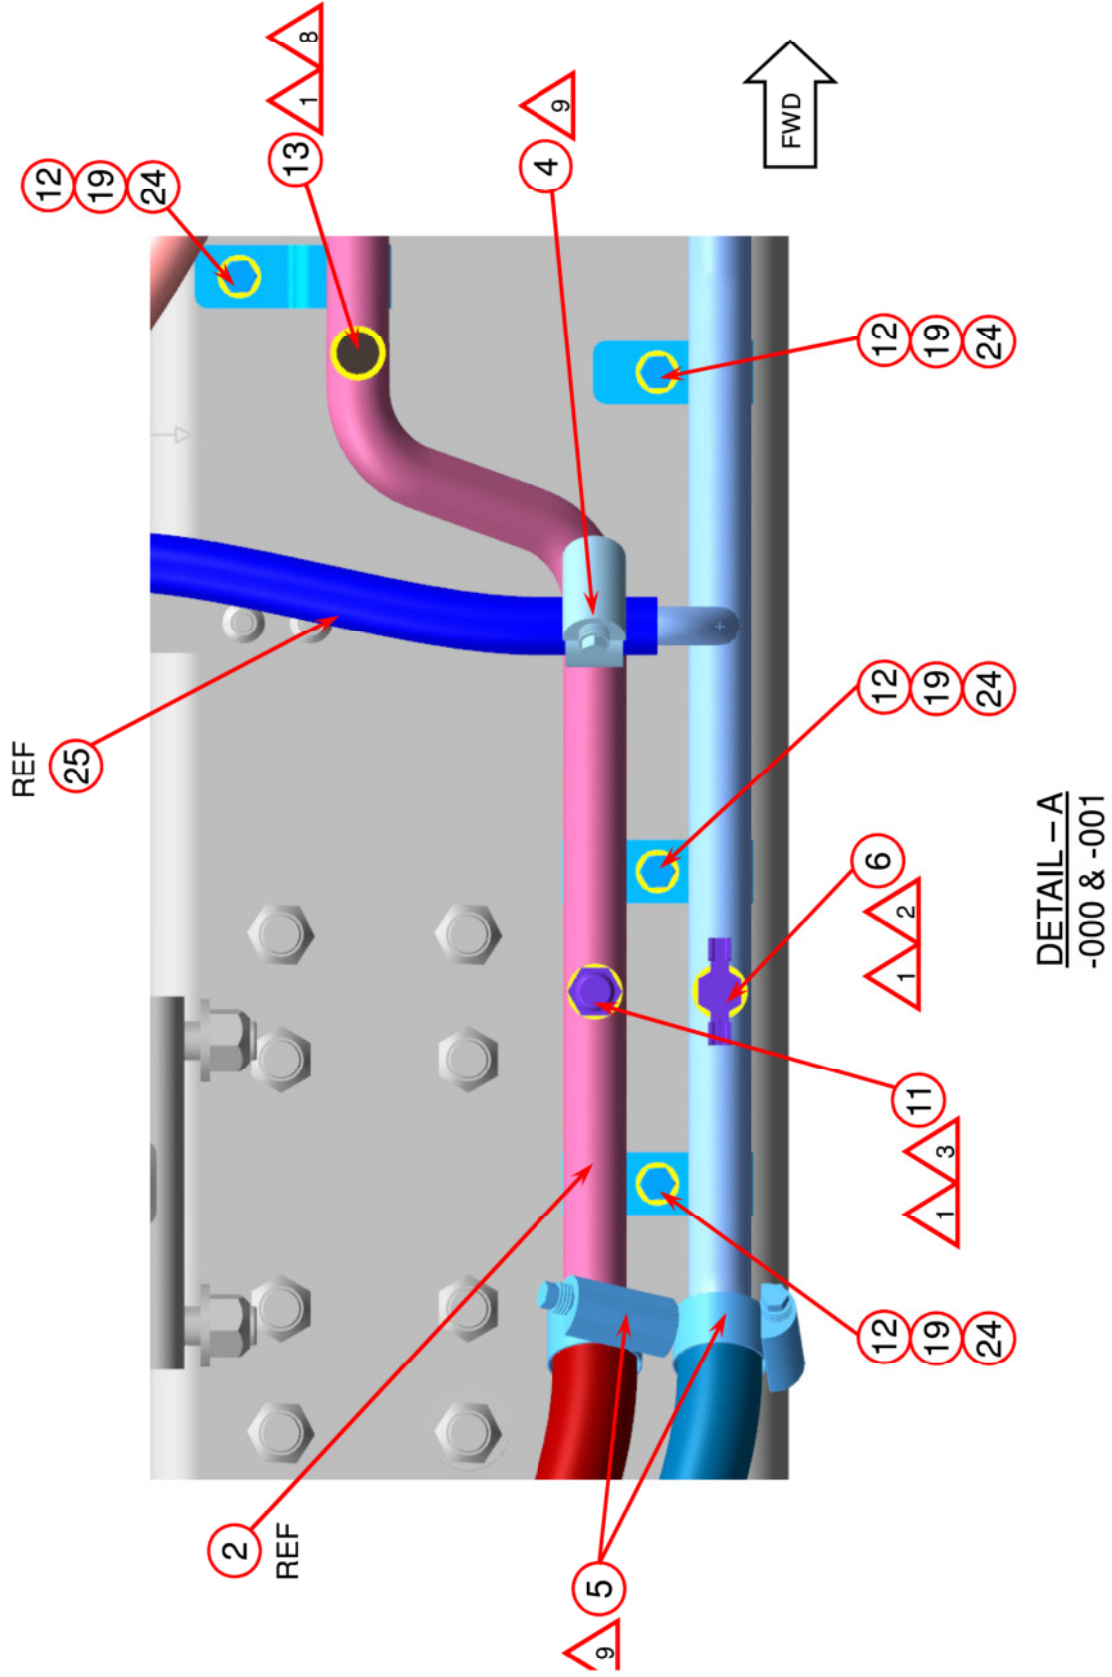
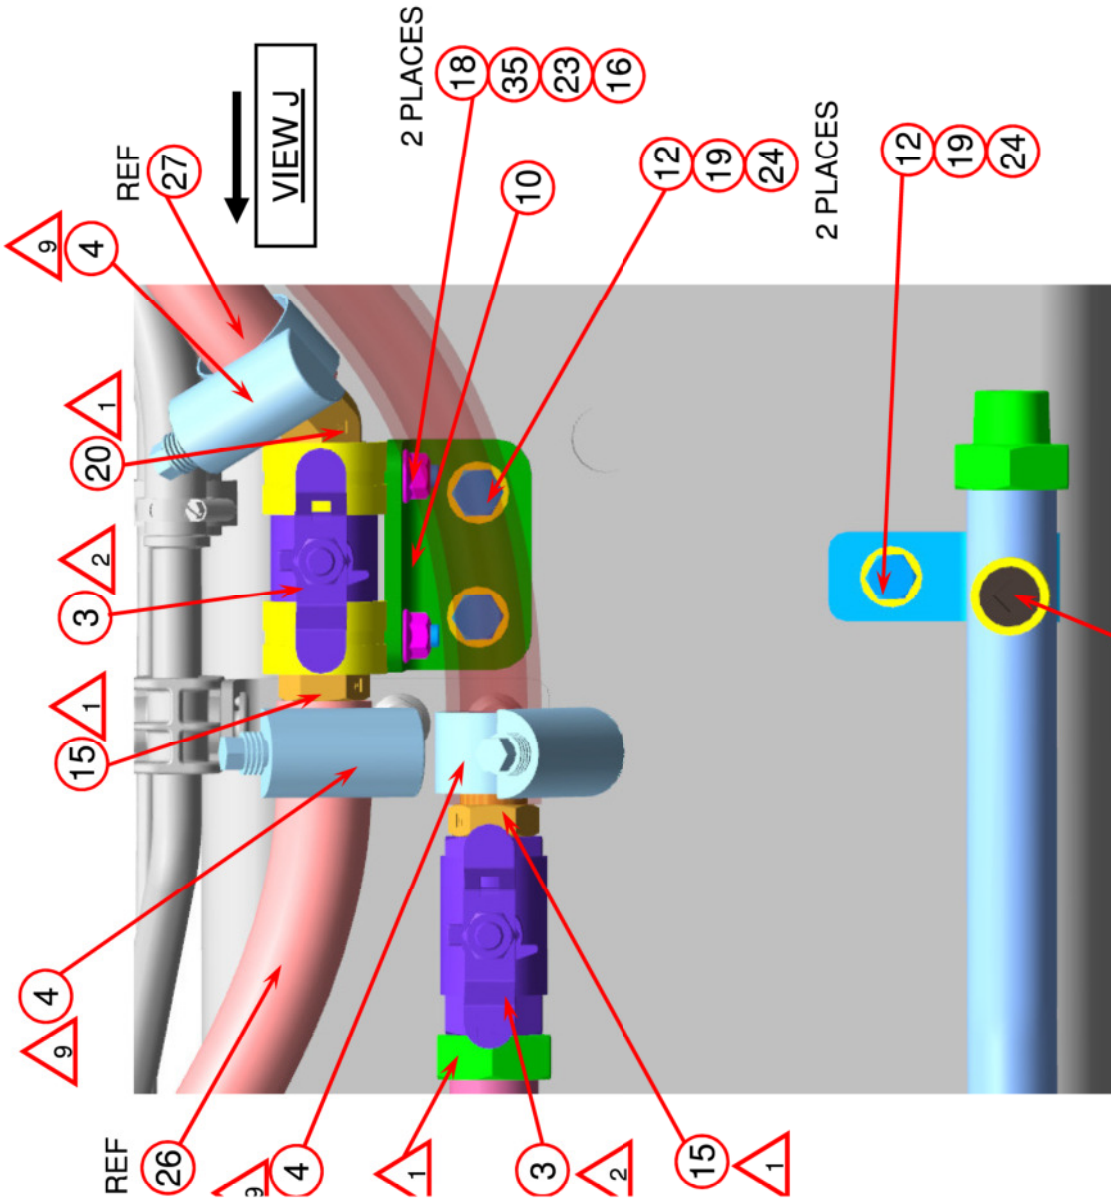
PAGE  
2 of 3

Unknown, as Detroit is looking into the matter. if you have this concern you can add a Flow Restrictor TBB 66000366 in the return line at the manifold tubing. Refer to diagram D22-75463, page 2 item 31

Shut the return line valve off, and the line connecting to the manifold pipe you can pinch the line off with an smooth type clamp. Loosen the clamp, remove the hose, and insert the Restrictor.
