BLOCKED AIR CONDITIONER DUCT

Bulletin Type:	TSB	Publication Date:	June 2021
Bulletin #(s):	21-019	Make(s):	Jayco
Job Code(s):	9801571	Model(s):	White Hawk
Flat Rate(s):	A. .10 Inspection only A/C ducting B. .30 Inspection and repair A/C ducting	Model Year(s):	2021

Incident:	Air conditioner ducting may be blocked with foil tape
Affected Units:	M1440123-0164 M14A0417-0507 M14H0129-0203 M14J0225-0284 M14K0171-0206
Parts Kit:	Parts Kit #: N/A
	Parts Kit Contents: N/A
Misc. Tools & Supplies:	Utility Knife

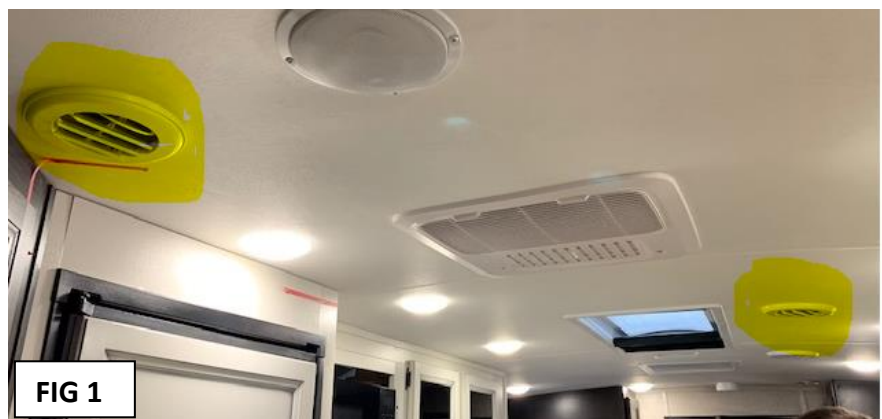
1. Inspect unit operation for proper airflow by turning on the A/C System and checking for air output from the two air vents highlighted in yellow (fig 1).
2. If airflow is present from the air vents - no remedy is required. Use flat rate Code **9801571A** for repair. No further action is necessary.

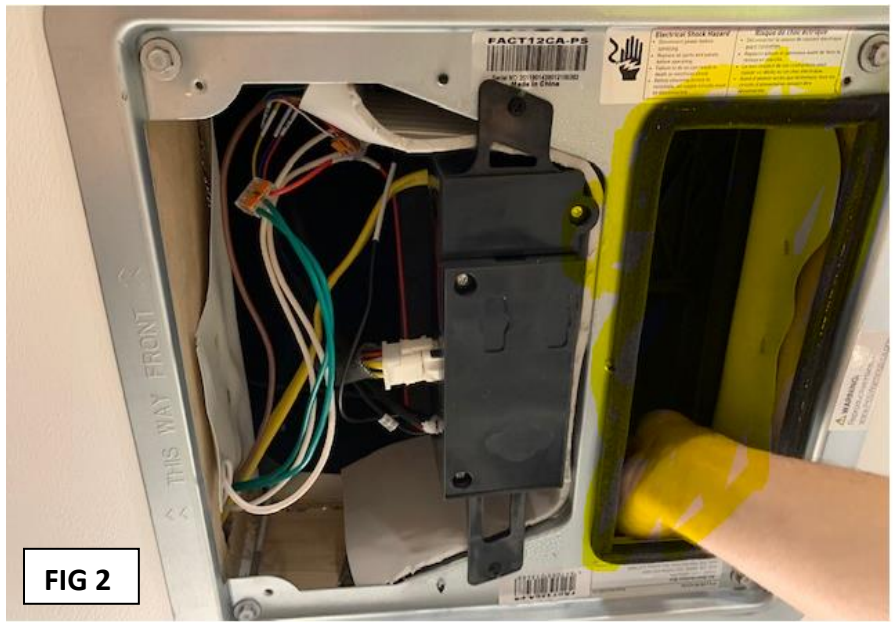
3. If airflow is NOT present from the air vents – a remedy is required. Proceed to step four.
4. Remove the A/C Cover by removing (4) screws; (2) are under the small plugs and (2) are under the removable vent. Save the screws.
5. With the cover out of your way, you will be able to reach in with your hand to access the plenum, which feeds air to both ducts. (Fig 2).

6. In the opening at the A/C unit, cut or remove the foil tape at both duct openings to allow airflow to move through ducting. (Fig 2) illustrates this step.
7. This process will help airflow due to the air duct running on both sides of the opening. One on the door side and one on the off door side.
8. Check A/C for proper airflow output at the vents. If A/C is running properly reattach A/C cover. Use flat rate code **9801571B** for repair.
