**Title:** SiriusXM Reception Issues with Film Antenna in Hi-Rise Sleeper

**Applies To:** Hi-Rise Sleeper with Film Antenna and SiriusXM Radio

Hi-Rise Sleepers equipped with a film antenna 4136172C1 and SiriusXM satellite radio may experience poor reception in the northern regions of North America. The reception may be worst when traveling north or east. The trailer can cause a shadowing affect, blocking proper reception for the antenna. Using a stand-alone Satellite Digital Audio Radio Service (SDARS) antenna can improve satellite radio reception.

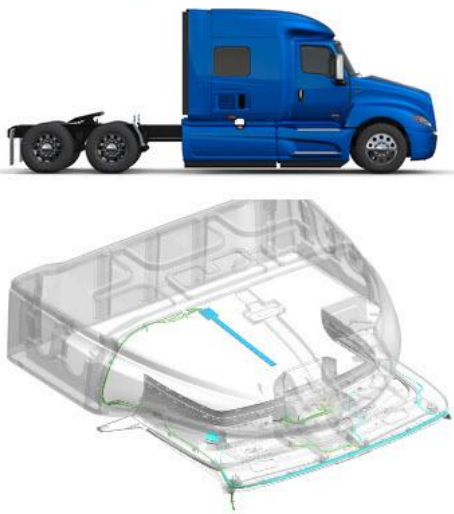
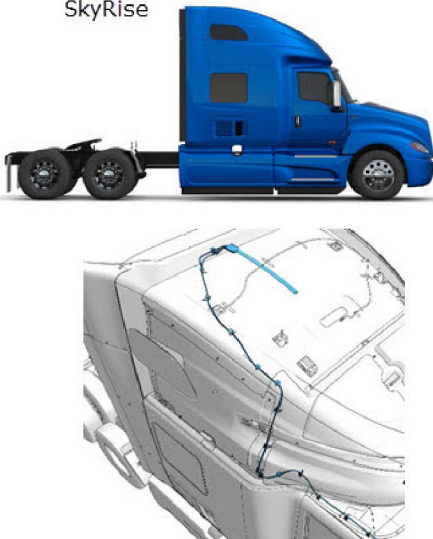
| Figure 1 - Cab Configurations | |
|---|---|
| <p>HiRise</p> <p>This configuration may experience reception issues with satellite radio</p> | <p>SkyRise</p> <p><b><i>This configuration is not impacted</i></b> and does not experience satellite radio reception issues with the film antenna. Film antenna is mounted higher due to cab type.</p> |

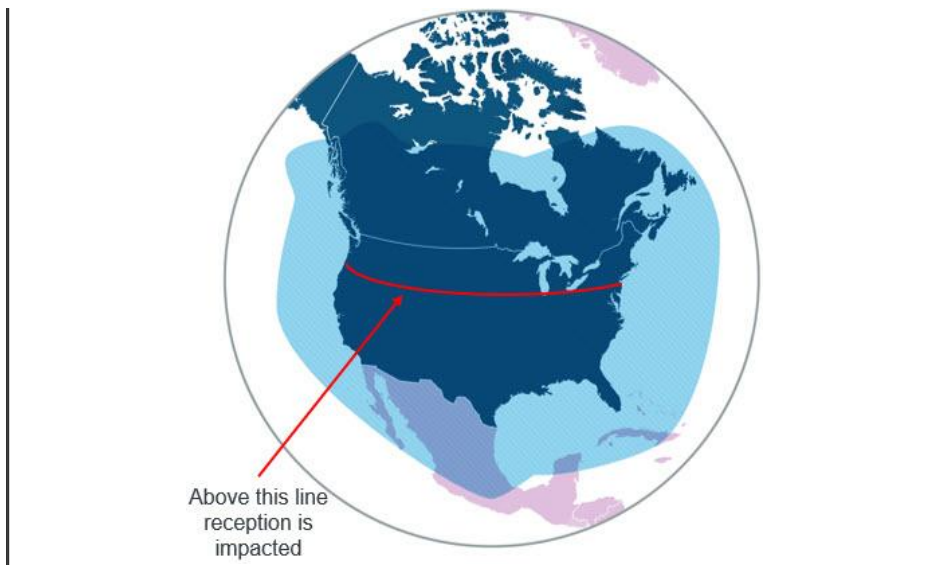
**Figure 2 - SiriusXM Coverage Map and Impacted Region**

| Step | Action | Decision |
|---|---|---|
| #1 | <b>DIAGNOSTIC:</b><br><br>Review the complaint, radio type and vehicle configuration.<br><br>Example feature of satellite radio:<br>08RPU - AM/FM/WB/ <b>SiriusXM</b> /Clock/Bluetooth/USB Input/Auxiliary Input<br><br>Example features of Hi-Rise Sleeper:<br>16AUM - CAB Conventional, <b>Hi-Rise Sleeper</b> Cab; 56" Seat to Inside Back of Cab, with 37" Wide Bunk<br>16AUN - CAB Conventional, <b>Hi-Rise Sleeper</b> Cab; 73" Seat to Inside Back of Cab, with 42" Wide Lower Bunk<br><br><b>Is the vehicle a Hi-Rise Sleeper experiencing satellite radio reception issues in northern North America?</b> | Yes: Continue to repair steps |

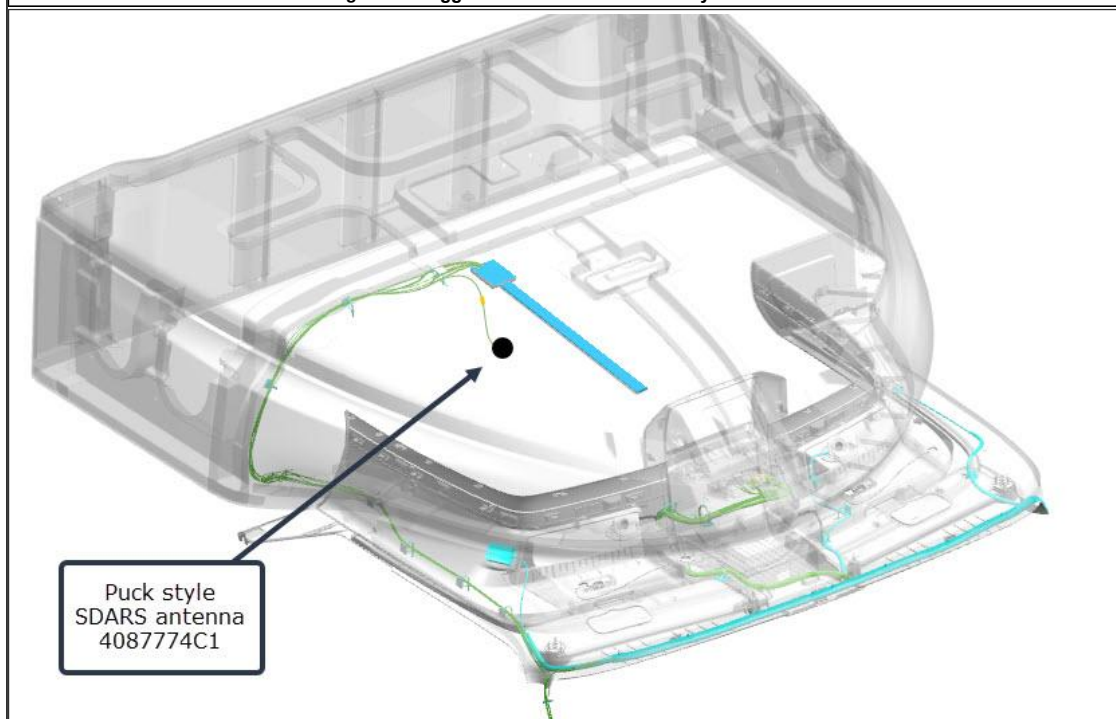
**Figure 3 - Suggested Placement of Puck Style Antenna**

1. Follow 0000885380 - 2017-2020 International LT / RH and LoneStar Technician Manual (Service and Diagnostic) to remove headliner to gain access to the film antenna and connectors.
2. Unplug the yellow "curry" colored connector from the film antenna. This is the antenna for the satellite radio.
3. Plug the puck style antenna into the antenna cable.
4. Using industrial strength two-sided tape or Velcro, adhere the puck style antenna to the roof. Refer to *Figure 3* and *Figure 4*.
  - Place the puck style antenna on the right (passenger) side of the vehicle, as far forward as you can without pulling on the harness cable. Verify the headliner can be re-installed without interference at that location.
5. Re-install the headliner

Install a puck style antenna in the hi-rise sleeper for satellite radio reception. The film antenna will remain for all other functions except satellite radio.
