15-029: Power Steering Reservoir Cap Separation

15-029

Power Steering Reservoir Cap Separation - Cap May Separate During Removal

6/1/2021

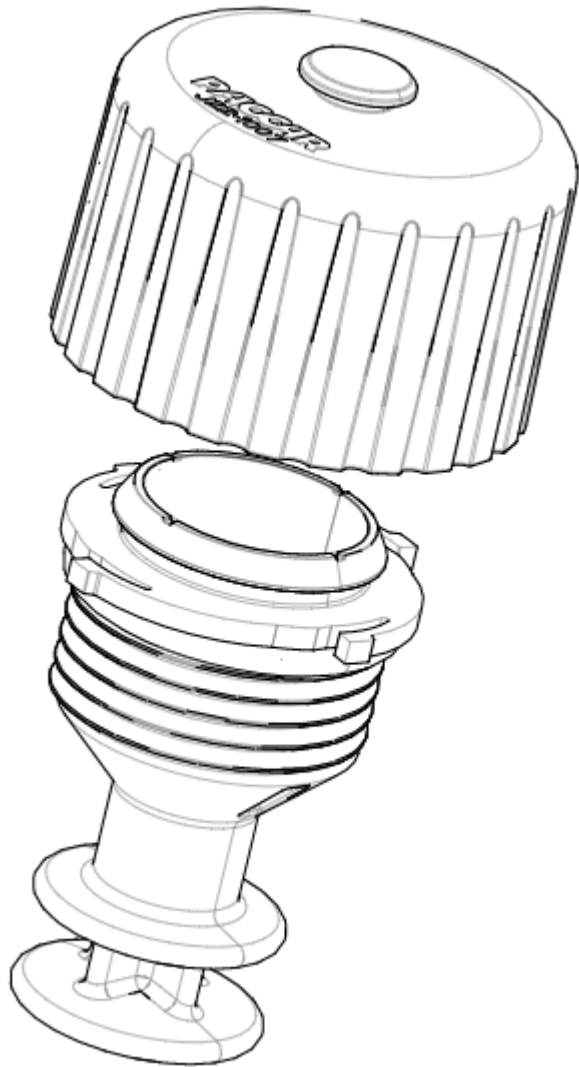
The power steering reservoir cap may separate into two pieces during removal.

The power steering reservoir cap may separate during removal when it is pulled instead of twisted off as intended. Reassemble the power steering reservoir cap instead of replacing it.

1. Press the separated portion of the power steering reservoir cap back into the base of the cap that remained attached to the power steering reservoir.
2. Ensure that the top portion of the cap is firmly attached to the base of the cap.
3. Twist the power steering reservoir cap to remove it from the reservoir.

Do not use pliers to remove the power steering reservoir (PSR) cap base, as this may result in damage to the cap.
