## Volvo Chassis - Model VNL, VNR - DEF Fill Door Loose, Vibrating, Broken - Repair Information

On certain VNL and VNR model Volvos built [August 21<sup>st</sup>, 2017 through January 01, 2021](#) and equipped with chassis fairing p/n 84744212 or 84744213, the DEF fill door in the fairing may become loose or break. A new magnet plate has been introduced to address this issue. The previous style plate Volvo p/n 84744218 comes installed in fairing p/n 84744212 or 84744213 and will have to be removed by drilling out the rivets. The new plate will then be riveted into place.

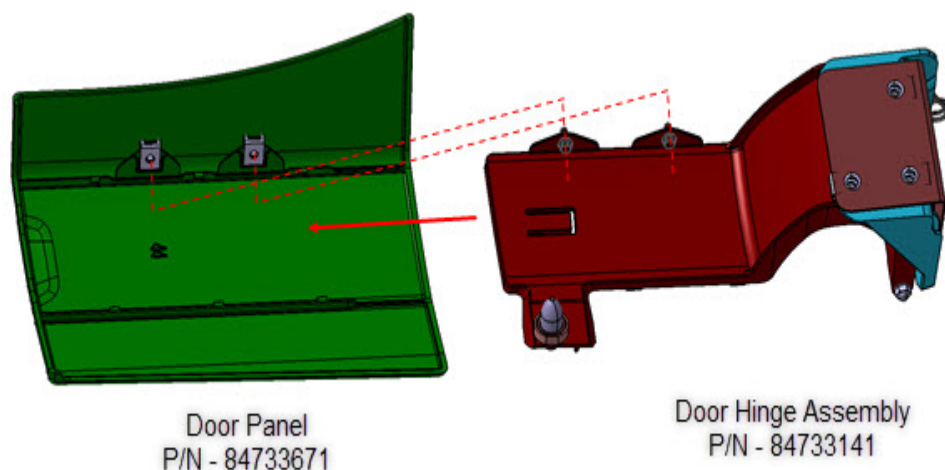
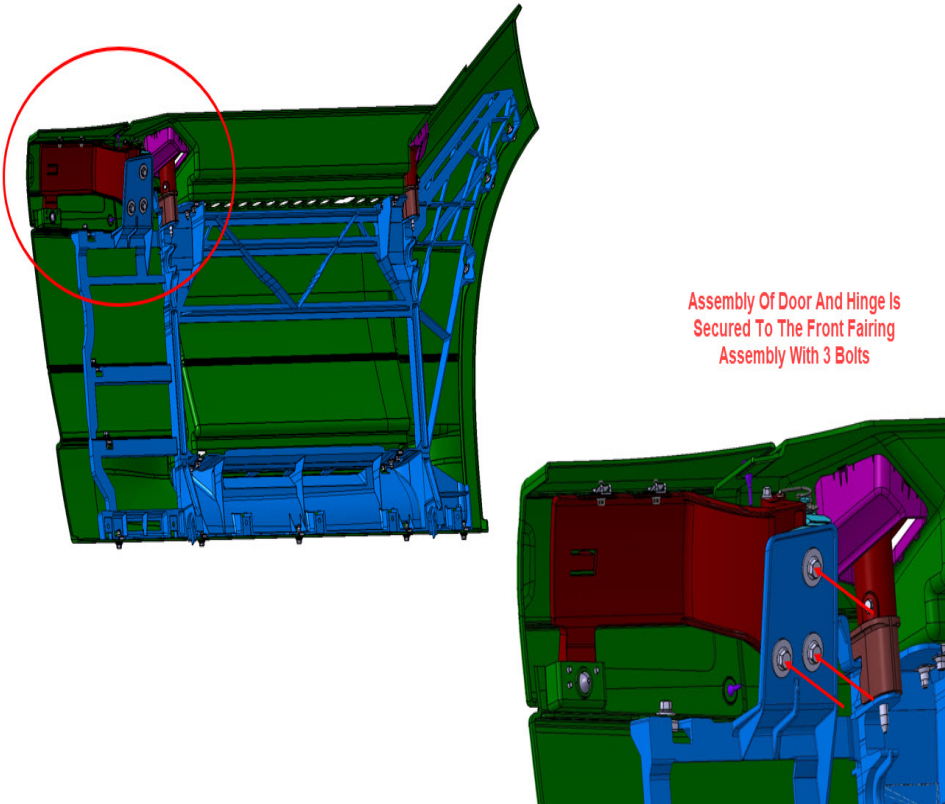
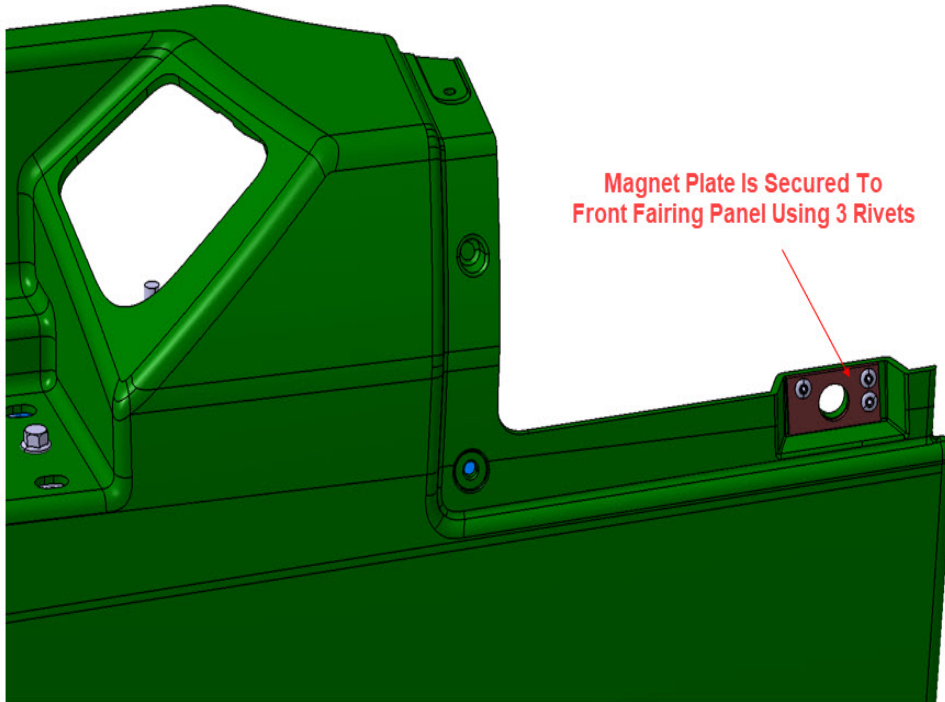
Door hinge assembly slides into the backside of the door panel and is secured with 2 fasteners at the top
