TECHNICAL TOPICS

BODY/CHASSIS

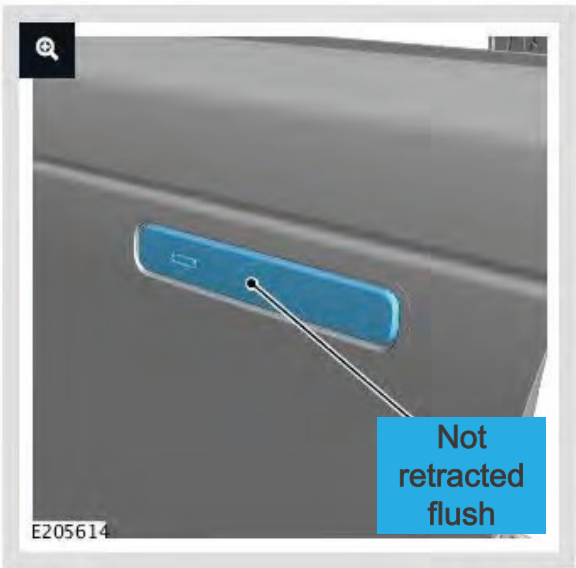
Deployable Exterior Door Handles	21MY I-PACE, RR Velar, RR Evoque
<p><u>Customer Voice:</u></p> <ul style="list-style-type: none">- A customer may report that the exterior door handle does not fully retract in the flush position in freezing temperatures. (This does not affect door latch operation.) <p><u>Technical Description:</u></p> <ul style="list-style-type: none">- TSB JLRTB02041NAS3 has been published to address this concern. Please note: all 4 door handles should only be replaced when the criteria of the TSB is met. <p><u>Status:</u></p> <ul style="list-style-type: none">- The door issue related to this TSB has been addressed in production at the following VINs: RR Velar = MA301206, RR Evoque = MH131144 and I-PACE = M1613540.- Door handles built after the assured VINs should not be replaced unless the guided flow diagnostics leads to this change.- The guided flow for door entry system 9360 is now live and includes deployable handles.

<p>The image shows a close-up of a blue door handle on a dark grey door. The handle is not fully retracted into the door panel. A white callout box with a blue background and white text points to the handle with the text "Not retracted flush". The image is framed with a white border and has a magnifying glass icon in the top left corner. The text "E205614" is visible in the bottom left corner of the image frame.</p>
