HYUNDAI

Technical Service Bulletin

GROUP CAMPAIGN	NUMBER 21-01-035H
DATE JUNE, 2021	MODEL(S) SONATA HYBRID (YF HEV)

SUBJECT: AIR FILTER AND NVLD REPLACEMENT
(SERVICE CAMPAIGN T6H)

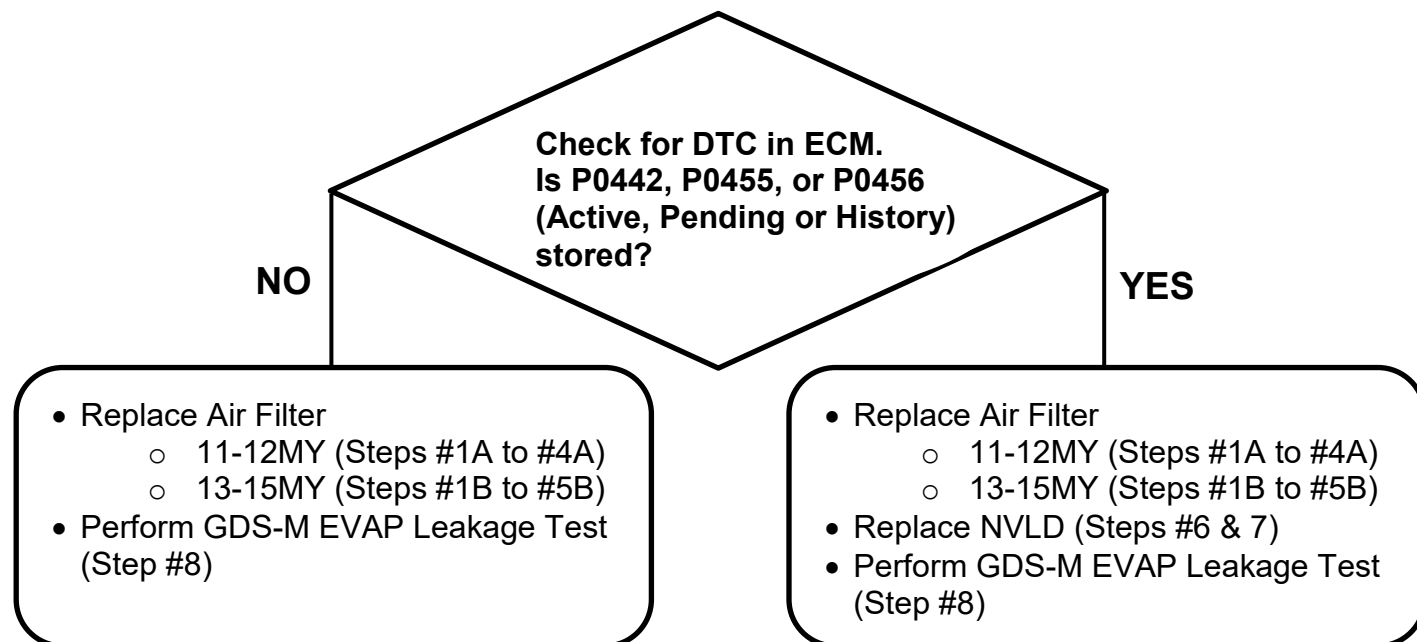
Part Number	Description	Photo	Remarks
31450-4R050QQH 11~12MY	AIR FILTER KIT	 	All vehicles
31450-4R000QQH 13~15MY	AIR FILTER KIT	 	All vehicles
31480-4R100QQH	NVLD Pressure Sensor Assembly	 	Replace if DTC P0442, P0455, or P0456 is stored

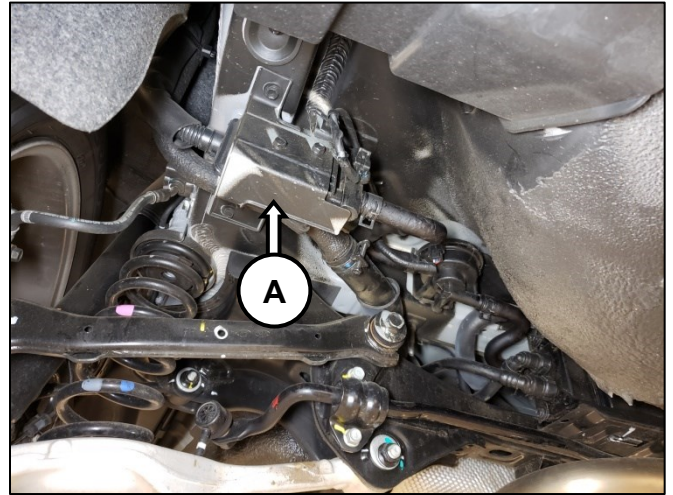
- 1.A Lift up the vehicle on a hoist and locate fuel tank air filter assembly (A).

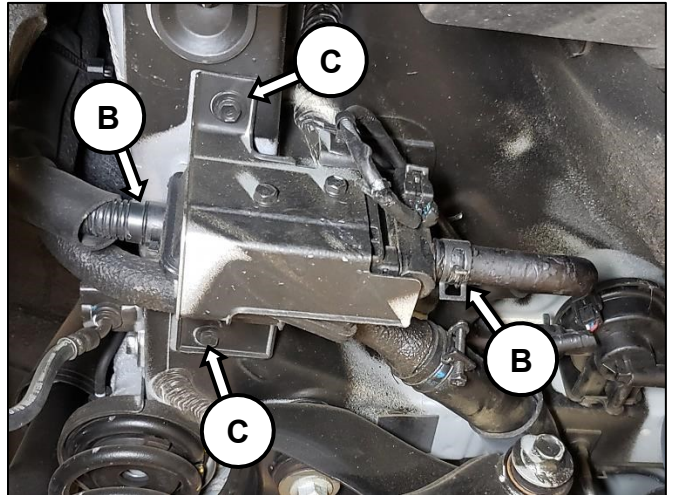
- 2.A Release the hose clamps and disconnect ventilation hoses (B).

Loosen fuel tank air filter mounting bolts (C) and remove fuel tank air filter assembly.

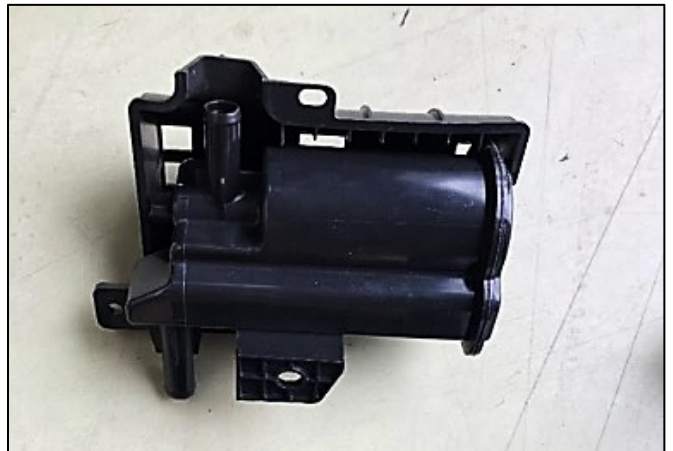
- 3.A Install the new air filter.

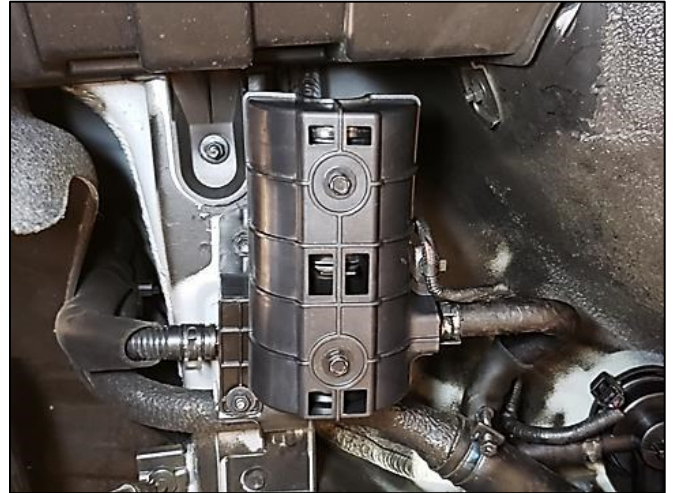
- 4.A Reinstall the air filter and removed parts in reverse order of removal.

Fuel tank air filter installation bolt:
2.3 ~ 3.3 N.m (0.2~0.3 kgf.m, 1.7 ~ 2.5 lb-ft)

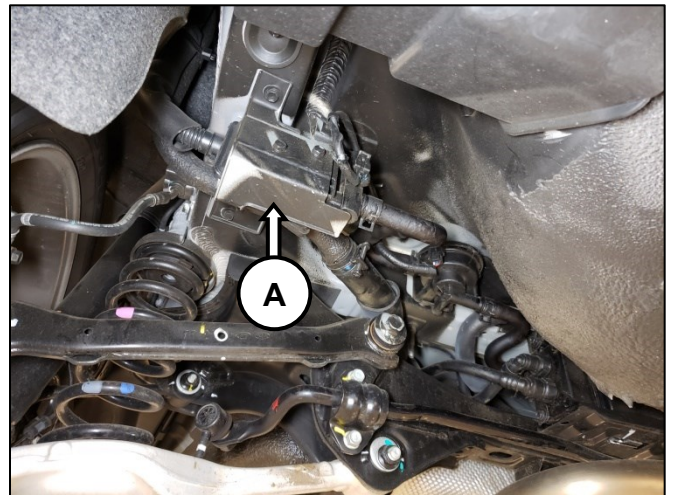
- 1.B Lift up the vehicle on a hoist and locate fuel tank air filter assembly (A).

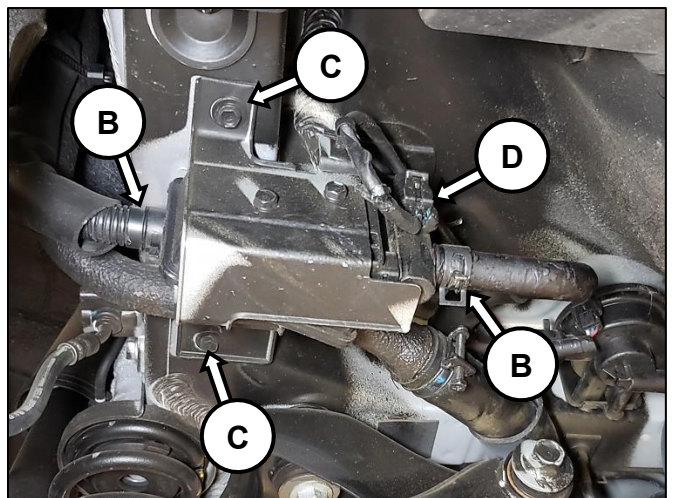
- 2.B Release the hose clamps and disconnect ventilation hoses (B).

Disconnect canister close valve (CCV) connector (D) and detach the harness CCV pig tail harness from key hole.

Loosen fuel tank air filter mounting bolts (C) and remove fuel tank air filter assembly.

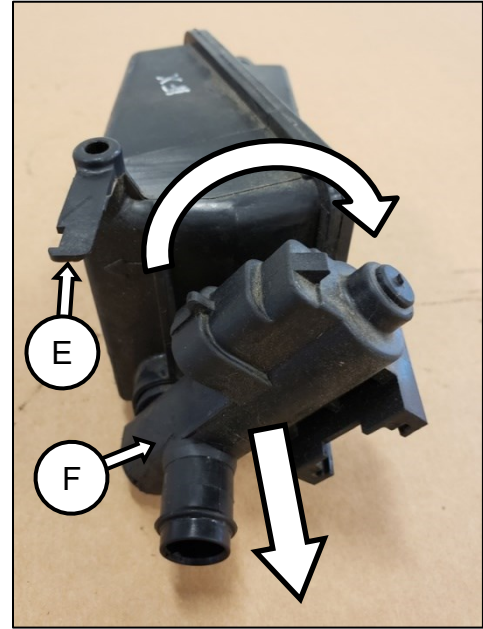
- 3.B Lift up the locking lever (E).

Turn the canister close valve (F) clockwise approximately 30 degrees and pull away straight from the air filter to separate.

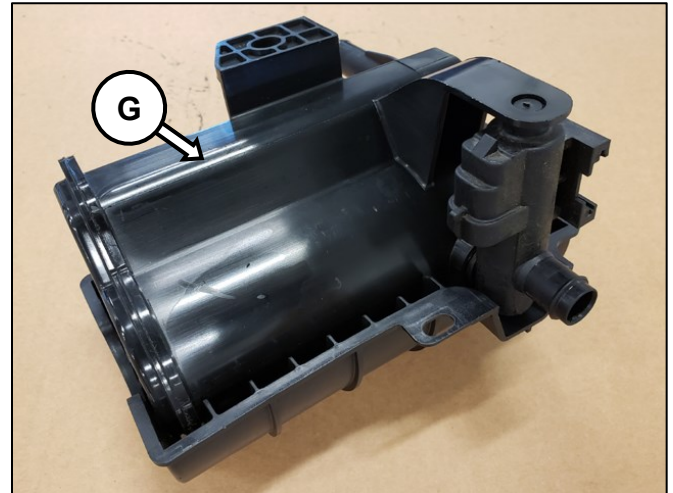
- 4.B Install the removed CCV to the new air filter (G) and place in the locking lever to secure.

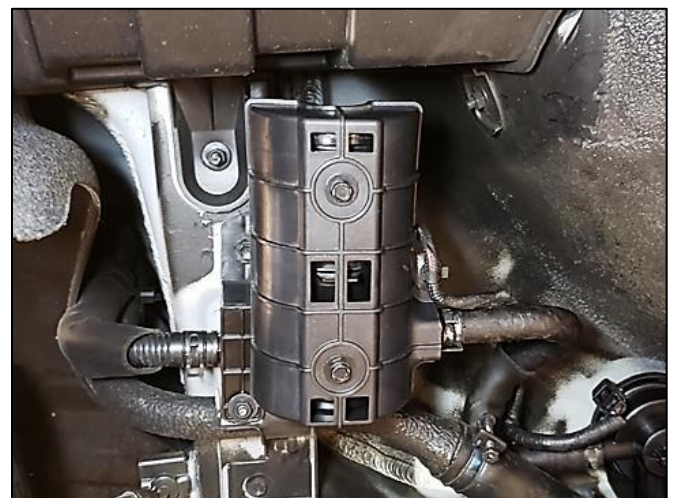
- 5.B Reinstall the air filter, CCV and removed parts in reverse order of removal.

Fuel tank air filter installation bolt:
2.3 ~ 3.3 N.m (0.2~0.3 kgf.m, 1.7 ~ 2.5 lb-ft)

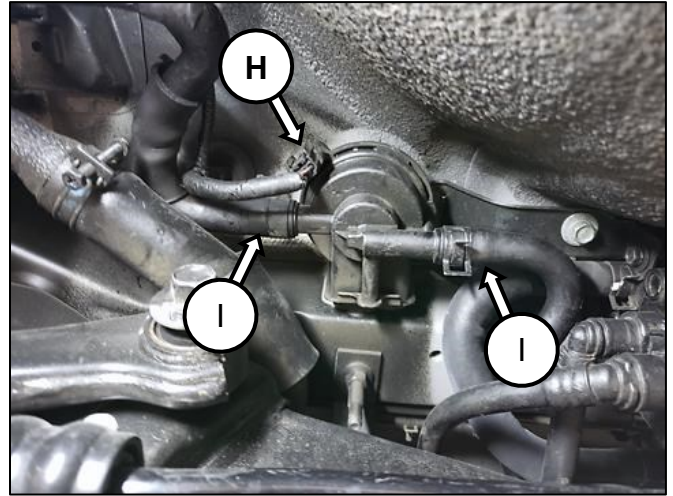
6. Disconnect the NVLD connector (H).

Release the hose clamps and disconnect the vent hoses (I).

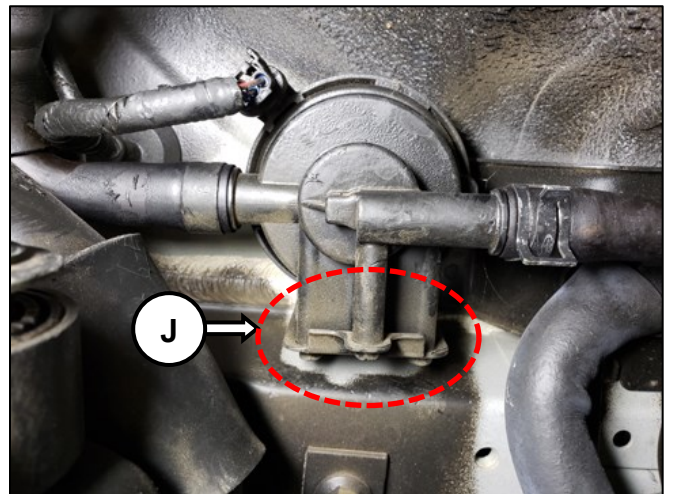
7. Loosen the NVLD mounting bolts (J) and remove the NVLD.

Note: Mounting bolt heads (8 mm) are facing towards the body. It is recommended to utilize a ratcheting wrench.

Install the new NVLD and reinstall the removed parts in reverse order of removal.

Tightening Torque: 2.3 ~ 3.3 N.m (0.2 ~ 0.3 kgf.m, 1.7 ~ 2.5 lb-ft)
