Technical Service Bulletin

GROUP FUEL SYSTEM	NUMBER 21-FL-002H
DATE JUNE, 2021	MODEL(S) SONATA HYBRID (YF HEV)

SUBJECT: EVAP SYSTEM DTC(S) P0442, P0455 & P0456

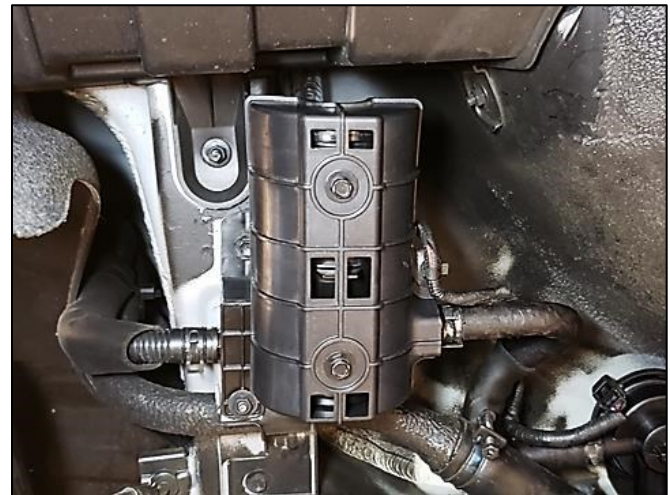
- 4.A Reinstall the air filter and removed parts in reverse order of disassembly.

Fuel tank air filter installation bolt:

1.7 ~ 2.5 lb-ft (0.2~0.3 kgf.m, 2.3 ~ 3.3 N.m)

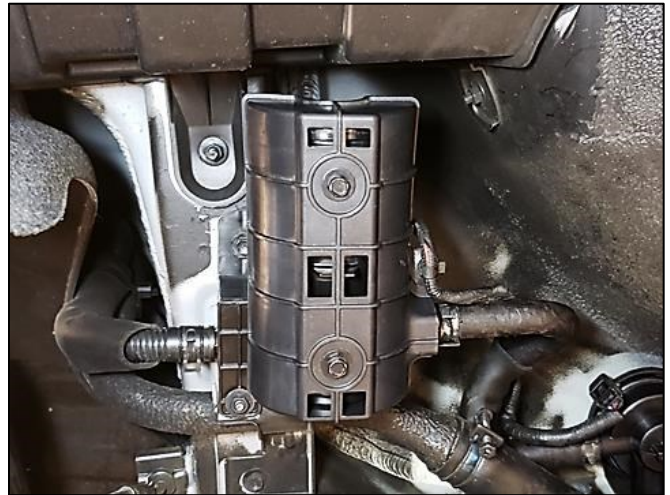
- 5.B Reinstall the air filter, CCV, and removed parts in reverse order of disassembly.

Fuel tank air filter installation bolt:
1.7 ~ 2.5 lb-ft (0.2~0.3 kgf.m, 2.3 ~ 3.3 N.m)
