SERVICE BULLETIN

Reference number:	SB-01-1528	Issued: 17 June, 2021
Subject:	Cracks on Body Side Finisher	
Model(s):	DB11 Coupe, DBS Superleggera Coupe	
Applicable to:	All Dealers	
Distribute to:	After Sales Manager Executive Manager Service Manager Sales Manager	Warranty Staff Technician(s) Parts Staff

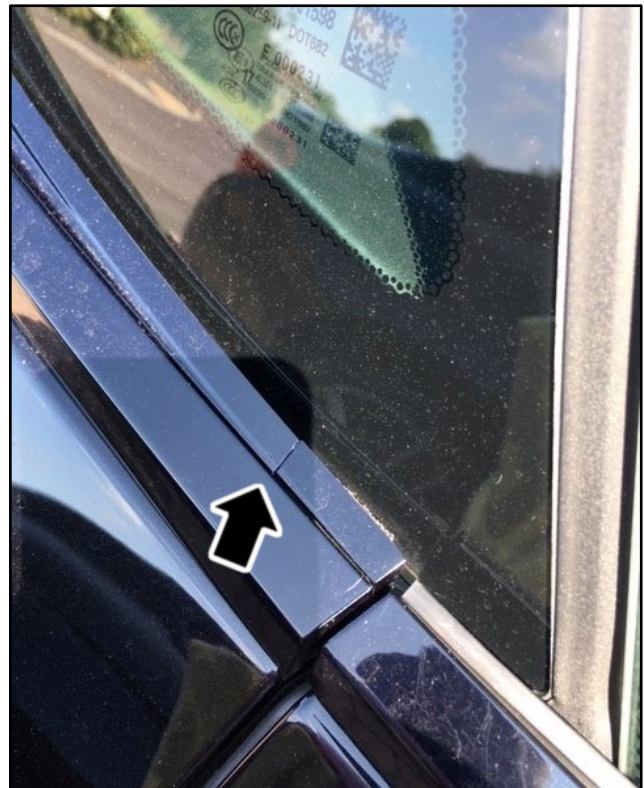
Figure 1

1. Do a check of the crack location. This can usually be found approximately 26mm from the front end of the body side finisher (refer to Figure 1). The location is above the end clip.
Start a SpotLight ePDR and attach photographs of all crack locations.

Aston Martin has found that the body side finishers (C-ducts) can crack on some DB11 and DBS Superleggera vehicles. This is because the incorrect bushes were installed with the screws that attach the finisher, or no bushes were installed.

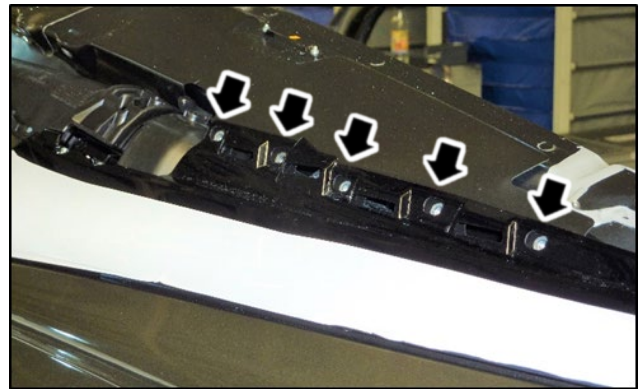
4. Take close-up photographs of the five screws and bushes that attach the bodyside finisher to the vehicle (refer to Figure 2). Attach the photographs to the ePDR.

5. Do steps 2 to 5 of the procedure to remove the body side finisher (refer to Workshop Manual Procedure 01.08.EJ or 01.08.EK).
6. Do steps 5 and 4 of the procedure to install a new body side finisher.
7. In step 3 of the procedure, make sure you install bushes with the screws that attach the finisher to the vehicle body (refer to Figure 2 and Figure 3).
