MODEL
2017-2019MY
Cadenza (YG)

NUMBER
204 (Rev 1, 07/14/2021)

TECHNICAL SERVICE BULLETIN

**PANORAMIC SUNROOF SLOW TO CLOSE AND/OR
ABNORMAL NOISE WHEN CLOSING**

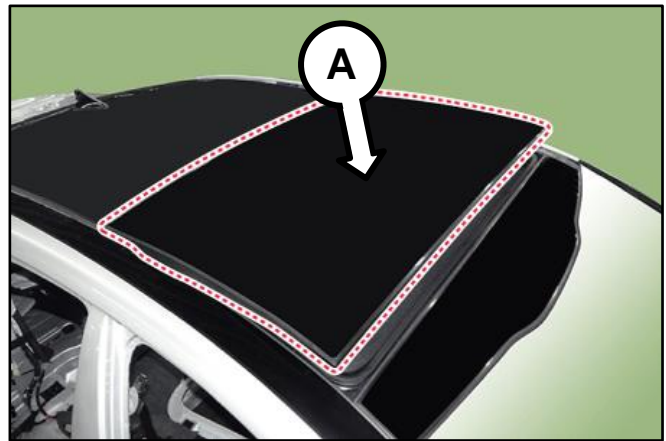
2. Remove the movable glass (A) by referring to the “Body (Interior and Exterior) → Panorama sunroof → Movable Glass → Repair procedures” chapter in the applicable Shop Manual on KGIS.

ⓘ IMPORTANT
 With the assistance of another person, lift and remove the movable glass from the vehicle.

⚠ CAUTION
 Use caution not to scratch, damage and/or break the glass during removal.

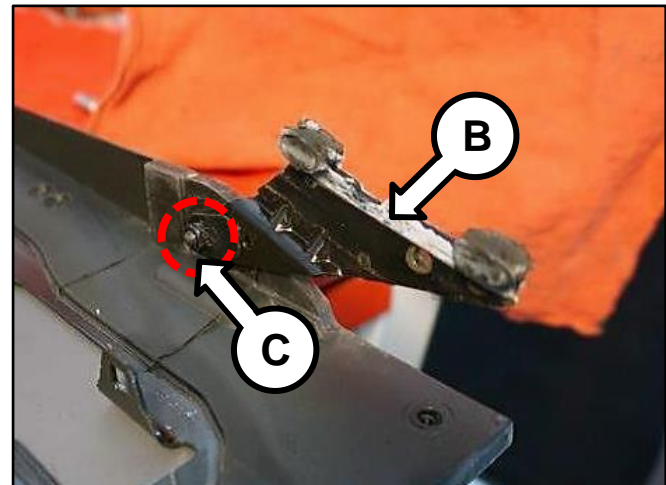
- 3a. Lay the glass on a soft, flat protected surface with the tilt levers (B) facing up.
- 3b. Remove the tilt lever(s) (B) retaining nut (C) and replace the tilt levers on both sides by referring to the application tilt lever table below:

Production Date	Lever Type	Part Number
Until 12/05/2018	A	81651 F6000 81651 F6000
After 12/06/2018	B	81651 F6001 81652 F6001

**Torque specification for nut (C):
 2.95 – 4.43 ft.lbs (4.0 – 6.0 Nm.,
 0.41 – 0.61kgfm)**

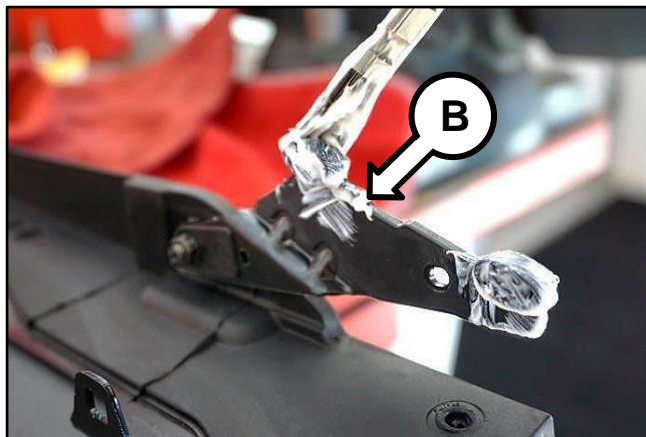
4. Lightly coat the tilt lever shoes (B) using the specified lubricant.

Failure to use the lubricant specified on page 6 of this bulletin may result in an ineffective or repeat repair.

Do not use Kia Dampening Grease (P/N UM011-CHA052), as it is not compatible with the grease used by the factory.

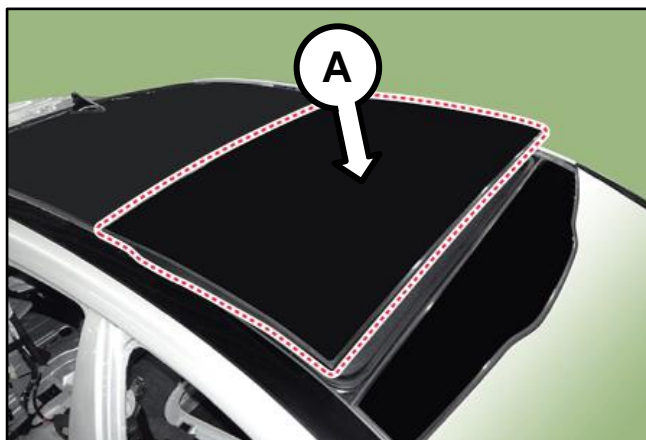
5. Re-install the movable glass (A) from step 1 in the reverse order of removal.

With the assistance of another person, lift and reinstall the movable glass to the vehicle.

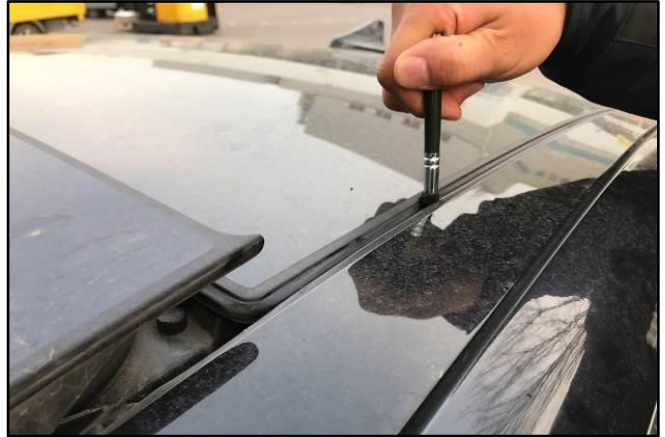
- Using a clean brush, remove any debris in the roof rails by brushing out towards the rear glass.

Use caution not to scratch, damage and/or break the glass.

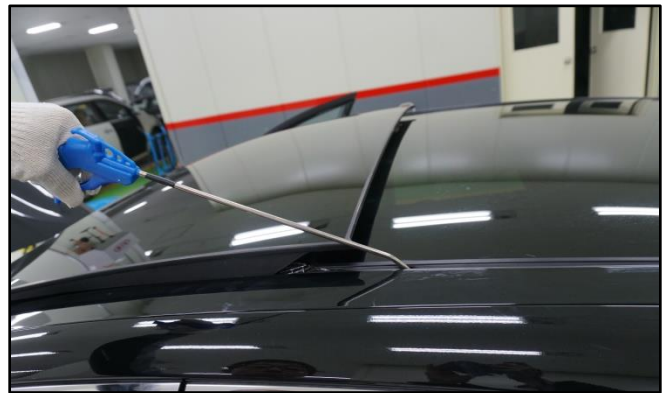
- Using an air gun, blow towards the rear glass to remove any remaining debris in the roof rail.

Use caution not to scratch, damage and/or break the glass.

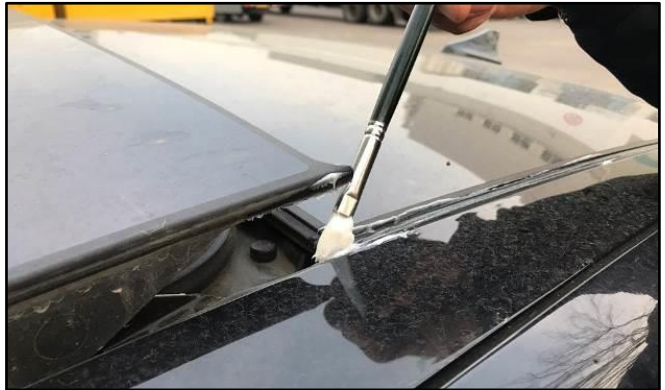
- Using a clean brush, apply grease along the inside of the roof rails.

Repeat procedure 3 times to make sure there is sufficient grease application on rails.

Ensure the glass and all other components contacted while performing this procedure are clean.

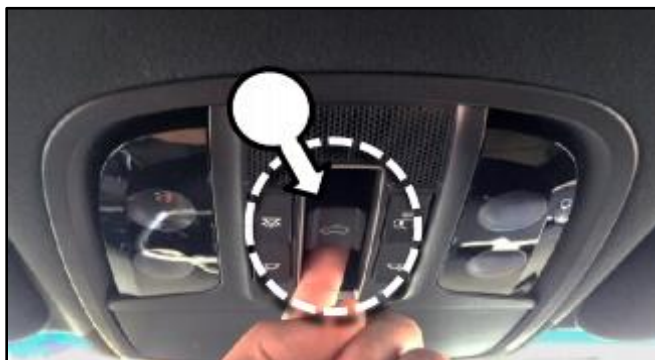
Panoramic Sunroof Reset Procedure:

1. Ensure the ignition is ON, the panoramic sunroof, and roller blind are completely closed.
2. Fully depress and hold the sunroof switch in the closed position and **DO NOT** release it until the roller blind fully opens and the sunroof glass vent position opens (about 15-20 seconds).
3. Once the vent opens, release the switch for 1-second and fully depress and hold the sunroof switch in the closed position again until sunroof glass fully opens then closes and the sunshade fully closes.
4. Verify operation of the sunroof to confirm reset procedure is successful.
