SIB 12 02 21

SERVICE ACTION: INSPECTION OF THE ELECTRONIC WASTEGATE ACTUATOR CONNECTOR

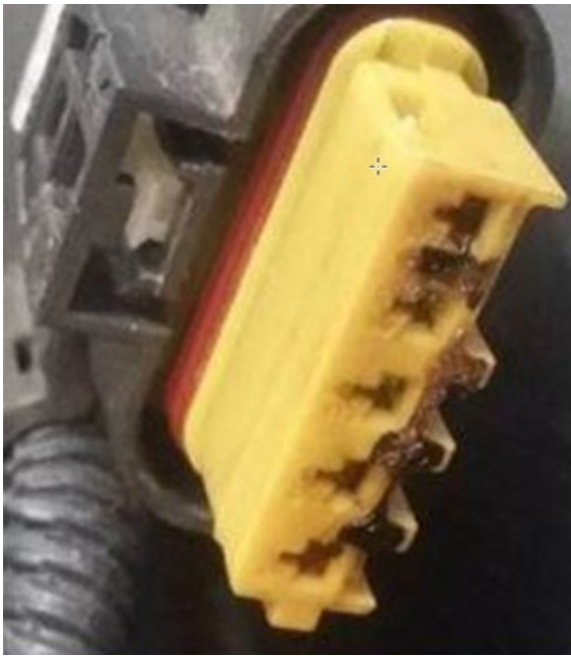
3. Disconnect and visually inspect the electric wastegate actuator's electrical pin connector.

4. If discoloration is visible on the connector as shown to the left, the electrical connector, pins, and the electronic wastegate actuator must be replaced.

Repair or replace the damaged components as needed.
