## Service Campaign 80-31

**AFFECTED:** 2021 Solis

**SUBJECT:** Battery Relay Wiring

## 2021 Solis Battery Relay Wiring

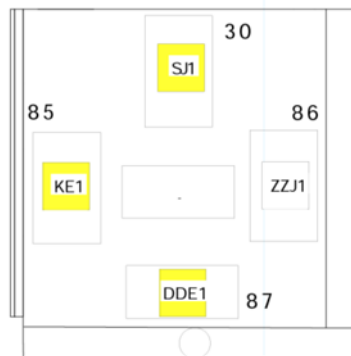
P1 for Connect

1. Start the engine and check the solar panel control pad. If the voltage is under 14V with no increase detected, it indicates the relay is wired incorrectly.

1. Remove the lower B post cover on the passenger side, locate the relay and rewire as shown:

| Cav | Wire ID |
| 30 | SJ1 |
| 85 | KE1 |
| 86 | ZZJ1 |
| 87 | DDE1 |
