GROUP	MODEL
Body	2020-2022MY Sportage (QL)
NUMBER	DATE
PS699	July 2021

WIND NOISE DIAGNOSIS AT 40-60 MPH

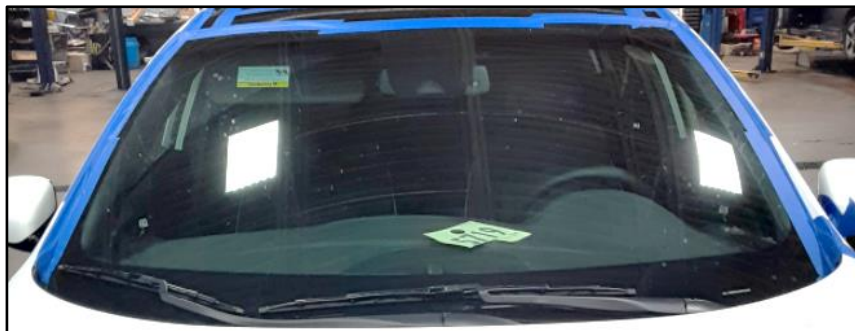
1. Exterior Accessories: To determine if the wind noise is coming from exterior accessories, such as roof racks or cross bars, remove the accessory and then test drive to see if noise has been eliminated. If noise is eliminated, and if accessories cannot be adjusted to eliminate the noise, inform the customer of the results.
2. Sunroof: Inspect seals and weatherstrips for damage, adjustment of sunroof glass may be necessary. Mask off the suspect area and test drive to confirm the noise level has decreased.
3. Windshield: Inspect for proper sealing of windshield assembly and molding installation, adjustment of trim pieces may be necessary. Mask off the suspect area and test drive to confirm the noise level has decreased.

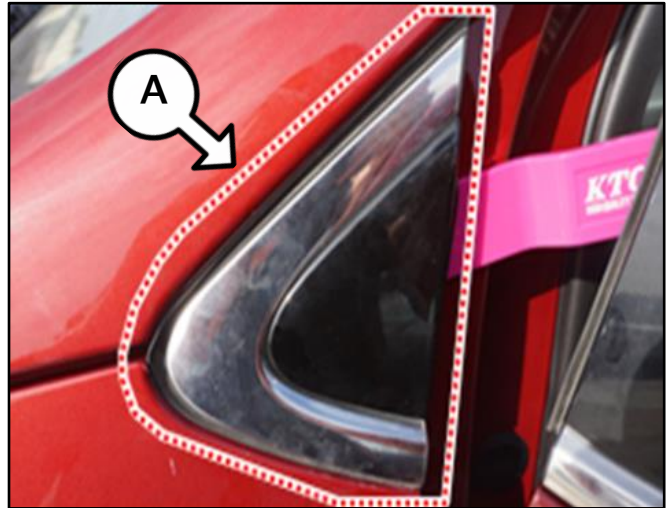
1. Outside Mirrors: Inspect side view mirror(s). Fold-in the side mirrors or mask off seams and test drive vehicle to determine if noise has been eliminated. Adjustment, application of insulating tape, or replacement of the mirror (if defective) may be required if determined to be the source of wind noise.
2. Trim/Moldings: Inspect for loose or damaged door trim/moldings. Mask off the delta garnish area (A) and test drive to confirm. Adjustment and/or application of insulating tape may be required.

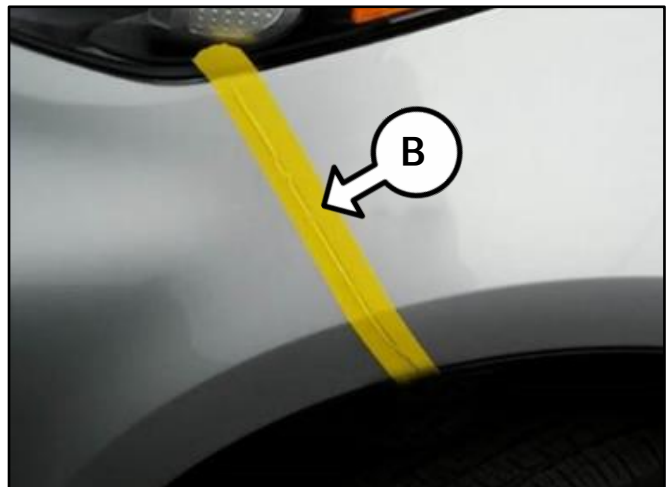
- Inspect bumper cover for damage.
- Mask off the bumper cover to fender seam (B) as shown and test drive the vehicle to determine if the noise has been eliminated.
- If noise has been eliminated, ensure that the bumper cover alignment and gaps are acceptable by comparing to a known good like vehicle. Adjust if necessary.

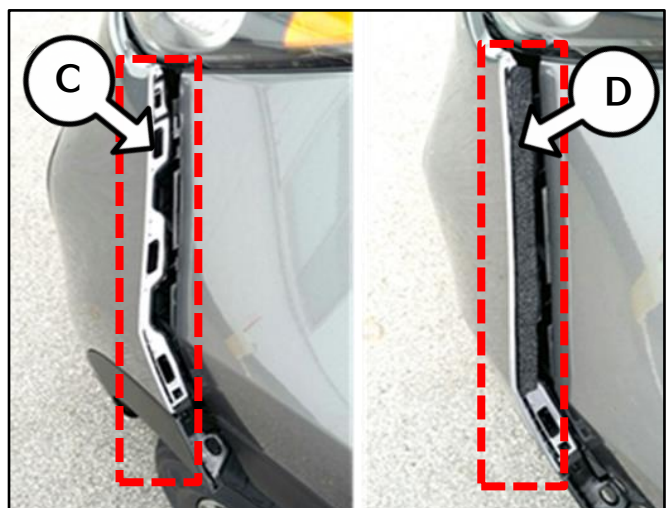
- If seam is acceptable (no gap), install foam insulating tape between the front bumper to the fender joint as follows:

- 1) Disassemble the front bumper to fender joint (C).
- 2) Ensure contact surfaces are clean, then apply foam insulating tape (D).
- 3) Reassemble in reverse order of disassembly.

Note: When reinstalling bumper, be sure to align the bumper flush with the fender.

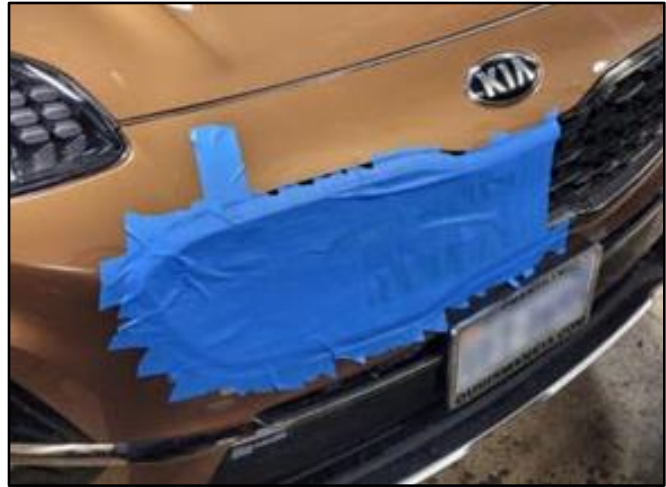
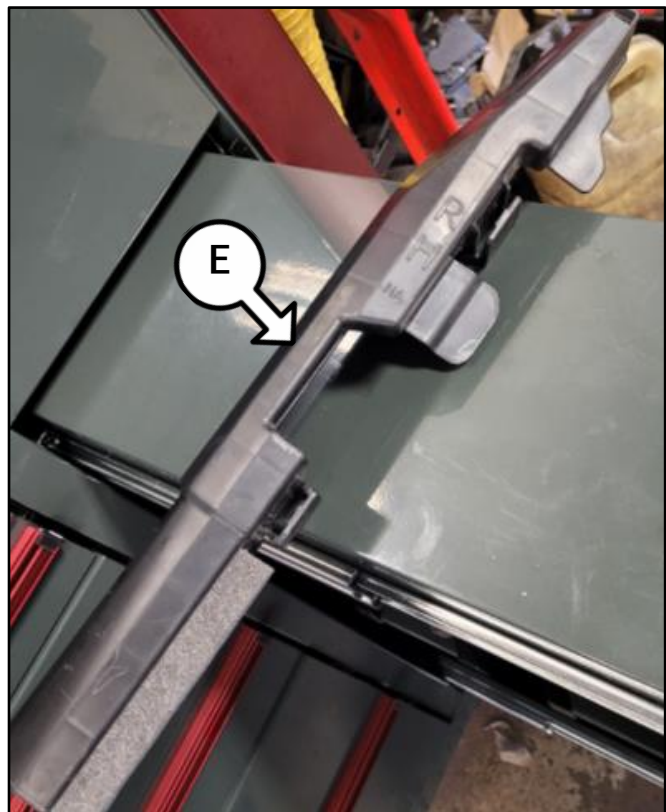
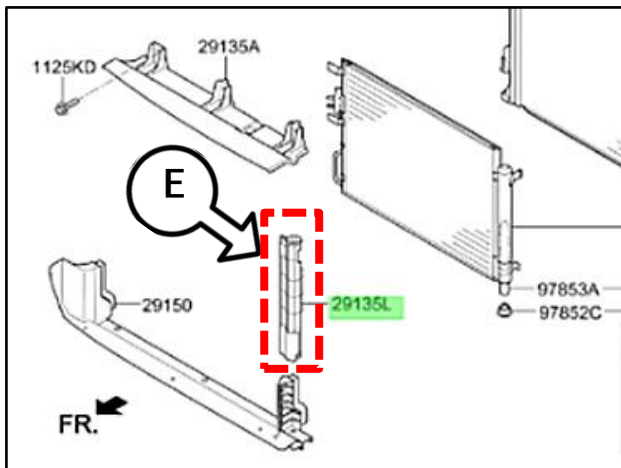
- If noise is eliminated, inspect the air guides installed on the sides of the condenser for proper installation or deformation.
- Test drive with one air guide removed at a time to determine if noise is eliminated.
- If the noise goes away after removing either air guide, adjust or replace the air guide on that side as needed, then test drive again.

Note: Shown below is an example of a condenser air guide in the EPC.

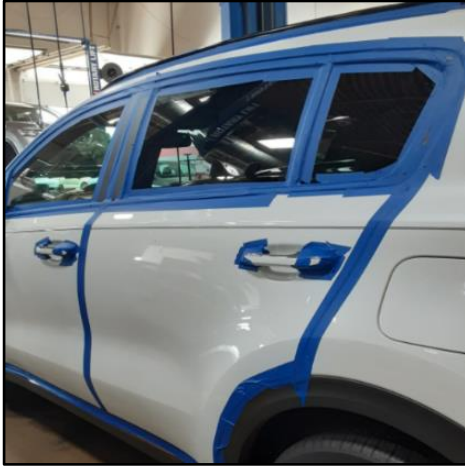
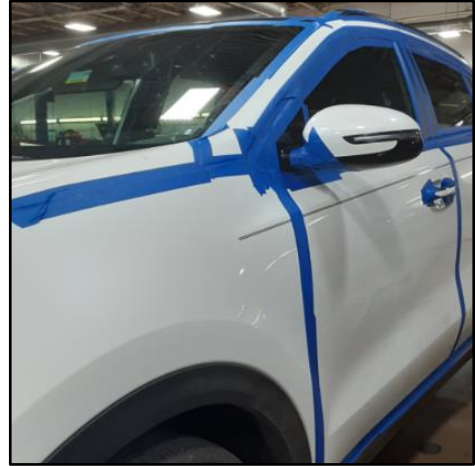
6. Other Areas: Inspect cowl, moldings, trim pieces, and body panels for damage, proper installation, and alignment. Continue to mask areas and test drive until the area of concern has been identified.
