## PRODUCT CAMPAIGN BULLETIN

**APPLICABILITY:** 2002~07MY Impreza (except STI)  
2003~08MY Forester  
**SUBJECT:** Front Lower Control Arm (Transverse  
Link) Corrosion

**NUMBER:** **WVX-34R**  
**DATE:** Nov 2011  
**REVISED:** **07/26/21**

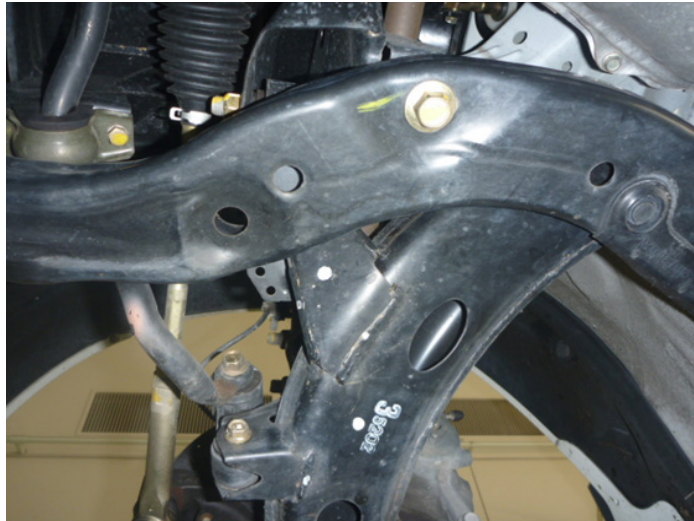
Right side, bottom

Starting on the right side, use a rag and remove any dirt, mud, surface rust or under coat from the top and bottom surfaces of the hanger bracket for measuring the location for punch testing.

Measure the bottom surface approximately 40mm from the weld to the center of the hanger bracket and make a mark.

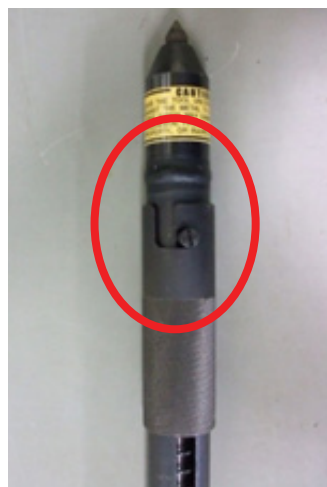
Slide the trigger tube toward the punch tip and set the lock pin to the trigger tube.

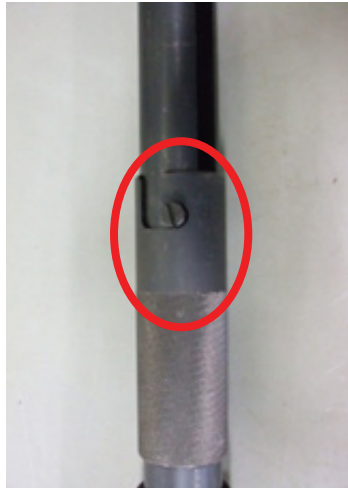
Draw the trigger tube downward and set the lock pin to the lock groove.

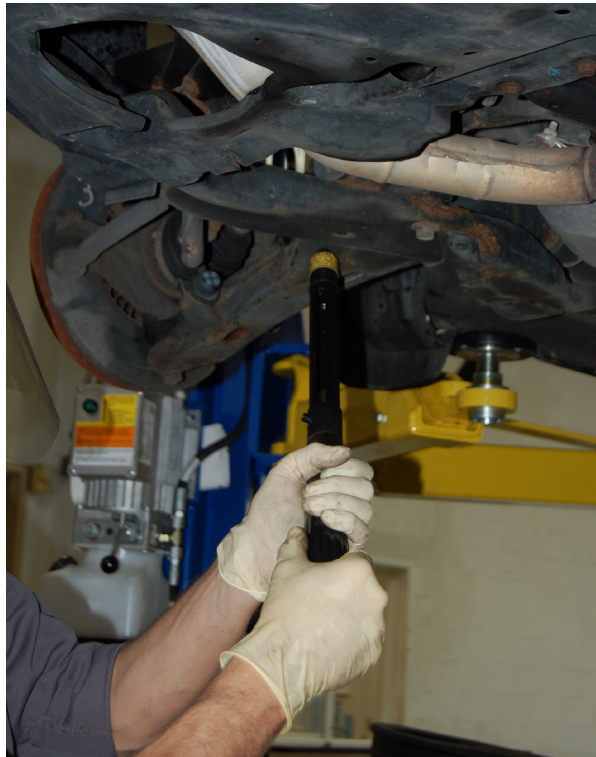
Lower punch test

Firmly, set the tip of the punch tester vertically at the previously marked point. While pushing up, hold the handle and twist the trigger tube clockwise to trigger punch test.

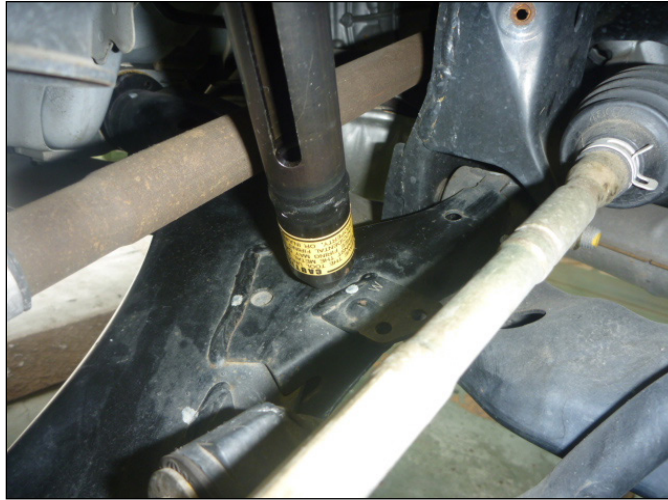
Upper punch test

Firmly set the tip of the punch vertically at the previously marked point. While pushing down, hold the handle and twist the trigger tube clockwise to trigger punch test.

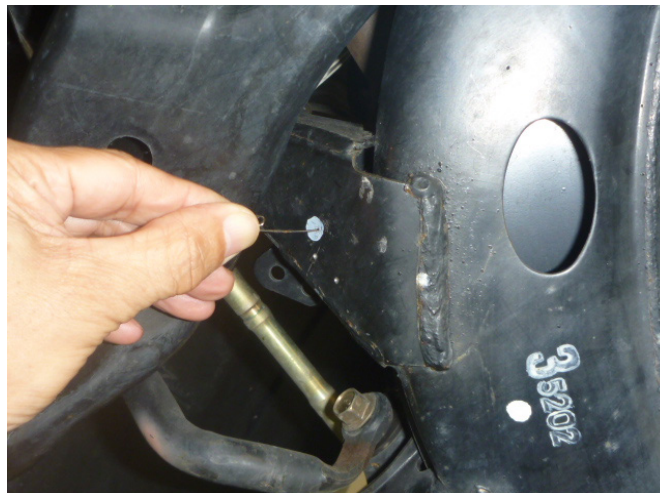
Using a paper clip, insert it into the indentation made by the punch tester. Work the paper clip back and forth in an attempt to penetrate the metal. If the paper clip cannot be inserted, perform the procedure on the upper surface.

If the paper clip can be pushed through the metal, the arm is failed.

**If the right side is failed, replace both control arms.**

**If the left side is failed, replace both control arms.**

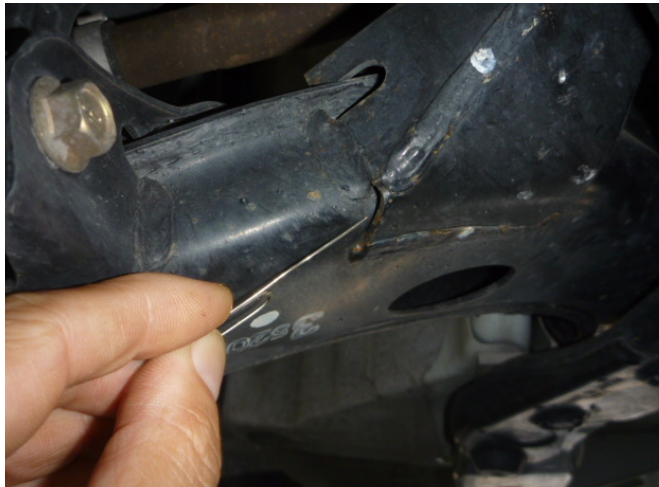
Insert a paper clip into the hanger bracket water drain hole and remove any rust particles and/or mud if clogged.

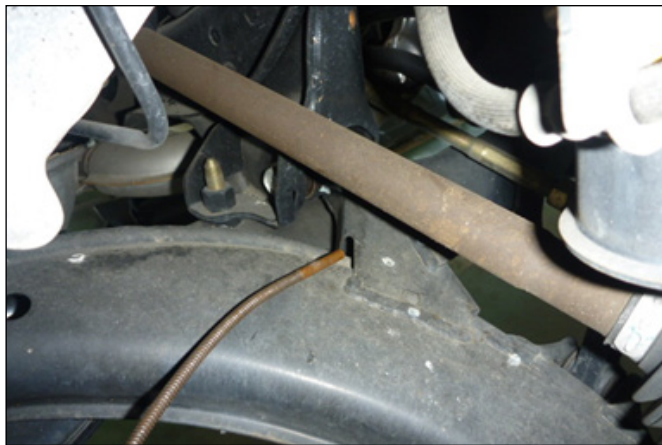
Insert a flexible magnet through the upper hole of the hanger bracket to remove any rust particles.

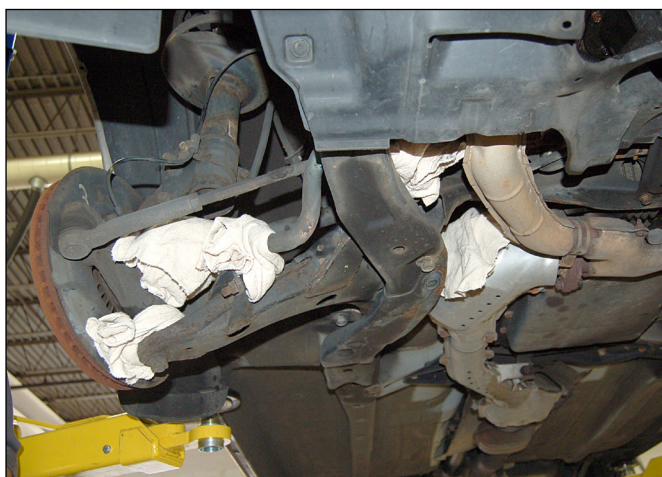
Wrap rags around stabilizer link, exhaust pipe, front control bushings, ball joint, steering gear box boot and axle shaft boots. Do the same on the opposite side.

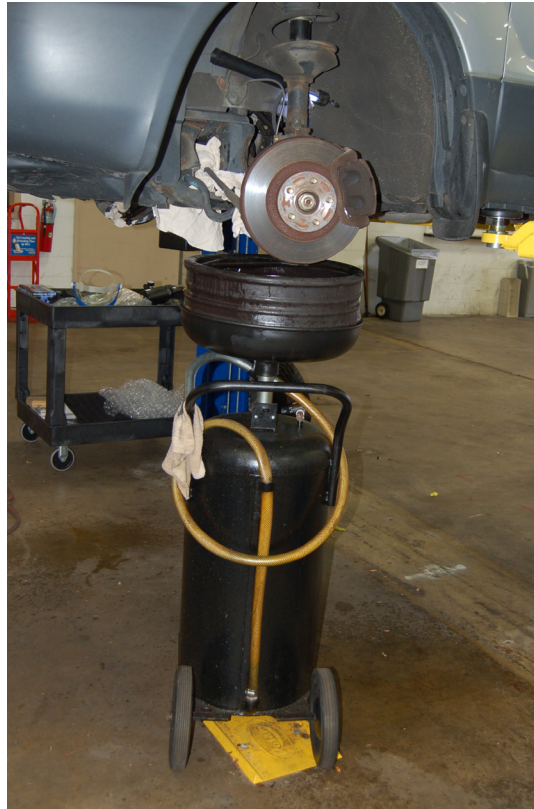
Position a suitable container under the control arm to catch any oil and wax during the application.

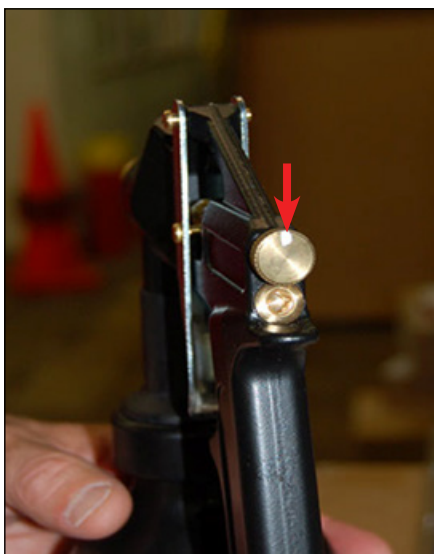
Close the spray gun stop screw to the fully closed position. Use a marker pen or paint and make a mark at the 12:00 position. Turn the stop screw counter clockwise one full turn.

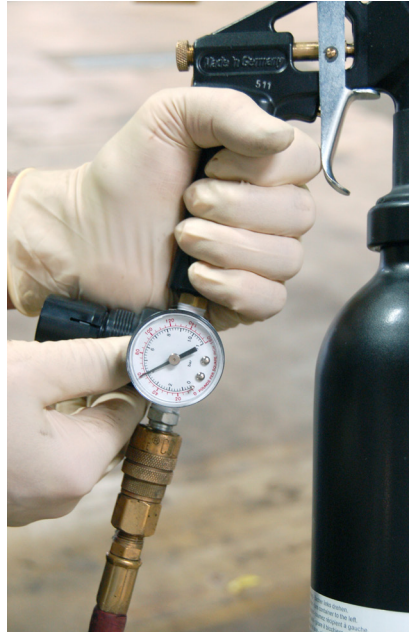
Add 160cc of Nox-Rust X210 (Oil) to the spray gun pot.

Attach air line to spray gun and adjust air pressure regulator to 60 PSI.

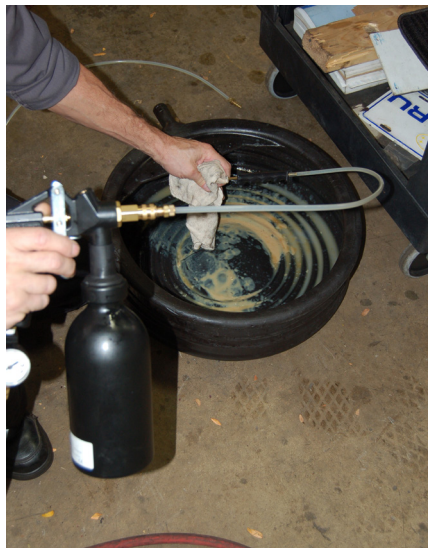
Test spray gun for proper operation. A rag and container should be used.

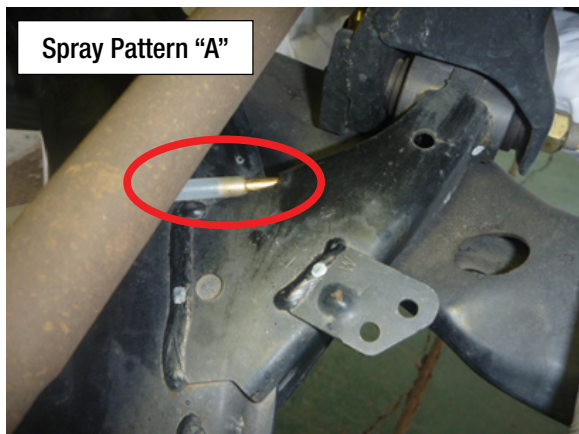
### **Spray Pattern “A”**

- A) Insert the spray nozzle through the upper hole of the hanger bracket (insertion length: 75mm) until it contacts the front surface of the hanger bracket wall.

Pull the trigger of spray gun while holding the wand in position to confirm that oil leaks out of an opening in the hanger bracket. Pull out wand with a constant gradual speed while spraying for at least 4 seconds.

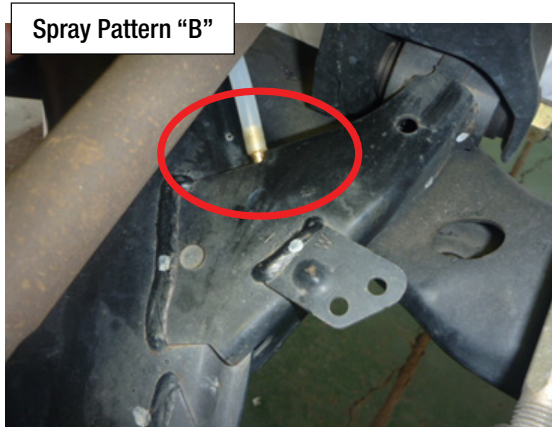
## Spray Pattern "B"

- B) Insert the spray nozzle with its tip facing down through the upper hole of hanger bracket (insertion length: 65mm) until it contacts the bottom surface of hanger bracket wall. Pull the trigger of spray gun while holding the wand in position to confirm that oil leaks out of an opening in the hanger bracket. Pull out wand with a constant gradual speed while spraying for at least 2 seconds.

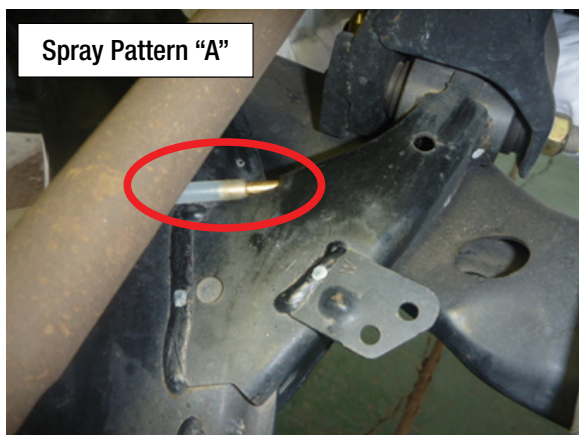
### Spray Pattern “A”

- A) Insert the spray nozzle through the upper hole of the hanger bracket (insertion length: 75mm) until it contacts the front surface of hanger bracket wall.

Pull the trigger of spray gun while holding the wand in position to confirm that wax leaks out of an opening in the hanger bracket. Pull out wand with a constant gradual speed while spraying for at least 2 seconds.

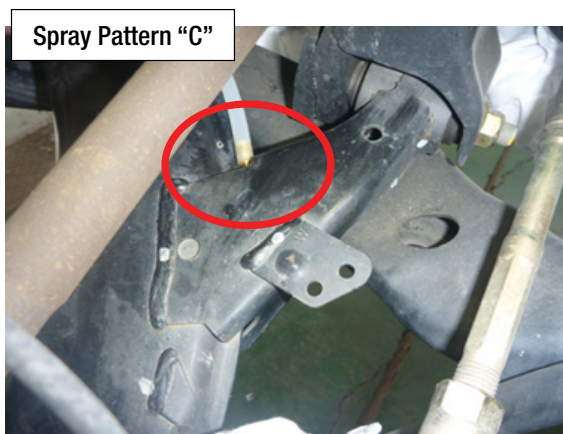
### Spray Pattern "C"

- C) Insert the spray nozzle with its tip facing up through the upper hole of hanger bracket (insertion length: 72mm) until it contacts the top surface of hanger bracket wall. Pull the trigger of spray gun while holding the wand in position for 2 seconds; confirm that wax leaks out of an opening in the hanger bracket. Pull out wand with a constant gradual speed while spraying for at least 1 second. Perform same procedure on opposite side of vehicle.

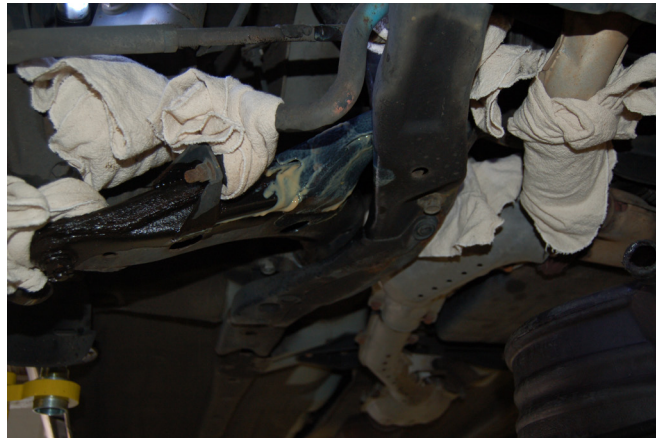
Spray anti-rust wax to the surface of the hanger bracket only, top, sides and bottom.

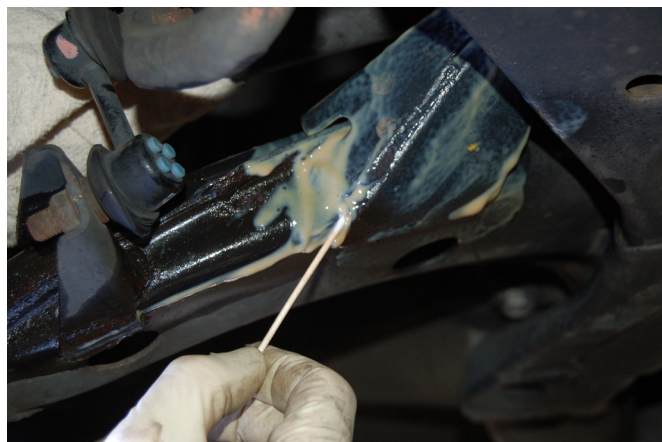
**IMPORTANT:** Remove rust-proofing wax from drain hole of hanger bracket using a cotton swab. Perform continuously until it can be confirmed that the hole is not clogged.
