HYUNDAI Technical Service Bulletin

GROUP Body Electrical	NUMBER 21-BE-009H
DATE July, 2021	MODEL(S) Santa Fe (TMa)

SUBJECT: SANTA FE (TMA) CRASH PAD CENTER SPEAKER REPLACEMENT PROCEDURE

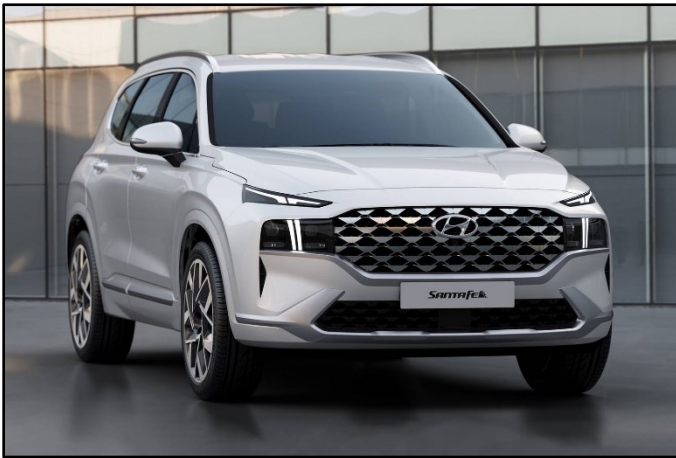
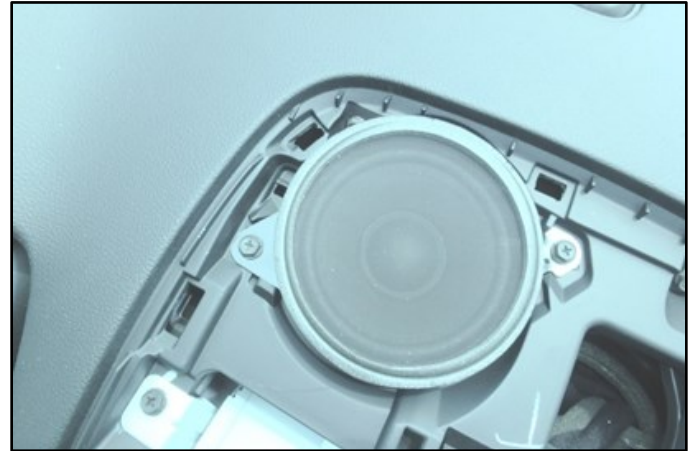
Description: The front center speaker may produce a scratchy or distorted sound during operation. This bulletin describes the procedure to replace the crash pad center speaker for certain 20 and 21MY TMa Santa Fe.
