## 2021 Plateau

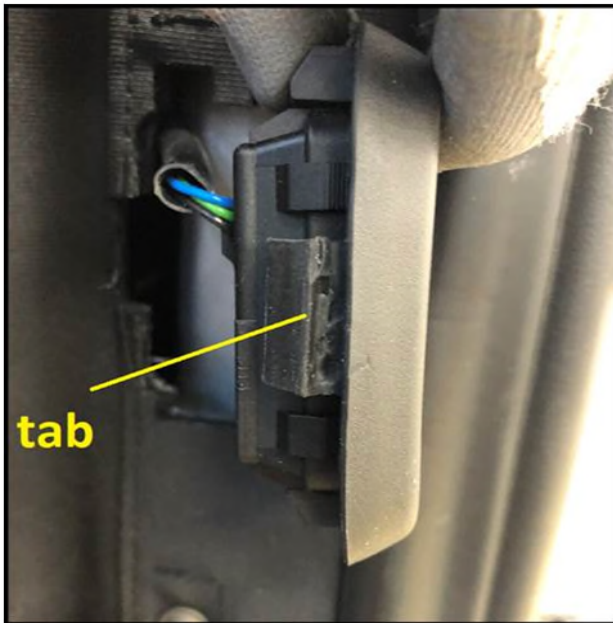
1. The bug screen, which is permanently attached to the frame of the sliding door frame seems to have an install issue. If you look at the attached image, you'll see what looks like a cut out of the material that's not under the door switch cover. As this is now exposed, is there a concern of this ripping? The procedure below shows how to re-install the sliding door control switch. You will need to remove the switch and push the material back in behind the switch and then re-secure. I advise you to have this repair done as soon as possible to prevent the material from ripping.

Procedure to insert the control switch back:

1. Looking at the left side of the control switch there is a tab. (picture 1 below)
2. Insert the whole control switch back to the cut out hole
3. On the inner side of the screen inside coach, using a screw driver push the control switch tab to the right so the control switch locks in place (picture 2 below)
