SIB 66 03 21

DELIVERY STOP: RADIO REMOTE CONTROL M SPORT

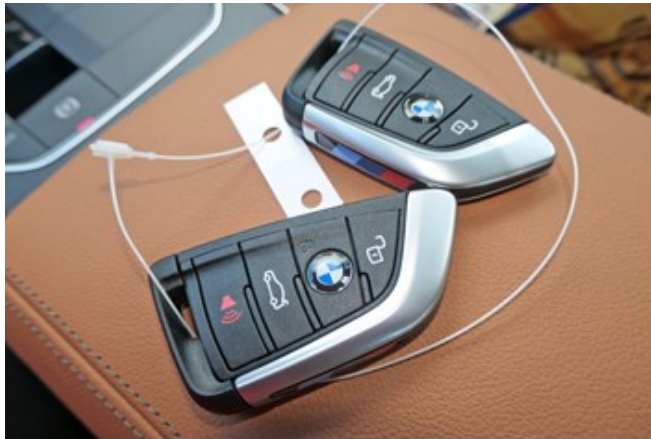
Vehicles were delivered with the wrong radio remote control (without motion sensor) which decreases the theft-proofing against range extenders.

Situation does NOT affect the BMW Display Key.

Replace the factory-provided remote control keys.
