# SS 715-WST 2021 49X Transmission Cooler Line Plumbing Fitting

## **Applicable Vehicles**

49X vehicles built with manual or automated manual transmissions.

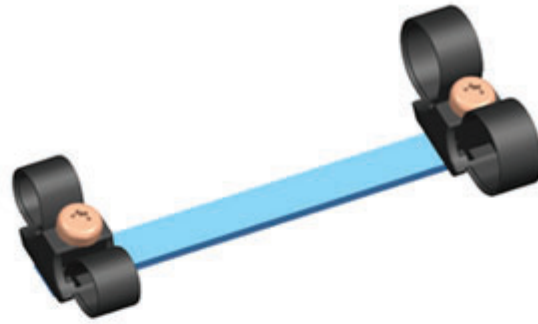
Retainer assembly

Install parts below to existing trans cooler plumbing lines as shown:

TYCDCT110HIR Tie cable dual, .375 to 2.25 quantity(2)

23-12781-725 SCR-MACH,PNH HDL,LKG,M6.25 quantity(2)

07-25565-000 BAR-RETAINER,PLUMBING quantity(1)
