August 2021
D21M6

Subject: Gen 5 Customer Demo Unit (CDU) and Pre-Series Unit Retrofits

Models Affected: Specific 2021 Freightliner New Cascadia model vehicles, powered with DETROIT™ Gen 5 DD15 Engines manufactured February 3, 2020, through December 14, 2020

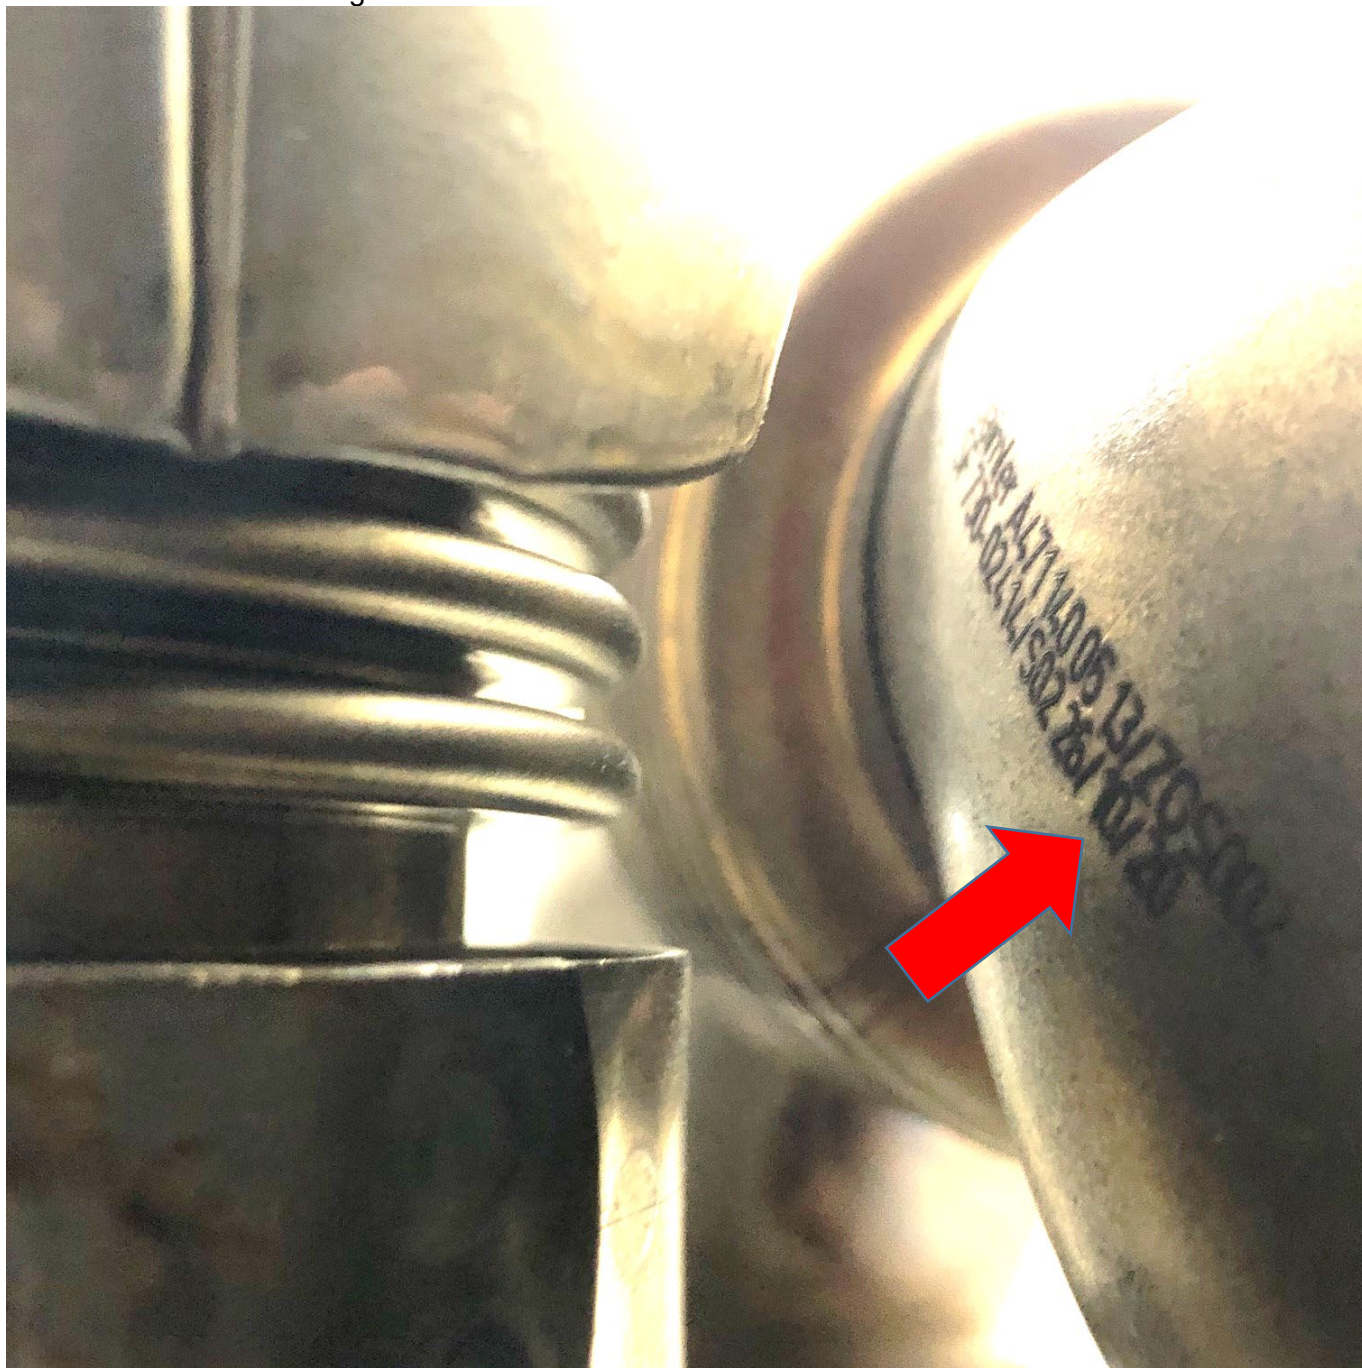
1. Please refer to the image below.

2. The red arrow is pointing to the date found on the EGR hot pipe. The date format is DD/MM/YY.
3. If the date is 31/07/20 or earlier, the EGR hot pipe needs to be replaced. Otherwise, it can be reused.
