SS 711-WST 2021 49X Aux E-vault Rattle in Day Cab

49X day cabs built with aux e-vault

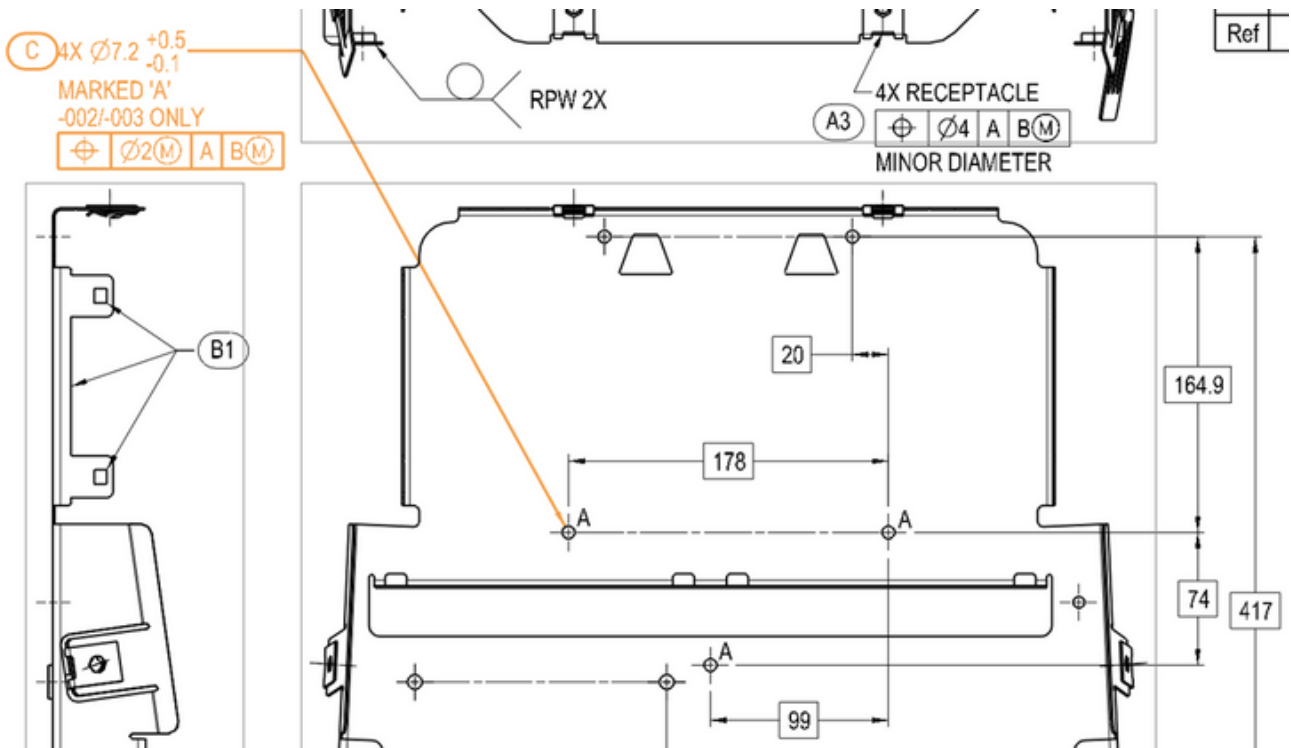
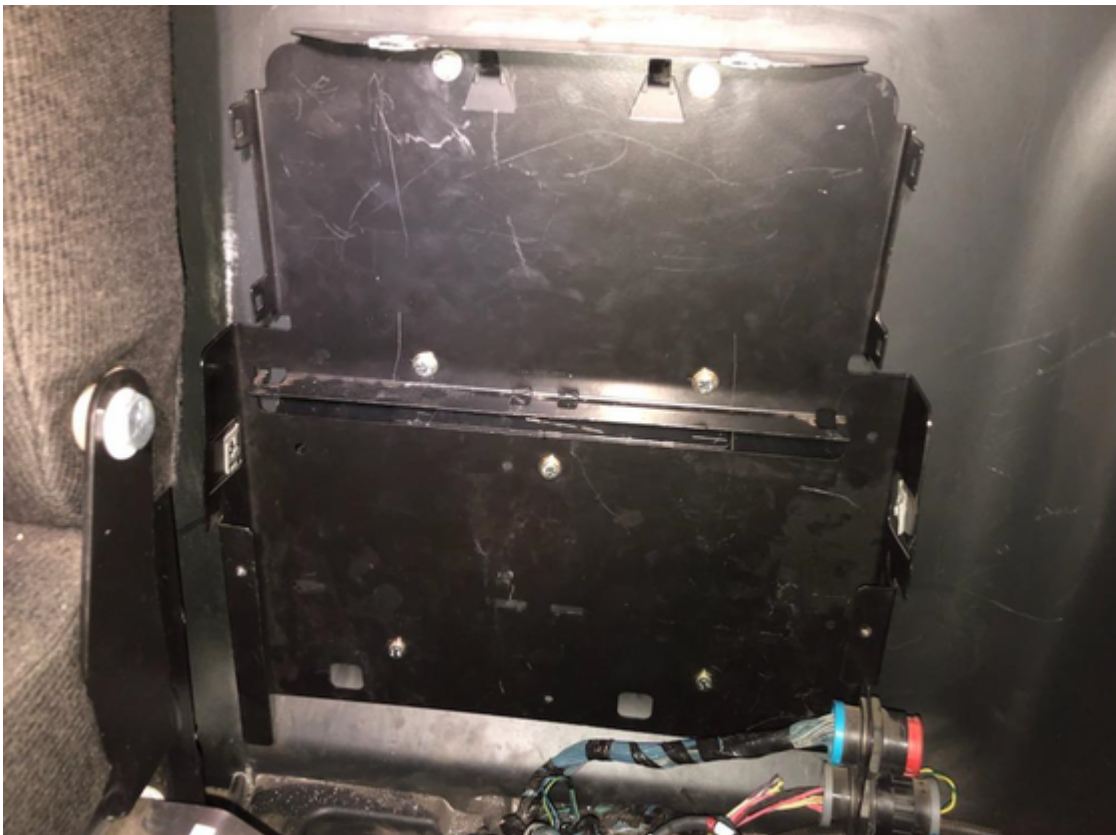
Rattle noise inside of cab coming from the e-vault location

Mounting bracket has low fore/aft stiffness

Drill quantity (3) 7.2mm dia hole 12mm deep through both mounting brackets while installed in vehicle per install locations below (additional 7.2mm hole shown below in upper rh corner of the drawing as reference point for dimensions) and add in quantity (3) each M6 bolt 000000 001476 & M6 23-12753-006 clinch nut.
