## AWD Indicator Comes On with DTC C1843-62 or C1844-62

Supersedes 20-032, dated March 29, 2021, to revise the information highlighted in **yellow**.

Year	Model	Trim Level	VIN Range
2019 – 20	RDX	All with AWD	ALL
2021	RDX	All with AWD	5J8TC2...ML000001 to 5J8TC2...ML011452

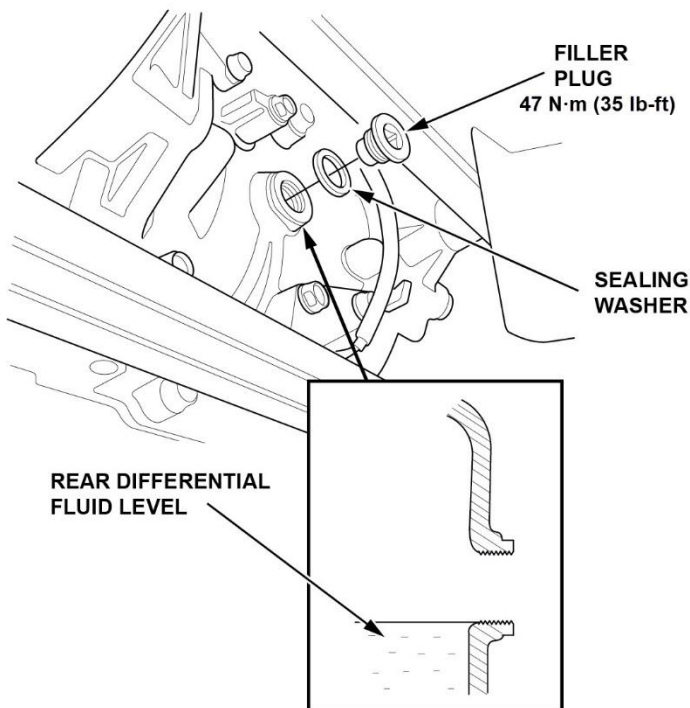
1. Raise the vehicle on the lift. Refer to the service information.
2. Check the rear differential fluid, and make sure the fluid is at the same level as the filler plug hole.
  - If the fluid level is OK, install a new filler plug sealing washer and torque the filler plug to **35 N·m (26 lb-ft)**. Then, go to REPAIR PROCEDURE.
  - If the fluid level is low, fill the rear differential with Acura All-Wheel Drive Fluid (DPSF) to the proper level. Refer to the service information. Then, go to STEP 3.

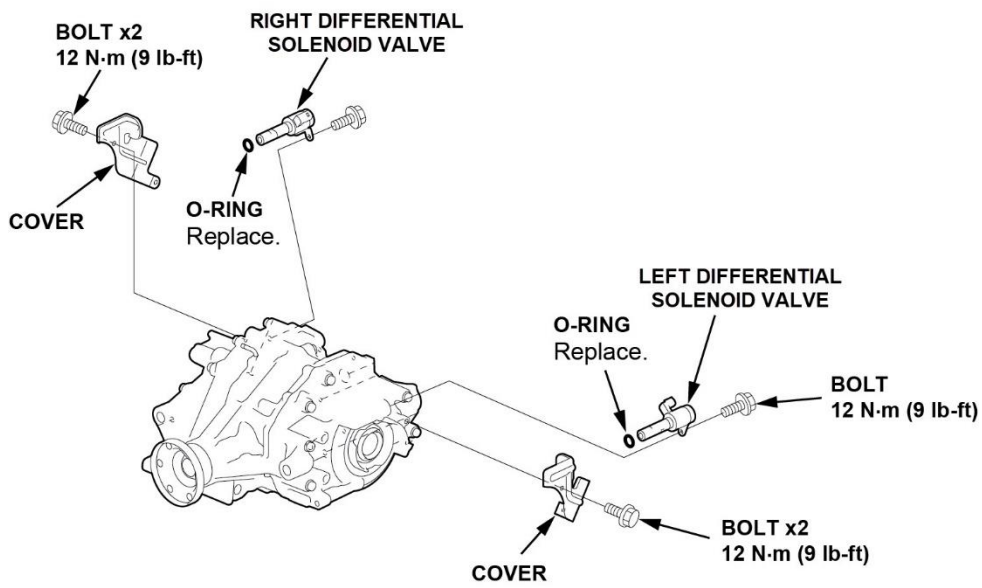
Replace the left and right differential solenoid valves.

1. Remove the differential solenoid covers.

4. Install the differential solenoid covers, and torque the bolts to **12 N·m (9 lb-ft)**.
5. Do an All DTC check, and clear DTCs from all systems.

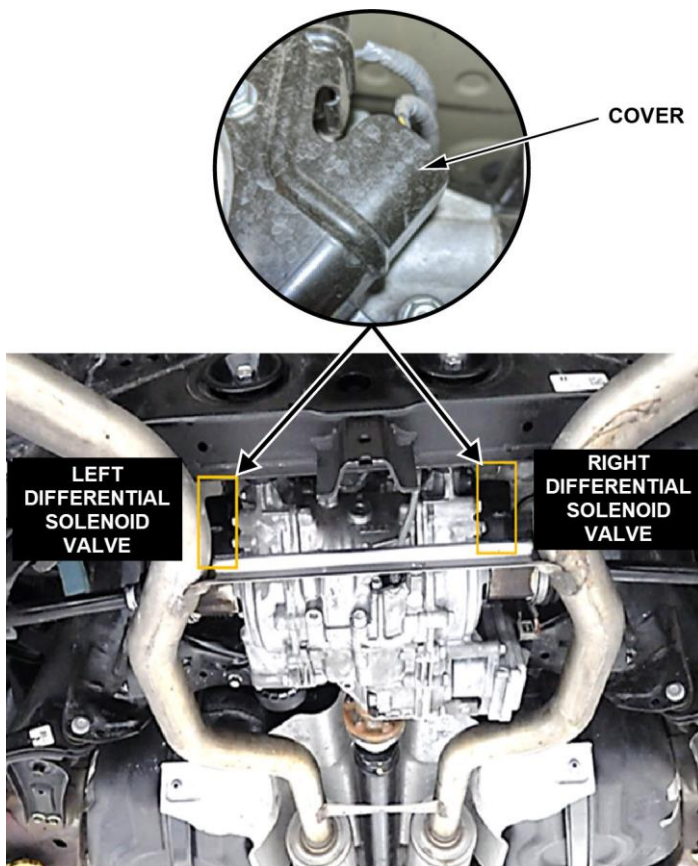
2. Remove the differential solenoid valves.

3. Install the new differential solenoid valves, and torque the bolt to **12 N·m (9 lb-ft)**.

NOTE: Lube the O-ring using Acura All-Wheel Drive Fluid (DPSF) before installing the differential solenoid valves to the rear differential.

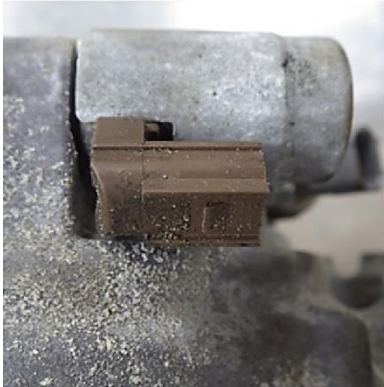
*Before Cleaning*

NOTE: Before removing the solenoids, clean around each solenoid to prevent contamination from entering the differential and/or the new replacement solenoid.
