## Side Pannier Sliding Shoe Replacement

Multistrada 1200 MY 2015-2017 (all versions)  
Multistrada 1260 MY 2018-2020 (all versions)  
Multistrada 950 MY 2017-2021 (all versions)  
Service Repair Bulletin SRV-SRB-21-039

Service Repair Bulletin SRV-SRB-21-039

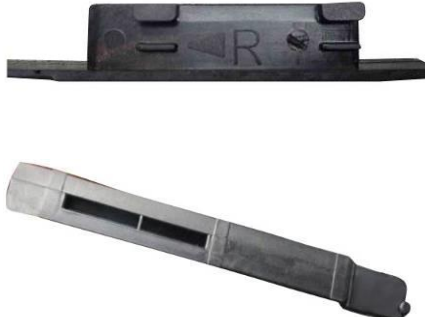
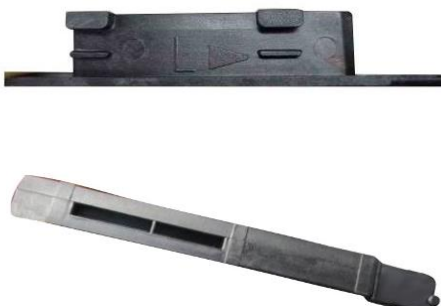
Although this is a very unlikely event, we would like to inform you that in order to prevent this issue from occurring, new sliding shoes have been installed on all side panniers manufactured from February 2021 with the date "21050" (50th day of 2021); the new sliding shoes can be easily recognized from the previous ones because of the presence of an arrow next to the letters "R" (Right) and "L" (Left).

RIGHT side pannier sliding shoe Part no. 69916791A	LEFT side pannier sliding shoe Part no. 69916801A

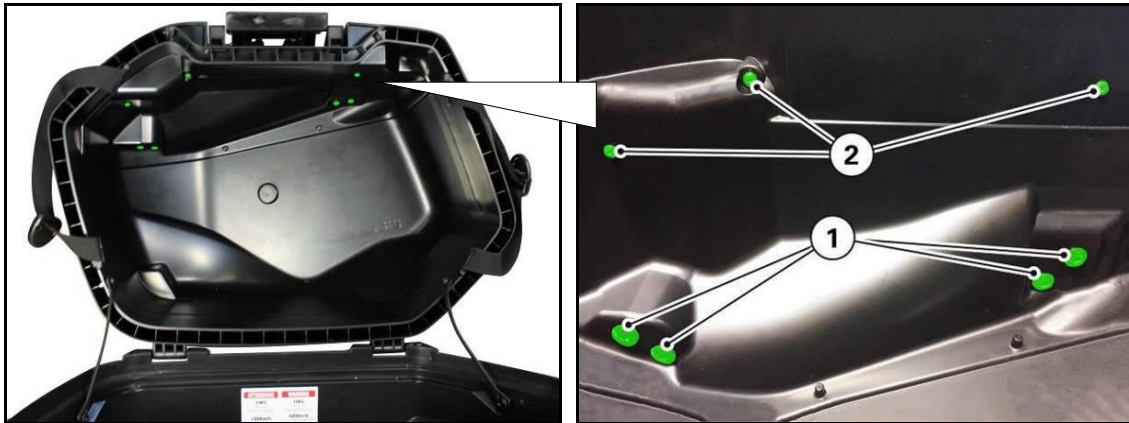
1. Open the pannier and, working on the hooks inner side, remove the **4 screws (1)** and the **3 self-tapping screws (2)** fastening the upper cover.

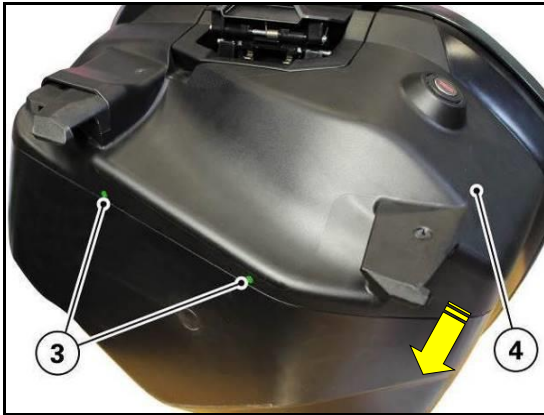
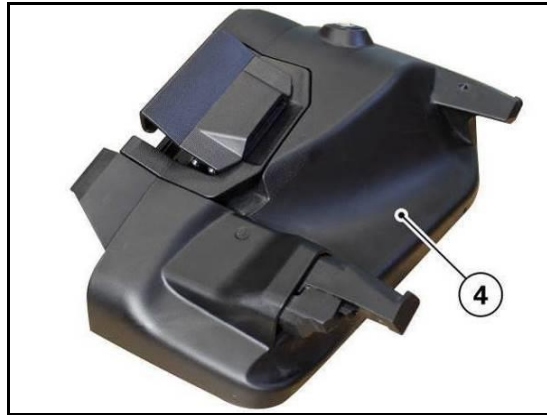
2. Working from the outside, remove the **2 self-tapping screws (3)** and slide out the **upper cover (4)**.

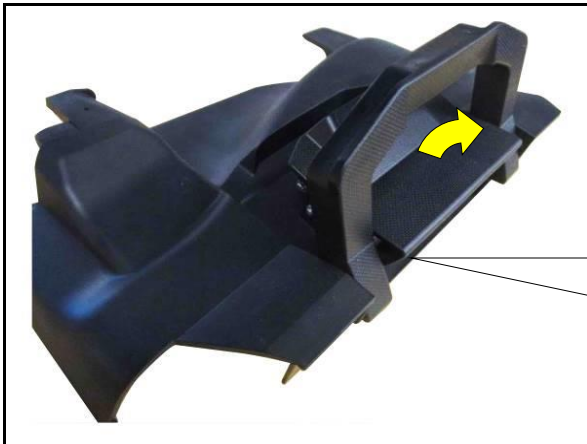
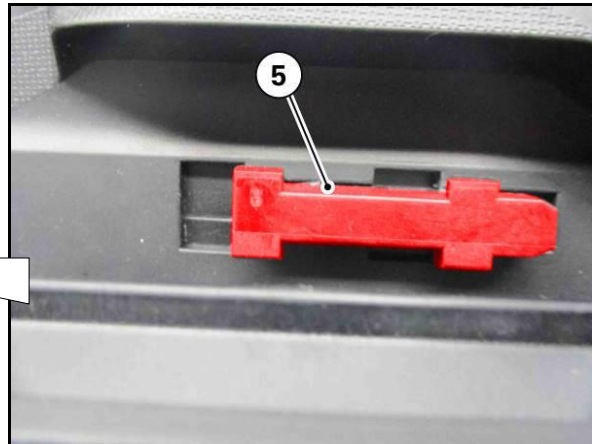
3. With the lock in the "open" position, raise both the handle and the locking hook so that the **RH sliding shoe (5)** is in the position shown in the figure.

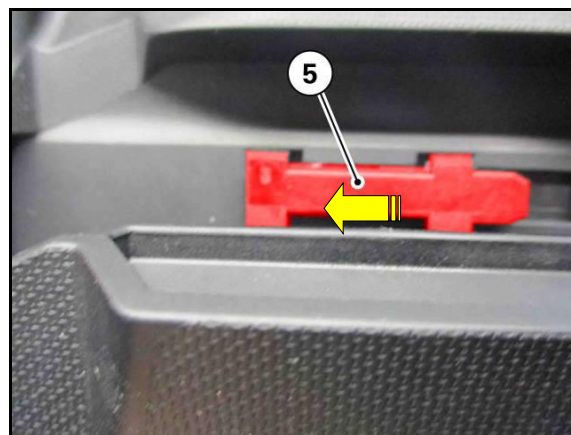
4. Turn the key to the closed position to retract the **RH sliding shoe (5)**

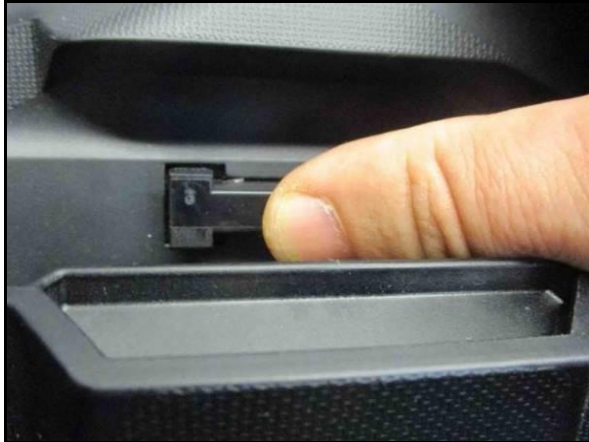
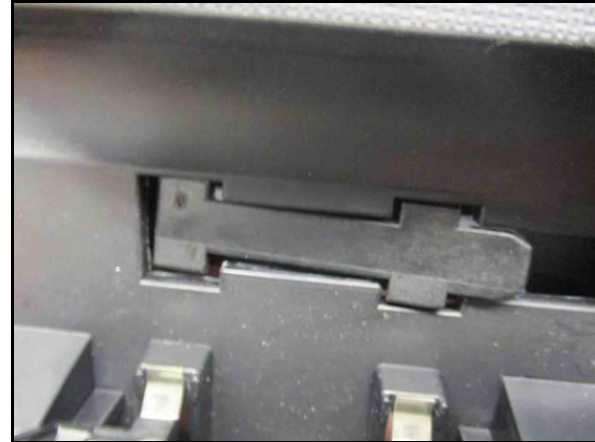
5. Push the sliding shoe downwards so that its teeth pass through the seats of the cover.

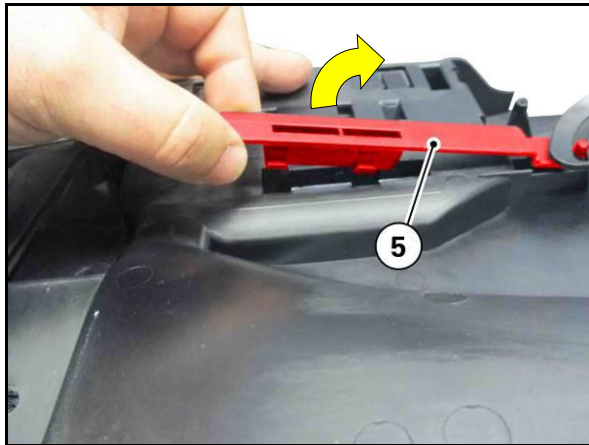
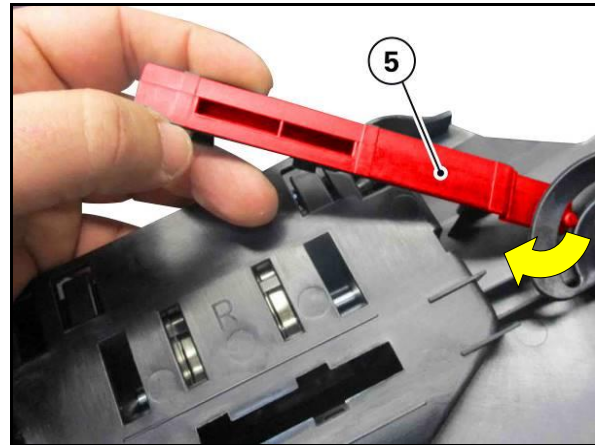
6. Turn the cover to the opposite side and lift the **RH sliding shoe (5)**.
7. Turn the **RH sliding shoe (5)** to release the pin from the piece under the lock as shown in the figure.

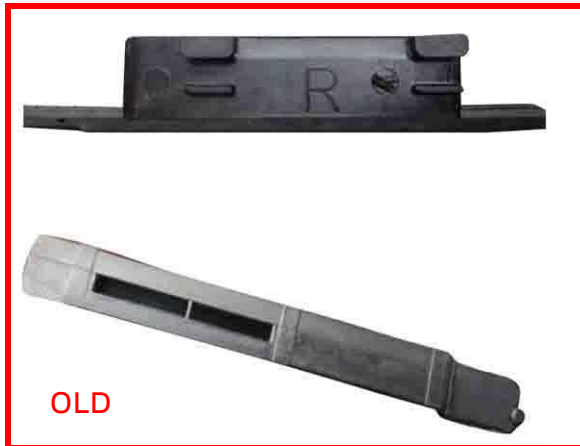
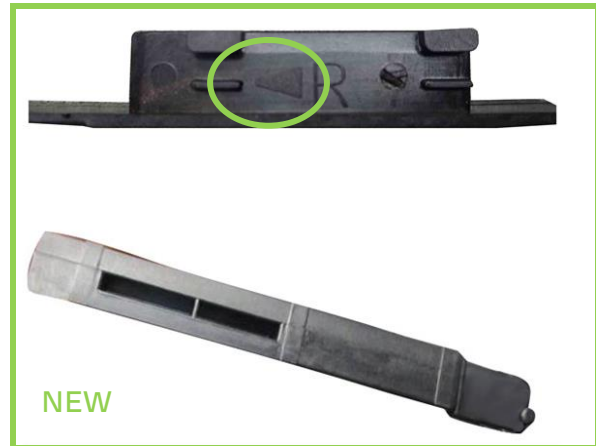
8. Take the new RH sliding shoe part no. 69916791A featuring an arrow next to the letter "R" (Right).

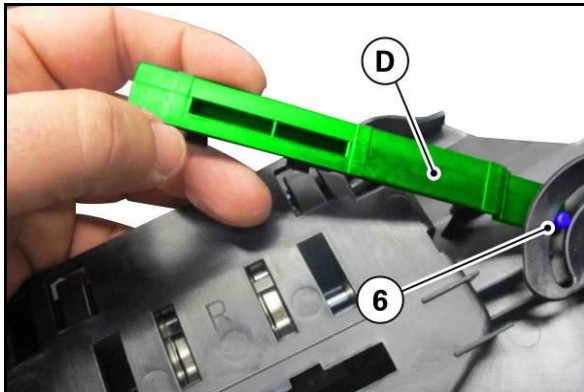
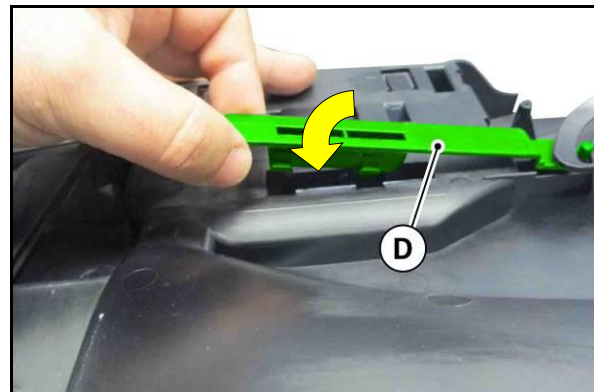
9. Insert the **pin (6)** of the **RH sliding shoe (D)** into the seat of the piece under the lock, aiming it as shown in the figure.

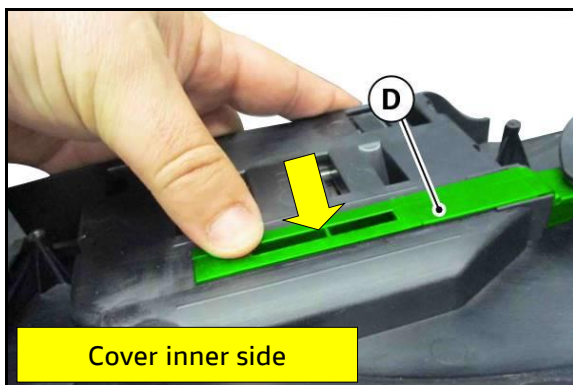
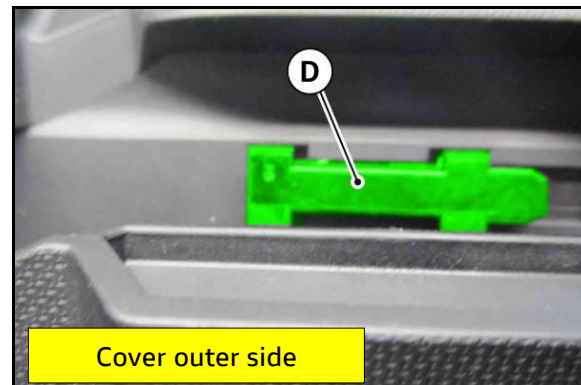
10. Press the **RH sliding shoe (D)** into the seat so that the teeth are engaged into the relevant seats of the cover.

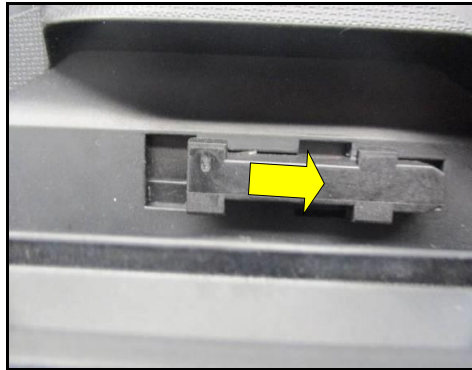
By turning the key to the "open pannier" position, the sliding shoe moves forward.

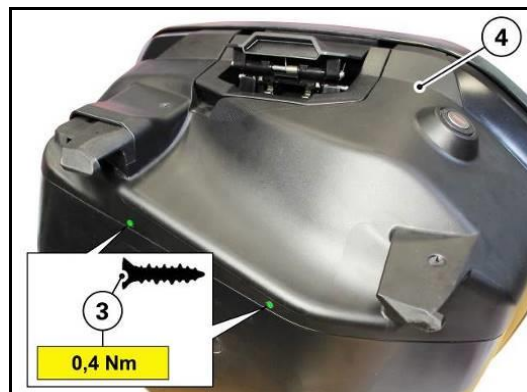
11. Install the **upper cover (4)** on the pannier and tighten the **2 self-tapping outer screws (3)** to **0.4 Nm**.

Ensure the fasteners are reinstalled into their original threads in the plastic cover, and that the designated torque is not exceeded. Damage due to improper installation is not a warrantable defect and is the responsibility of the dealer to correct.

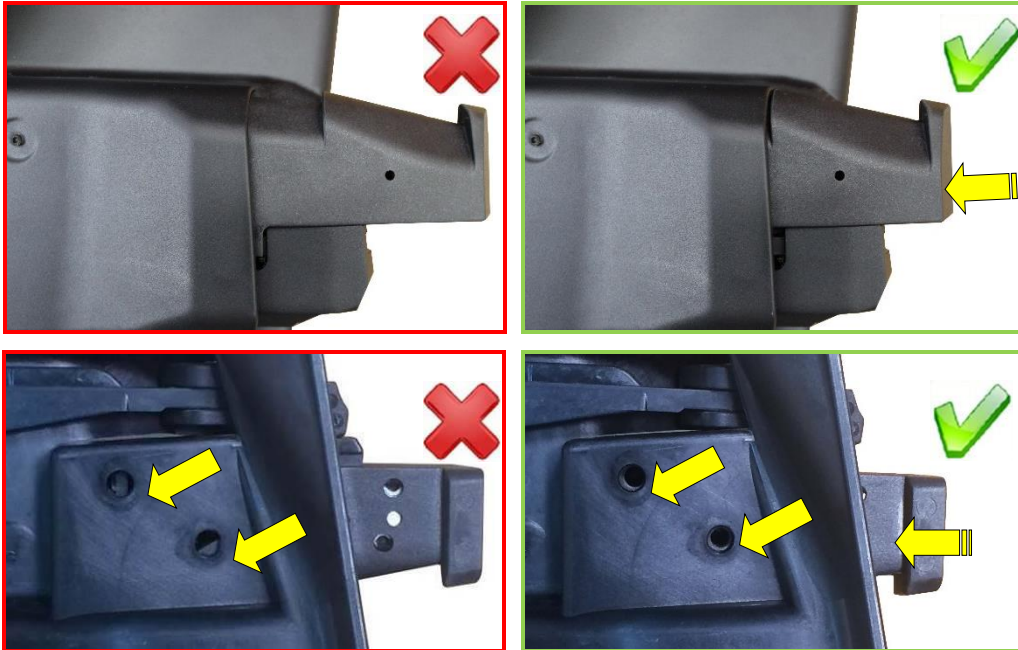
Before tightening the **4 screws (1)** and the **3 self-tapping inner screws (2)**, make sure that the hook is in "fully closed" position.

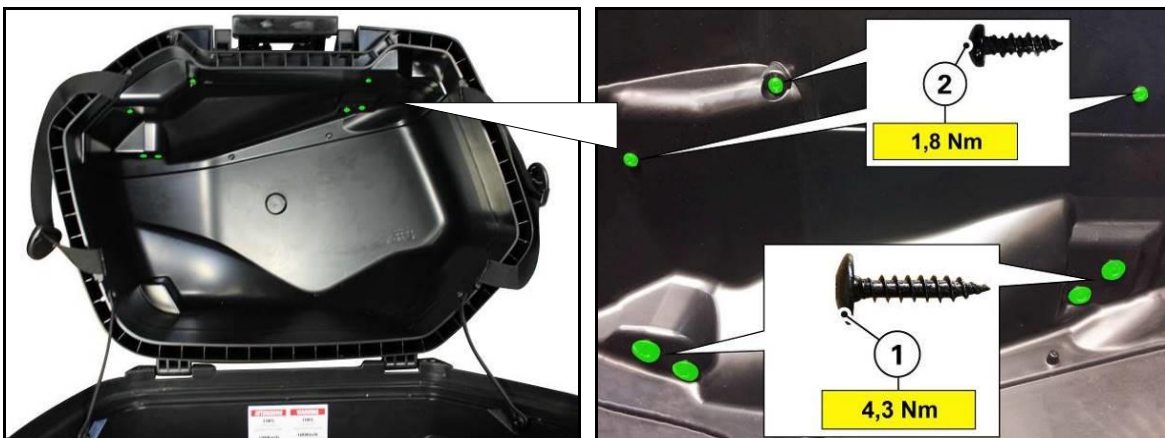
- Working from the inner side of the pannier, tighten the **4 screws (1)** to **4.3 Nm** and the **3 screws (2)** to **1.8 Nm**.

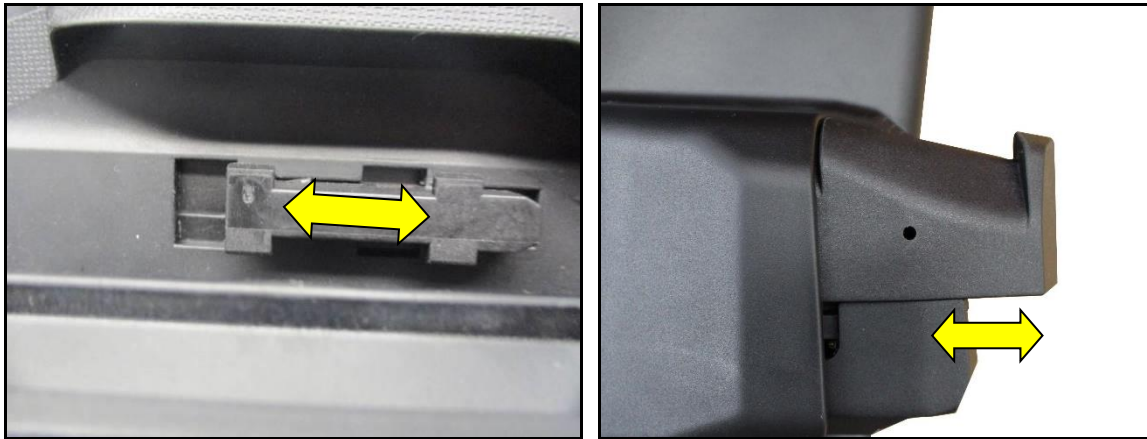
13. Repeatedly turn the key to the open/close position and check that the sliding shoe slides correctly.
14. With the key in the "open pannier" position, raise and lower the handle to check the correct movement of the tooth locking the pannier to the bike.
