SERVICE BULLETIN

Communication #: I-21-02

SUBJECT: FORK COVER ALIGNMENT (INT'L ONLY)

I-21-02 FORK COVER INSPECTION

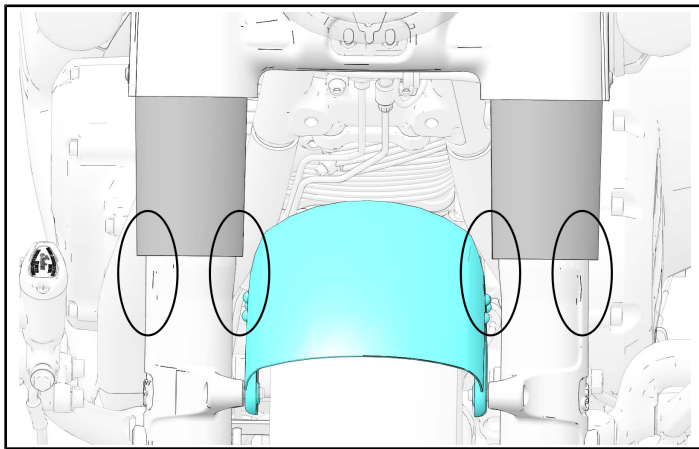
1. Park motorcycle on a flat surface, fully extend kickstand, and make sure vehicle is stable.
2. Turn key or ignition switch to OFF position and remove key. If equipped with keyless fob, remove fob from proximity of vehicle.
3. Locate the fork covers and inspect the fork covers, fork tubes and fender for paint damage.

Fork Cover Damage Example

If there is no paint damage proceed to the next step. If paint damage is found please proceed to step 5 and align fork covers.

- Cosmetic damage has no influence on bike performance. Damaged parts should be replaced through the standard warranty process.
- It is acceptable for the customer to delay standard warranty replacement of cosmetic parts during the off-riding season. Proceed with completing this Bulletin.

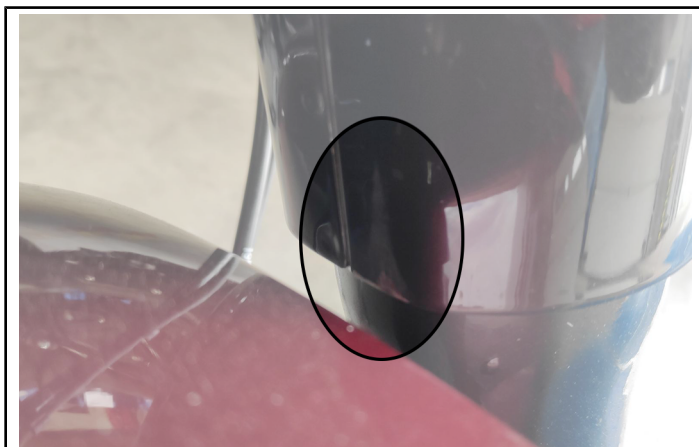
Fork Damage Example

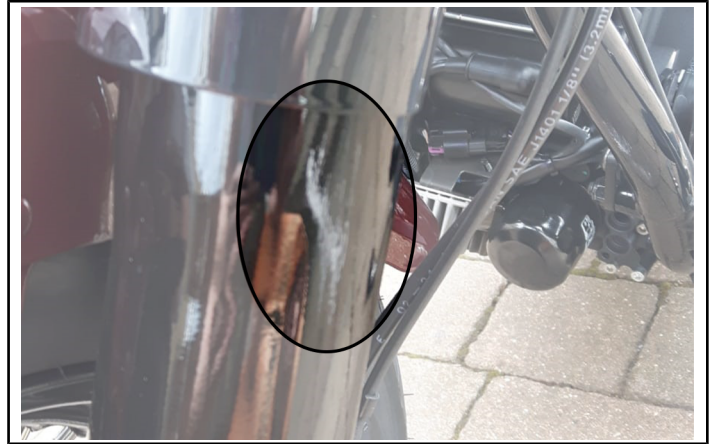
Fender Damage Example

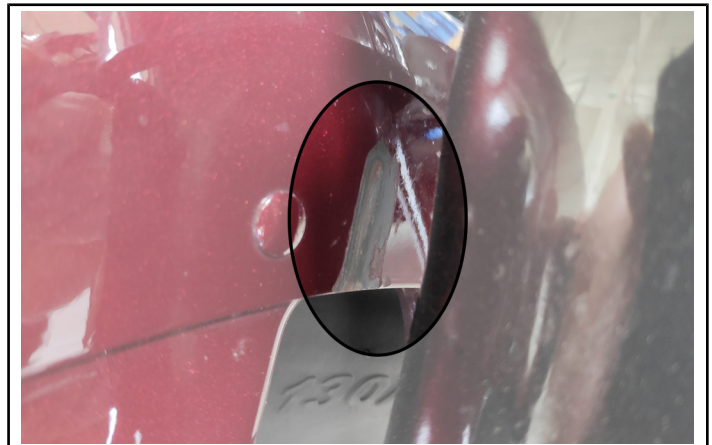
Indian Motorcycle has determined some 2022 Indian Chief motorcycles may have a misaligned fork cover. This may cause cosmetic damage to the fork, fork cover, and fender.

5. Loosen the fork cover fasteners, and align the covers to 6.6 mm +/- 1 mm (0.26 in. +/- 0.04 in.). Torque fasteners to specification.

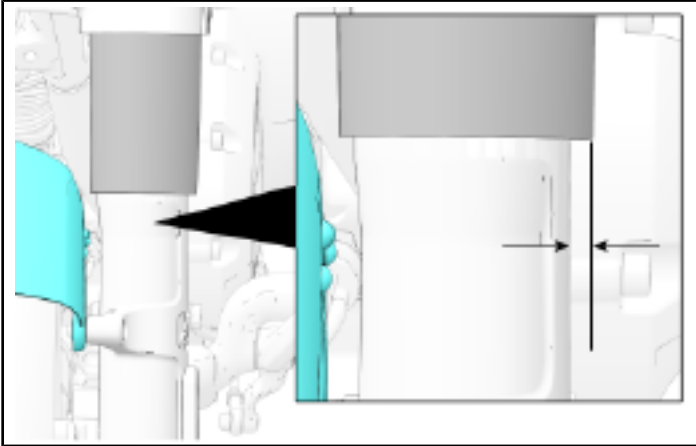
Gap Specification:
6.6 mm +/- 1 mm (0.26 in. +/- 0.04 in.)

Front View

If the fork covers are out of alignment, proceed to the next step.
If the fork covers are aligned on both sides proceed to step 6.

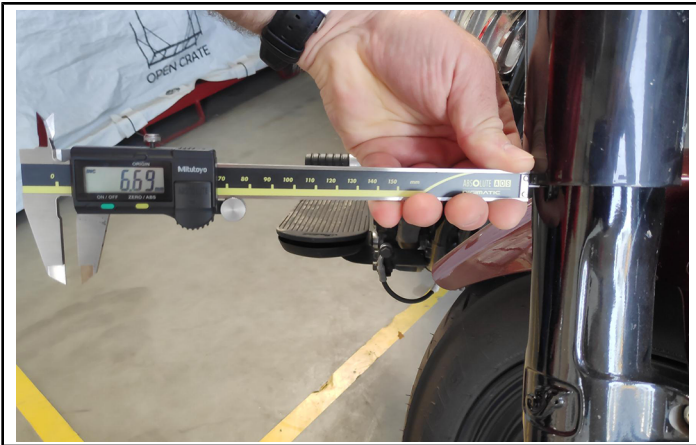
4. Using a vernier/dial/digital caliper, measure the lateral distance between the fork cover and fork body.

Lateral Distance Measurement

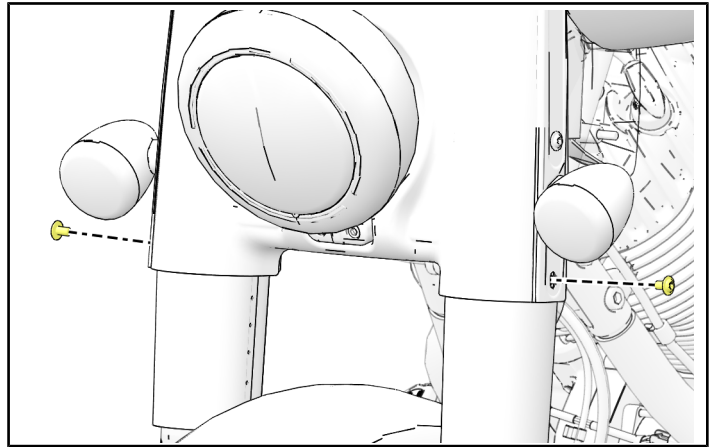
Fork Cover Fasteners:
(10 N·m) 89 ft-lbs
