Hydrogen Tank Cover Appearance Condition

Engine/Hybrid System

Fuel System

2016-2020 MIRAI

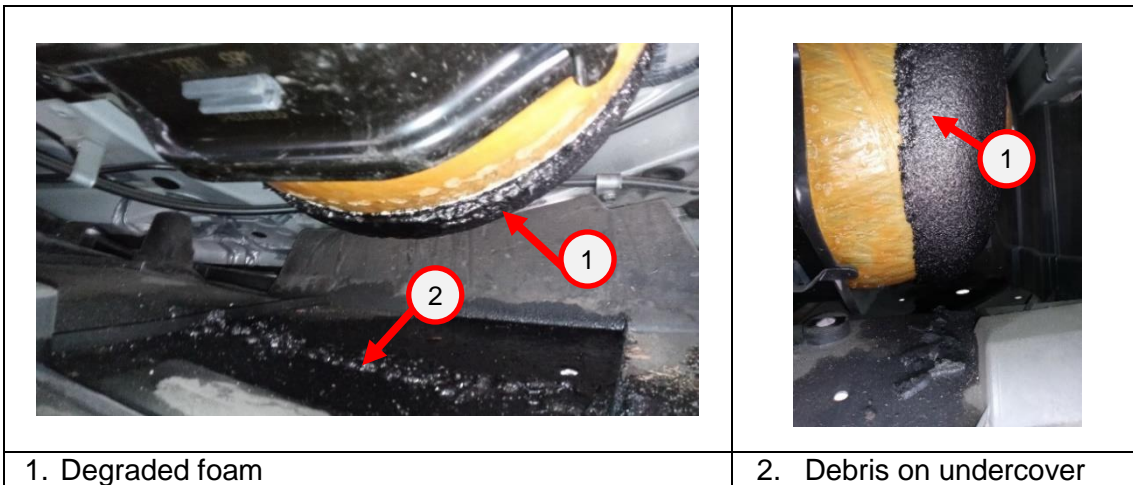
During vehicle inspections, when the vehicle under covers are removed, debris is found on the undercover near the end of the hydrogen tank. Upon closer inspection the debris is found to be coming from the end protector of the tank.

During vehicle use heat and ultraviolet light can cause degradation of the tank protector causing the foam to come off.

This protector is added by the supplier to protect the tank during the production process, this does not negatively affect the tank and is only an appearance concern.

1. Degraded foam

2. Debris on undercover

It is recommended to clean the undercovers before reinstalling. No repairs are recommended.
