Clicking/Creaking Noise From Clad Wheels While Driving

Service Category Suspension

Section Tire/Wheel

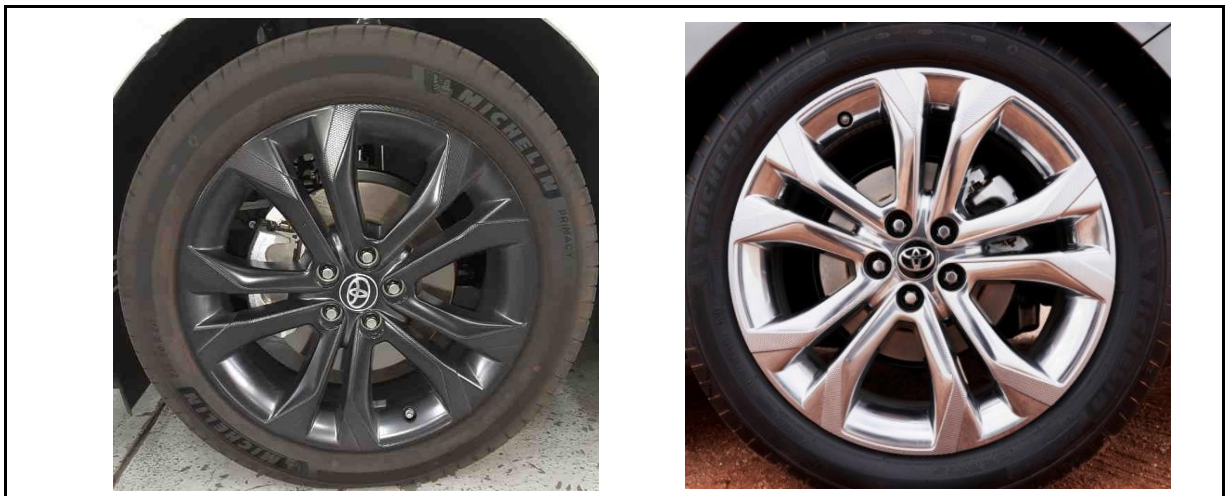
Figure 1. Clad Wheel Examples

1. Is the vehicle equipped with 20-in. clad wheels?
 - **YES** — Continue to step 2.
 - **NO** — This bulletin does NOT apply. Continue diagnosis using the applicable Repair Manual.

3. Determine which wheel(s) exhibit the clicking/creaking noise.
4. Remove and replace the wheel(s) that exhibit a clicking/creaking noise with the NEW post countermeasure wheel(s).
