HVAC Evaporator Drain Hose Clogged Due to Insect Intrusion

Service**Category** Vehicle Interior**Section** Heating/Air Conditioning**Market** USA
 Toyota Supports
 ASE Certification

The information contained in this bulletin supersedes Service Bulletin No. T-SB-0033-14.

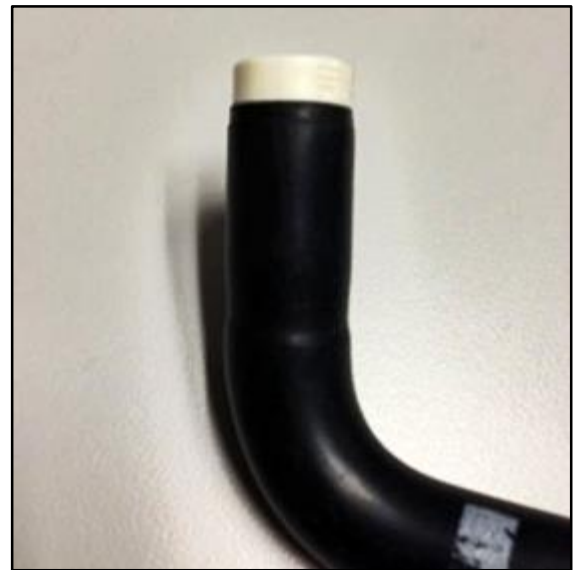
1. Follow the instructions provided in the Safety Requirements for Handling the ARINIX[®] Tip (Water Hose Connector) section of this bulletin.
2. Locate the HVAC evaporator drain hose.
3. Following the vehicle specific Repair Manual, remove the HVAC evaporator drain hose.
4. Put on all necessary PPE and install the ARINIX[®] Tip (water hose connector) into the NEW HVAC evaporator drain hose listed in the Parts Information section of this bulletin.
5. When installing the ARINIX[®] Tip, verify it is fully seated in the HVAC evaporator drain hose as shown in Figure 1.

1. Follow the instructions provided in the Safety Requirements for Handling the ARINIX® Tip (Water Hose Connector) section of this bulletin.
2. Locate the HVAC evaporator drain hose.
3. Following the vehicle specific Repair Manual, remove the HVAC evaporator drain hose.
4. Put on all necessary PPE and install the ARINIX® Tip (water hose connector) into the NEW HVAC evaporator drain hose listed in the Parts Information section of this bulletin.
5. When installing the ARINIX® Tip, verify it is fully seated in the HVAC evaporator drain hose as shown in Figure 1.
6. Following the vehicle specific Repair Manual, install the HVAC evaporator drain hose.

5. Put on all necessary PPE and install the ARINIX® Tip into the NEW HVAC evaporator drain hose listed in the Parts Information section of this bulletin.
6. When installing the ARINIX® Tip, verify it is fully seated in the HVAC evaporator drain hose as shown in Figure 1.
7. Following the vehicle specific Repair Manual, install the HVAC evaporator drain hose.

1. Follow the instructions provided in the Safety Requirements for Handling the ARINIX® Tip (Water Hose Connector) section of this bulletin.
2. Locate the HVAC evaporator drain hose.
3. Following the vehicle specific Repair Manual, remove the HVAC evaporator drain hose.
4. Before installing the ARINIX® Tip (water hose connector) into the original HVAC evaporator drain hose, the end of the hose MUST be cut perpendicular as shown in Figure 2.
5. Put on all necessary PPE and install the ARINIX® Tip into the original HVAC evaporator drain hose listed in the Parts Information section of this bulletin.
6. When installing the ARINIX® Tip, verify it is fully seated in the HVAC evaporator drain hose as shown in Figure 1.
7. Following the vehicle specific Repair Manual, install the HVAC evaporator drain hose.

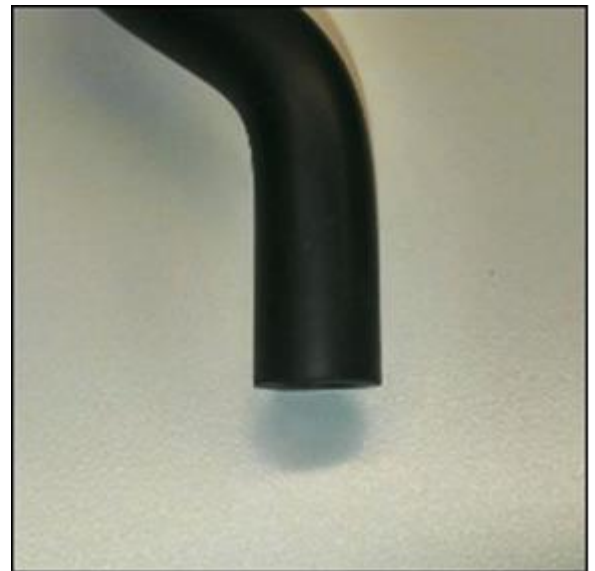
1. Follow the instructions provided in the Safety Requirements for Handling the ARINIX® Tip (Water Hose Connector) section of this bulletin.
2. Locate the HVAC evaporator drain hose.
3. Following the vehicle specific Repair Manual, remove the HVAC evaporator drain hose.
4. Before installing the ARINIX® Tip (water hose connector) into the NEW HVAC evaporator drain hose, the end of the hose MUST be cut perpendicular as shown in Figure 2.
