# Service Action

## Code: 23DG

<b>Subject</b>	<b>Air Intake Drain Valve</b>															
<b>Release Date</b>	September 7, 2021															
<b>Affected Vehicles</b>

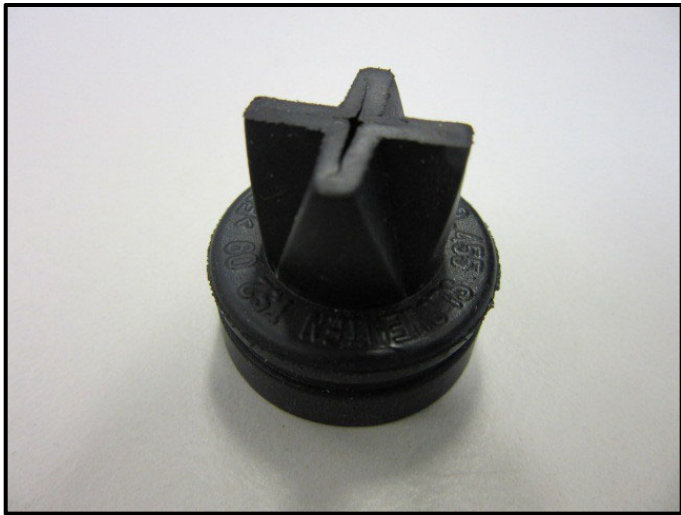
## Repair Overview

- Remove drain valve from air intake hose.

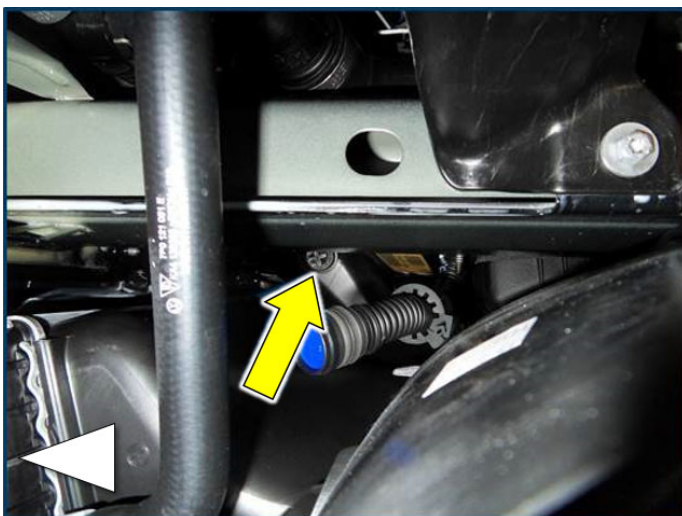
- Remove the drain valve from the air intake.
- The drain valve to be removed <arrow> is made of rubber and can be pulled off the air intake without using much force.

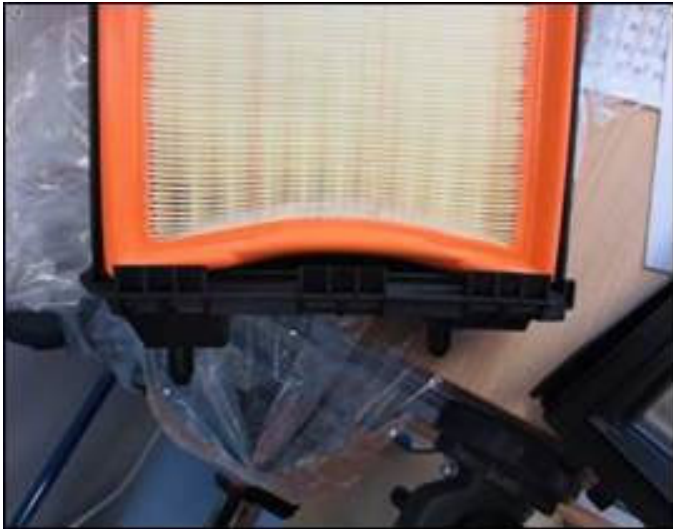
- Access the air filter:
  - See ELSA Maintenance Manual: *Maintenance > Air Filter, Cleaning Housing and Replacing Filter Element*
- Check the air filter for damage caused by humidity or water ingress.
- If damage is found:
  - Replace the air filter.
  - Proceed to Section C.
- If no damage is found:
  - Reinstall air filter.
  - Proceed to Section C.
