**87-18-08 - Air Conditioning, Cleaning of the R1234yf Refrigerant Circuit (U.S. Only)**

Release date: 9/9/2021

Debris can be dispersed throughout the refrigerant circuit after A/C component damage. In order to maintain A/C operating efficiency, it is important to flush the refrigerant circuit after A/C component repairs.

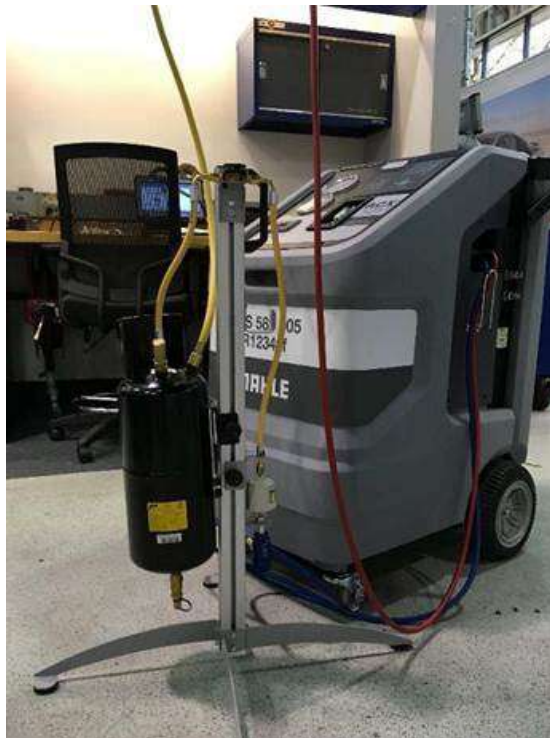
Use an approved R1234yf servicing machine and the R1234yf Flush Kit RTI360831840 (Figure 1).

Used for effective refrigerant handling and air conditioning circuit flushing after air conditioning component failure.

**Figure 1.** The VAS581005 Air Conditioning Service System with Flushing Device.

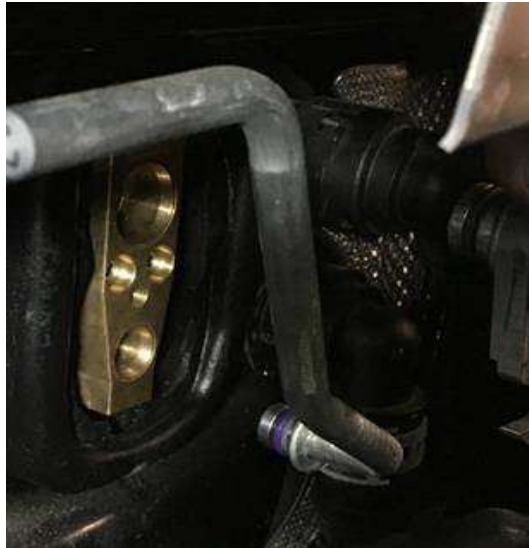
**Figure 3.** Installation of front expansion valve  
bypass adaptor VAS 6338/38.

7. Remove expansion valve and install flush plate  
VAS 6338/38. (Figure 3)

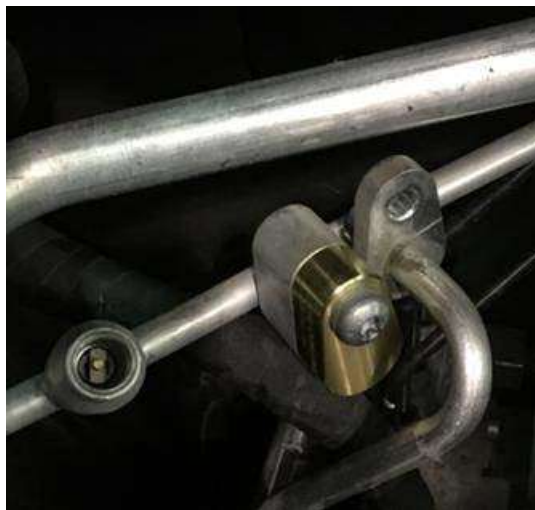
**Figure 4a.** Installation of high side rear A/C Line  
connection block adaptor VAS 6338/63.

(Atlas Only) The rear A/C unit refrigerant lines must  
be disconnected and replaced with block off  
adaptors VAS 6338/5 and VAS 6338/63 before  
performing the front A/C unit flush procedure.

8. (Atlas Only) Disconnect rear refrigerant lines and  
install adaptors VAS 6338/5 and VAS 6338/63 as  
shown. (Figure 4a, 4b)

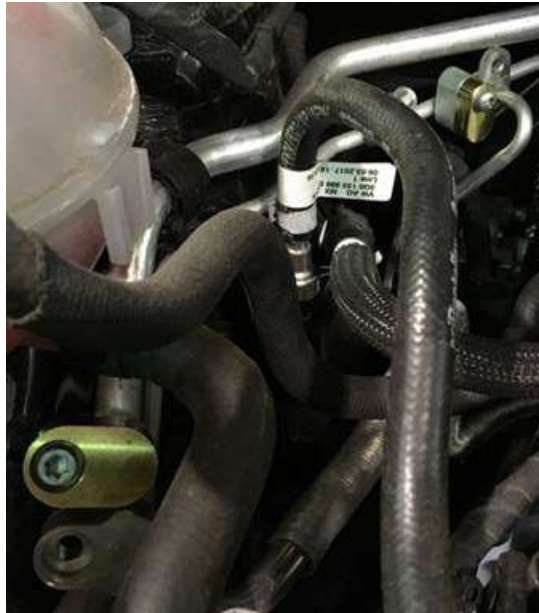
**Figure 4b.** Installation of Low side rear A/C Line connection block adaptor VAS 6338/5.

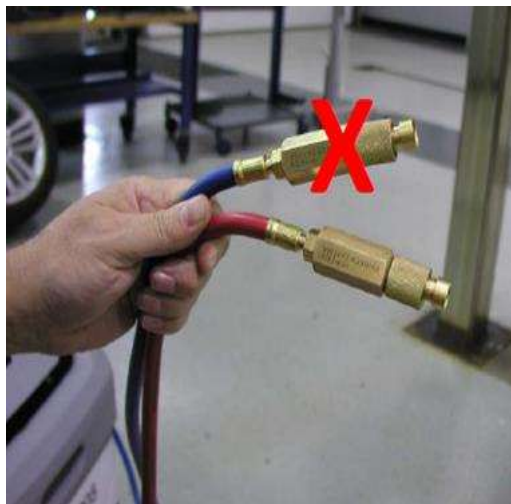
**Figure 5.** A/C hose adaptor 6338/44

9. Remove A/C Recovery machine high side coupler from hose.

Install flush adaptor VAS 6338/48 to high side A/C recovery machine hose. (Figure 5)

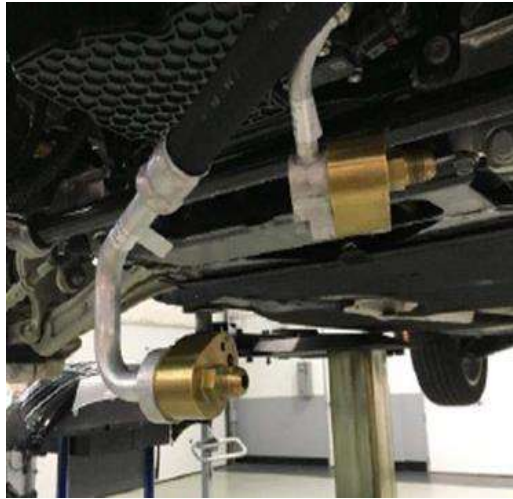
Figure 6. Installation of VAS 6338/3 and 6338/12.

10. Disconnect A/C compressor hoses from the compressor.

Install flush adaptor VAS 6338/3 on the high side compressor hose.

Install flush adaptor VAS 6338/12 on low side compressor hose. (Figure 6)

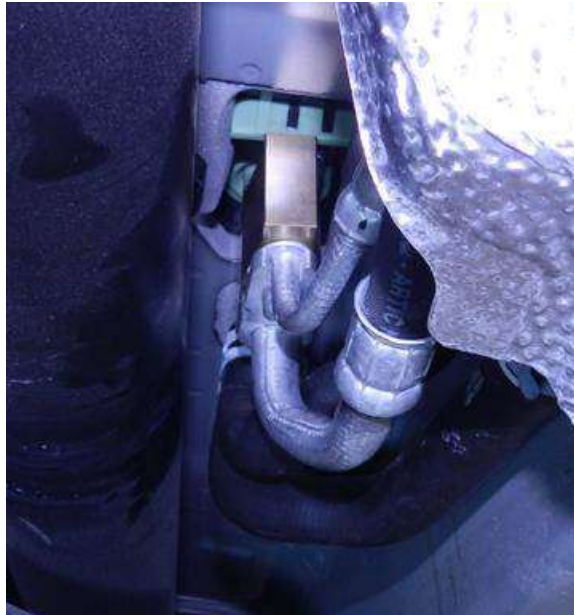
**Figure 13.** Location of rear air conditioning unit expansion valve.

23. Remove rear expansion valve and install VAS6338/38 as shown. (Figure 13)

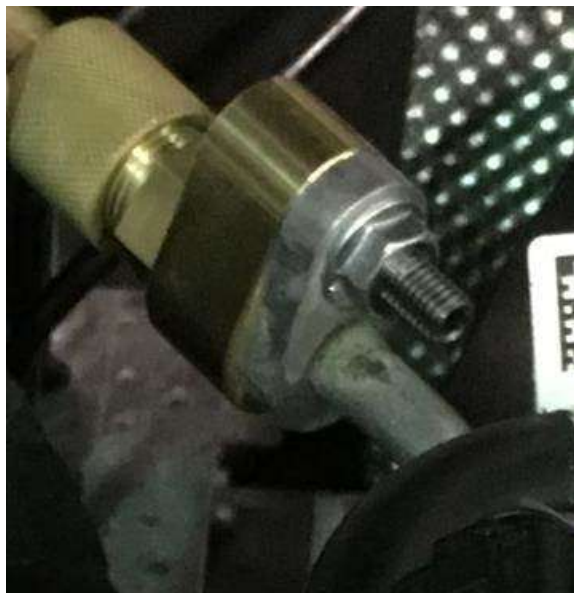
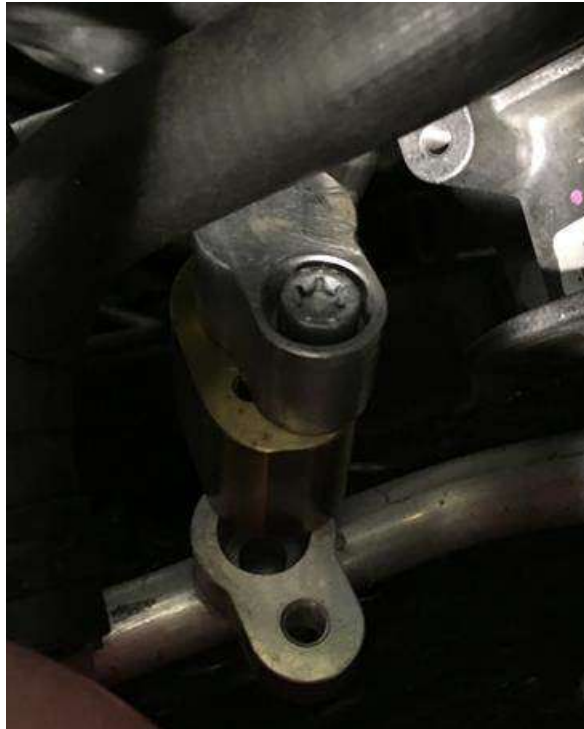
**Figure 14.** Location and connection of the adaptors for the rear unit A/C lines

24. Connect the VAS 6338/3 and VAS 6338/60 to the rear refrigerant A/C lines (Figure 14)

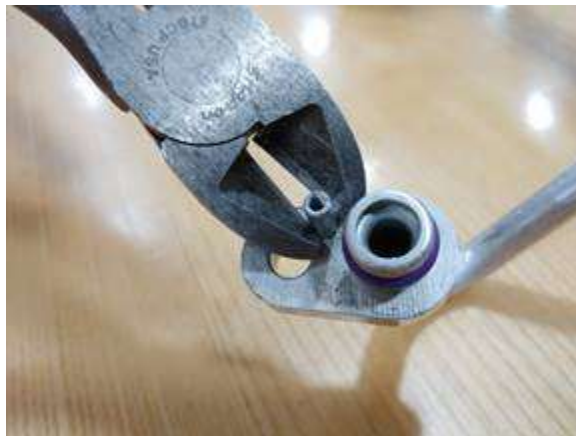
**Figure 15.** Removal of dowel pin.

Later models may have a dowel pin in the high pressure refrigerant line that does not allow the VAS 6338/60 to be installed. The pin must be temporarily removed to install the VAS 6338/60. . DO NOT cut the pin flush with the refrigerant. Side cutters can be used to remove the pin and pliers to reinstall the pin (Figure 15 and 16).

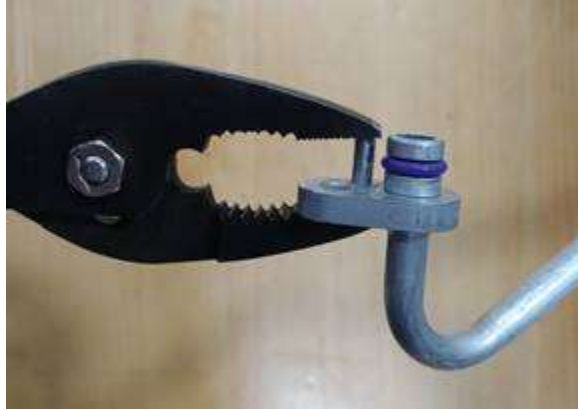
**Figure 16.** Installation of rear refrigerant line dowel pin.

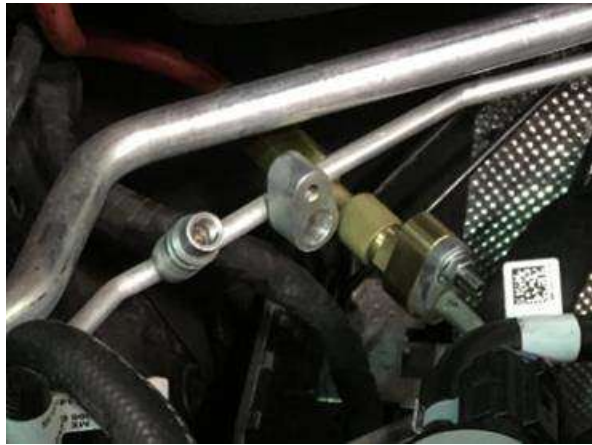
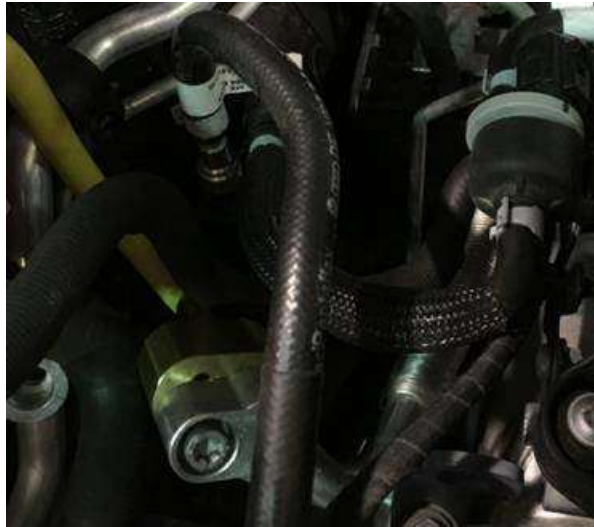
**Figure 17.** Attaching service station and flush hoses to rear A/C lines.

25. Connect the VAS 6338/48 to adaptor VAS 6338/60

26. Connect flush tank hose (Yellow) to the high side compressor hose adaptor VAS 6338/3. (Figure 17)
