Technical Service Bulletin

69 Airbag light on, DTC B101C29 and/or B101D29 is stored in the airbag control module - Repair Authorization

69 21 70 2064545/1 September 14, 2021.

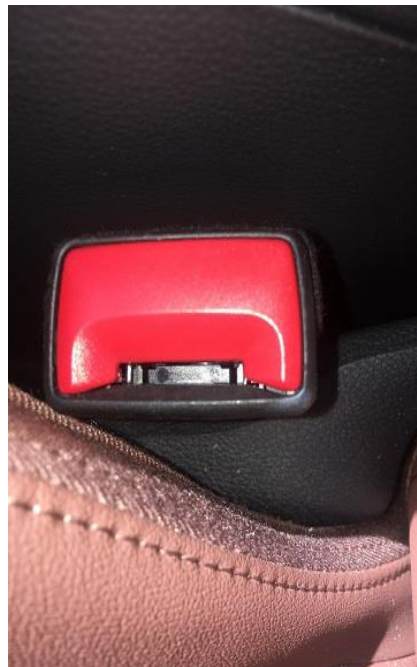
1. Verify the customer concern.
2. Before performing any repairs, please take detailed photos of the following:
 - Belt buckle with latching mechanism (Figure 1).

Figure 1. Belt buckle with latching mechanism.

3. Perform root cause analysis.
4. Inspect the seat belt buckle for foreign objects and/or sticky fluids, the belt buckle wiring for damage and the belt buckle connectors for any concerns (e.g. damaged wiring, backed out or widened pins, corrosion, etc.).
5. Take detailed photos of any concerns found during analysis.
6. Upload photos to Doc-It and reference this TSB in the claim comments.

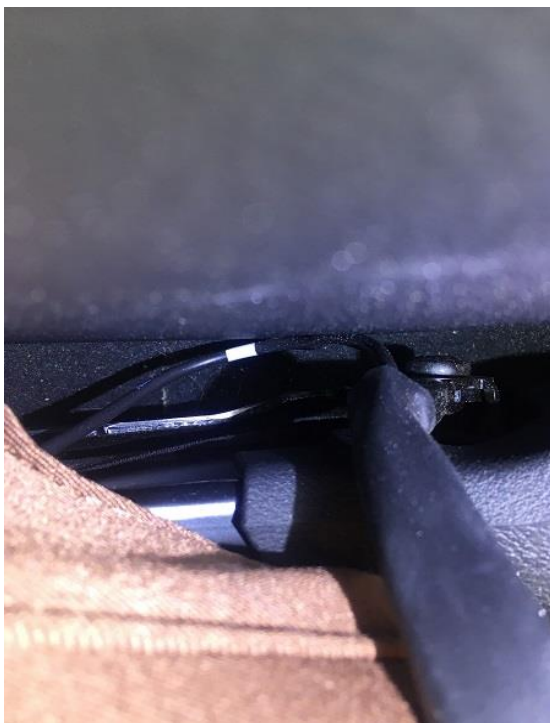
- Belt buckle wiring from buckle to seat frame (Figure 2).

Figure 2. Belt buckle wiring from buckle to seat frame.

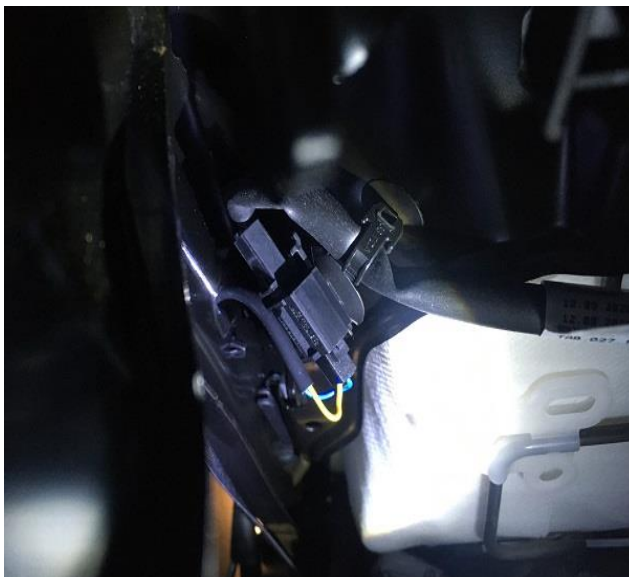
- Belt buckle wiring and connector on seat frame (Figure 3).

Figure 3. Belt buckle wiring and connector on seat frame.

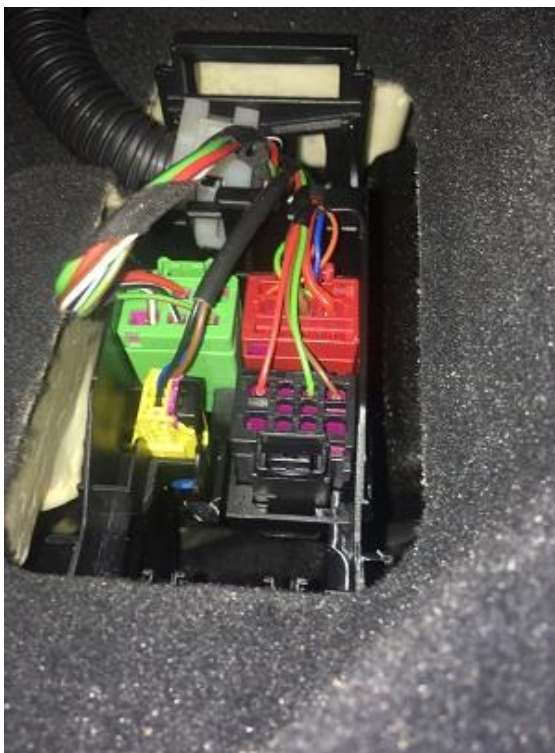
- Belt buckle wiring and connector in seat coupling point underneath seat (Figure 4).

Figure 4. Belt buckle wiring and connector in coupling station.
