# Service Bulletin

Bulletin Number: **SB-21-351-WM**  
Release Date: **September 17, 2021**  
Distribution: **Waste Management Managers, Heil Dealers, Heil Technical Services, Heil Customer Care**  
Subject: **Half/Pack® and Half/Pack® (Featuring Odyssey® Controls): Front Head Manifold Hydraulic Tube Failures and Body Controller Program Update to Smooth Packer Operation**

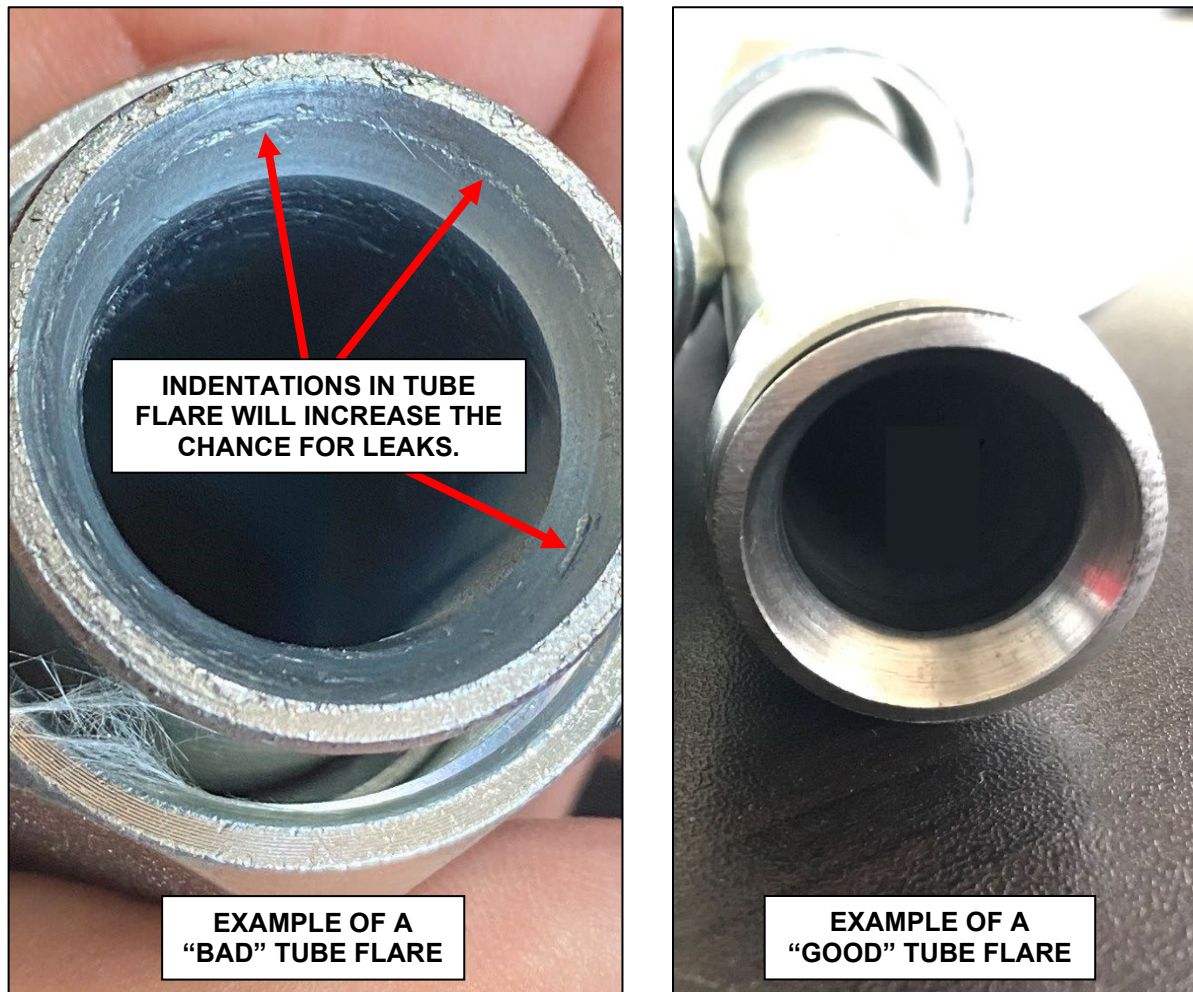
**Figure A. Example of "Bad" and "Good" Tube Flares**

Visually inspect the tubes to be reinstalled. The tube flares must not show damage or manufacturing defects, including scratches, scoring or indentations. If indentations are found in tube flares, do not install them, and contact Heil Technical Service at 866.310.4345.

- ☐ Remove and visually inspect the four (4) front head hydraulic tube to ensure that the tube flares show no damage or manufacturing defects, including scratches, scoring or indentations. See **Page 6** and **Figure A**.
