GROUP	MODEL
Product Improvement	See Model List On Page 1
NUMBER	DATE
PI2002Y/Z (Rev 2, 09/23/2021)	April 2021

PRODUCT IMPROVEMENT CAMPAIGN

ENGINE REPLACEMENT INSTRUCTIONS FOR DTC P1326 (PI2002Y/Z)

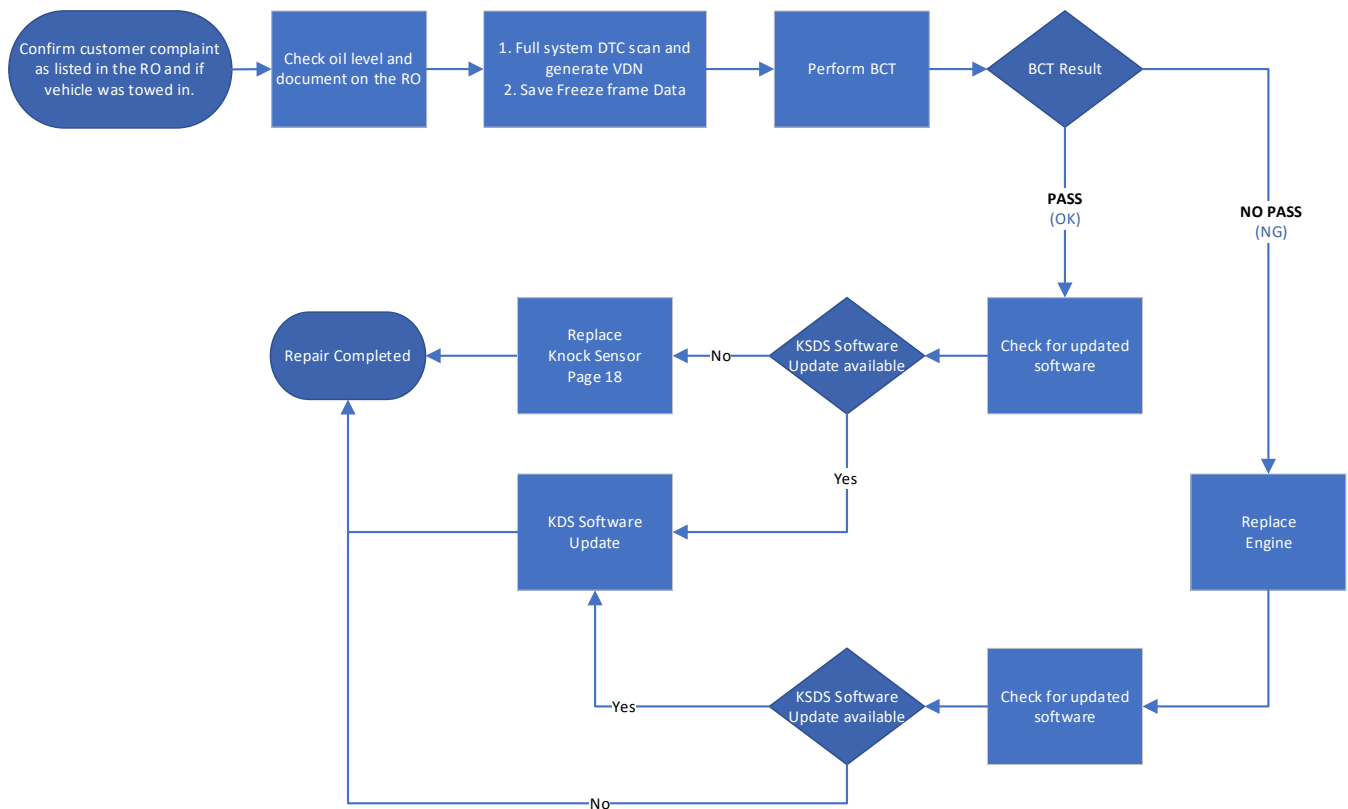
A. DTC P1326 STORED

Create PI2002Y Claim – No Techline PWA Required

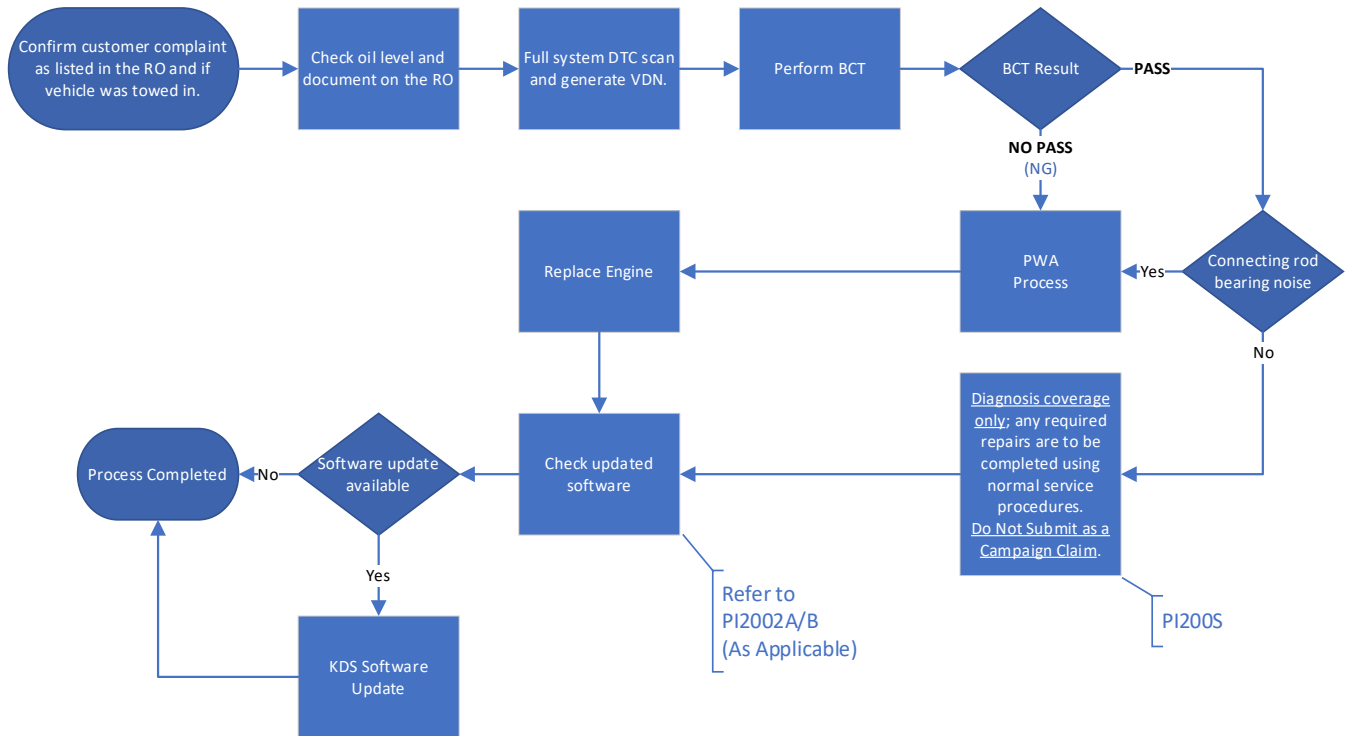
B. ENGINE NOISE

Techline PWA Required; Diagnosis only Campaign Possible

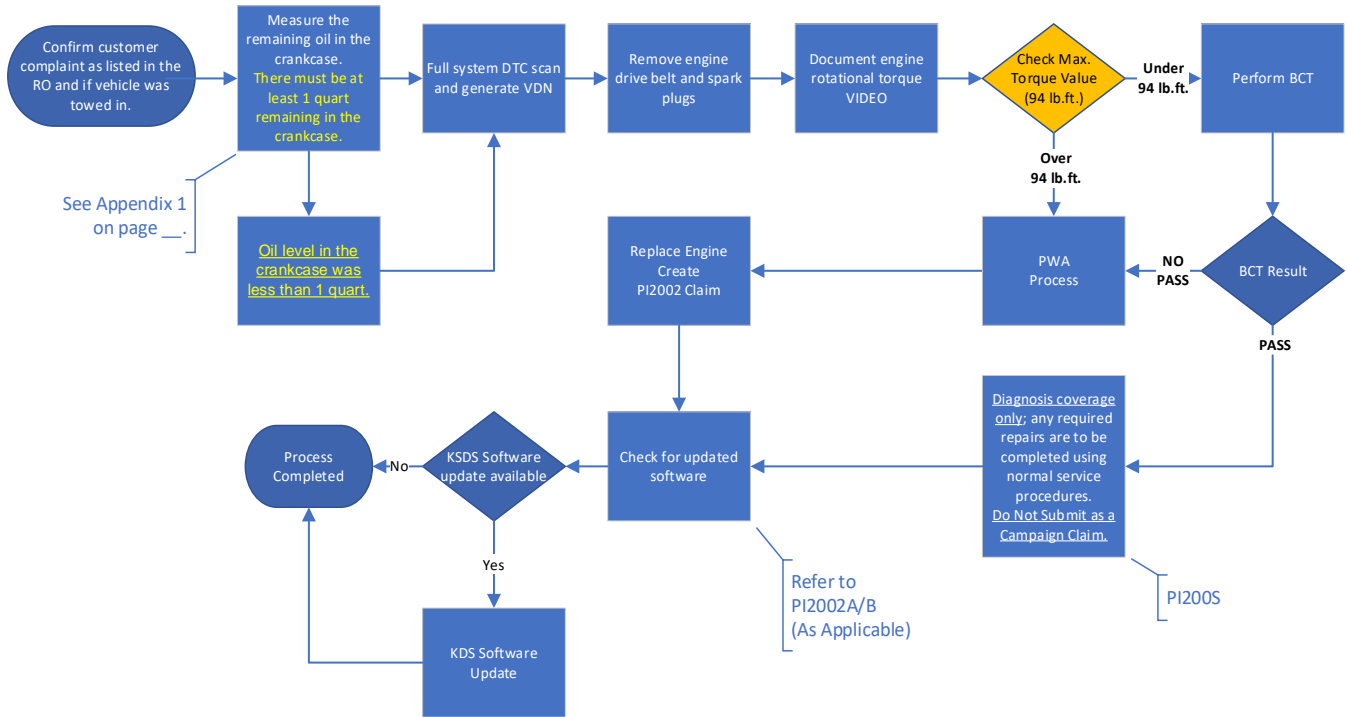
C. ENGINE NO CRANK

Techline PWA Required; Diagnosis only Campaign Possible

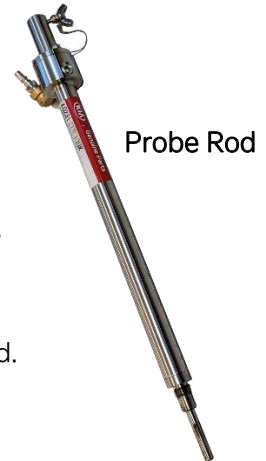
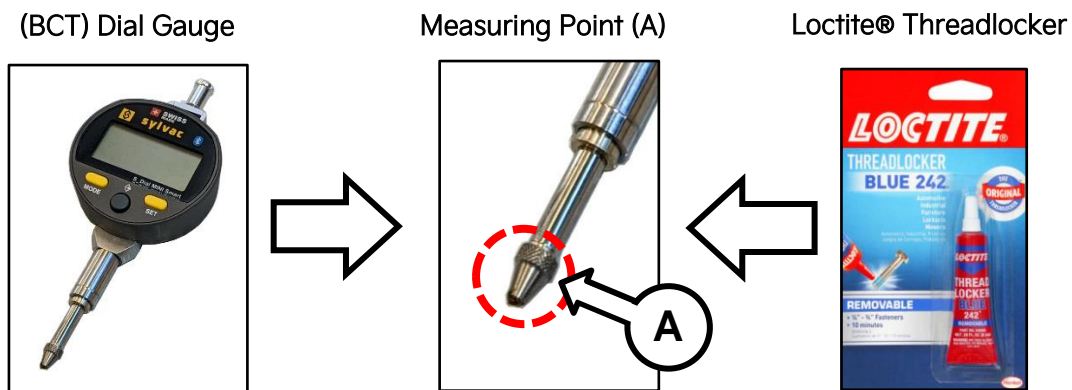
This outline provides information regarding the application of Loctite® Threadlocker Blue 242 to the dial gauge 'measuring point' end included in the Engine Bearing Clearance Tester (BCT) kit SST KQ231 2T110QQK. This extra step helps reduce the possibility of the measuring point tip loosening on the dial gauge due to repeated use. If measuring tip comes loose, inaccurate BCT measuring readings will result.

1. Unscrew the 'measuring point' end (A) from the base of the dial gauge.
2. Apply one drop of blue Loctite® to the threaded end of the 'measuring point'.
3. Reinstall the 'measuring point' end back onto the dial gauge finger tight.
4. Fully insert the dial gauge into the probe rod.
5. Secure the gauge to the probe rod by tightening the locking wing nut by hand.
6. Test gauge operation by pressing the lower bar of the probe rod inward and verify the gauge readings correspond with the movement

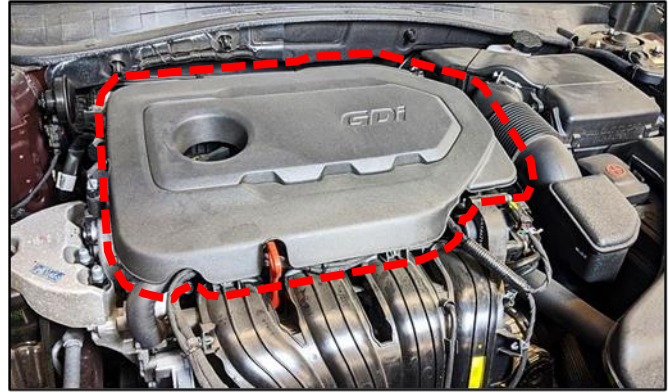
Have the SST Engine Bearing Clearance kit ready. Place it on a table/cart next to the vehicle and use a fender cover. Use air gun to blow off any debris from the engine top area.

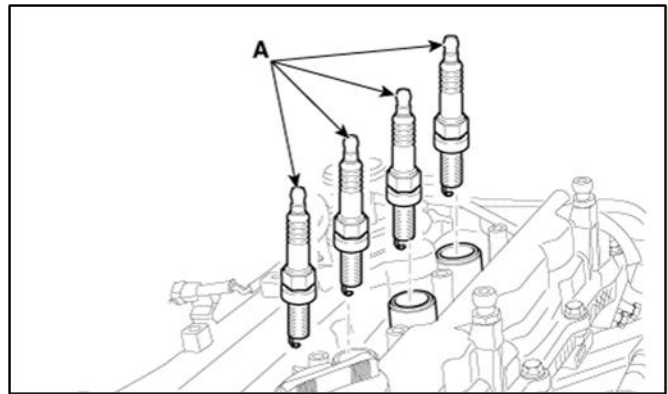
2. Remove the four (4) spark plugs (A) by referring to the "Maintenance → Power Train → Spark Plug → Repair procedures (Replacement)" in the applicable Shop Manual on KGIS.

Tightening torque for Spark Plugs:
 10.9 - 18.0 lb.ft (14.7 - 24.5 N.m,
 1.5 - 2.5 kgf.m)

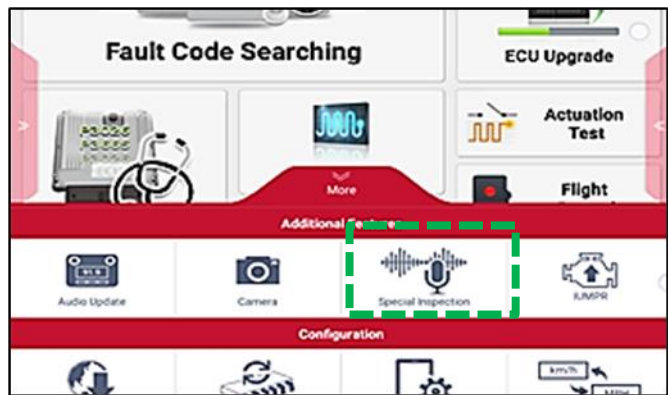
- 3a. Using KDS, connect the VCI-II to the vehicle's OBD-II port.
- 3b. Turn the ignition to 'ON'.
- 3c. On the KDS screen, select 'Special Inspection' on the bottom tab of the Home screen.
- 3d. Select the applicable vehicle model/year.

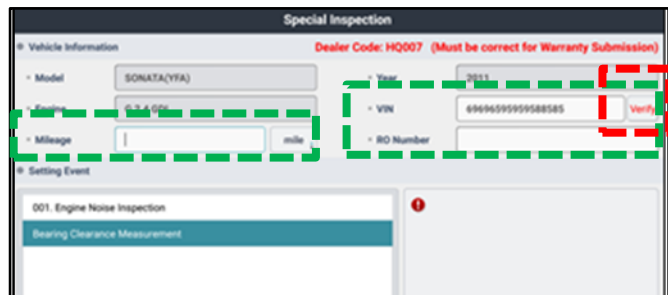
- 4a. Enter the vehicle information: the vehicle mileage and RO number.
- 4b. Select 'Verify' to confirm the automatically detected VIN.

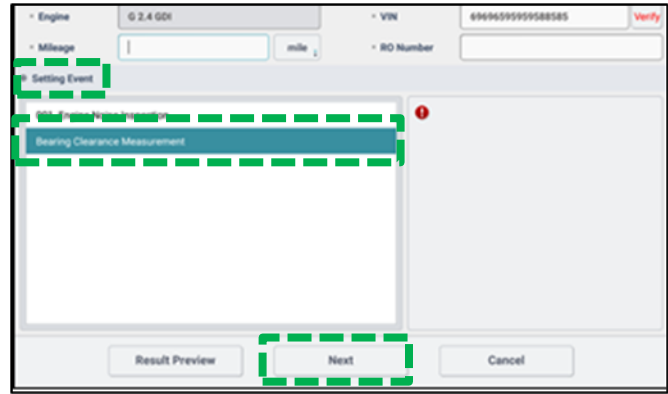
5a. Under "Setting Event", select 'Bearing Clearance Measurement' and then select 'Next'.

5b. Turn the ignition to 'OFF' and remove the VCI-II after verifying the VIN on KDS.

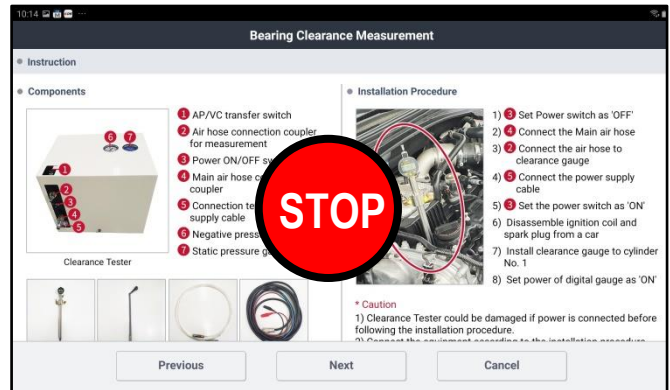
6. STOP on this screen, proceed to step 7 first before continuing to KDS.

IMPORTANT
DO NOT select 'Next' at this time. Proceed to steps 7 - 9 first and continue with KDS as instructed after installing the SST components.

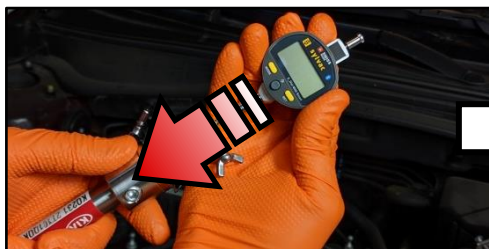
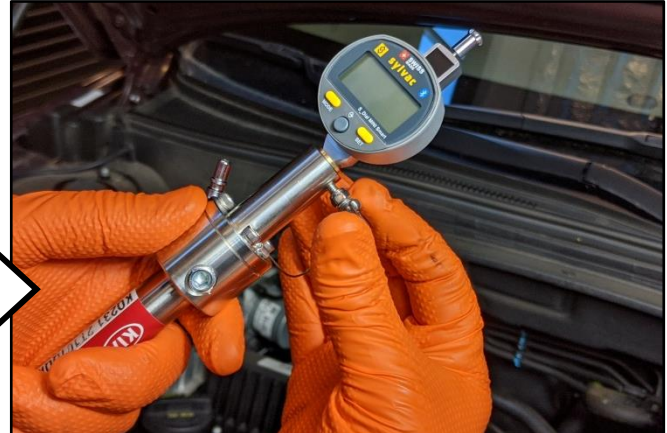
7. Install the Dial Gauge fully into the Probe Rod and secure together by hand tightening the locking wingnut.

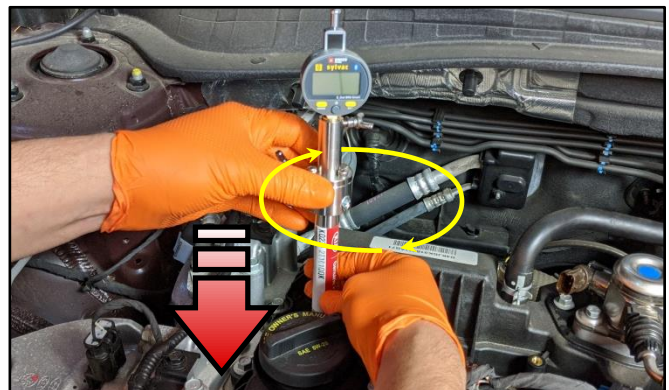
8. Carefully, insert the assembled SST Probe Rod and Dial Gauge into the Cylinder 1 spark plug hole and carefully turn the SST Crankshaft Rotator by hand clockwise until hand tight.

CAUTION
Damage to cylinder head can occur if spark plug hole is cross-threaded. DO NOT use a wrench to tighten the SST rod.

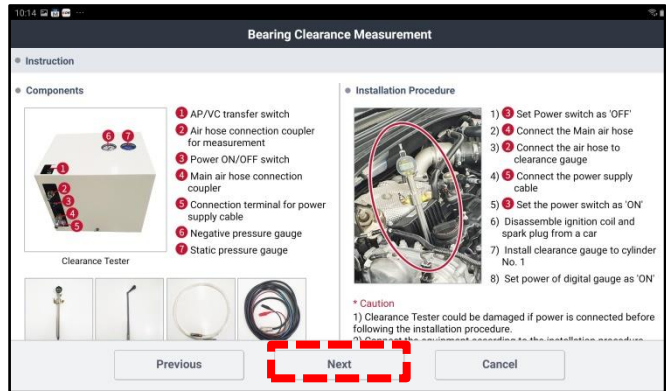
- Pair the Dial Gauge Bluetooth by selecting the device displayed on the screen: Device name is SY303.

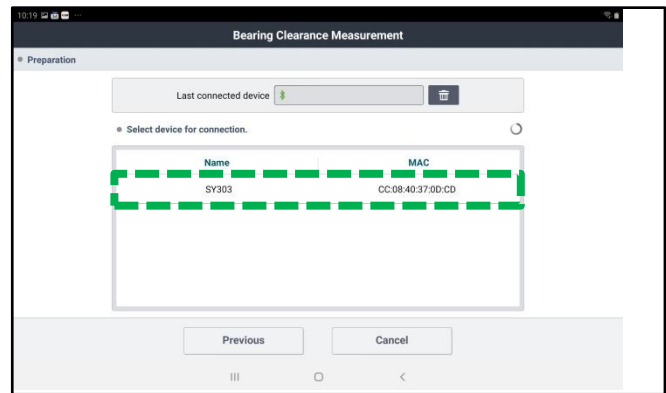
- Once the Dial Gauge is paired to the KDS, the shown screen will appear instructing to insert probe rod into Cylinder 1.

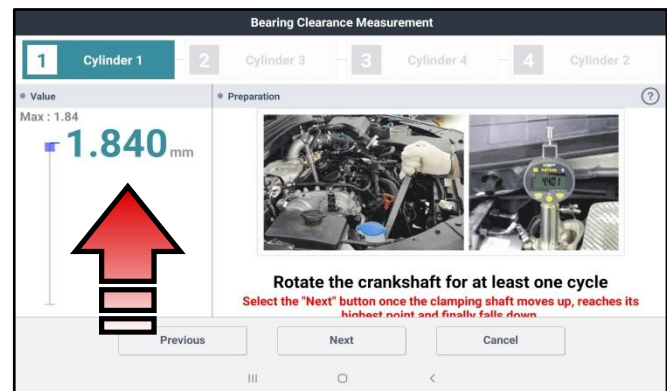
15. Once the 'Max' value is reached (sample shows Max: 2.86mm), continue to turn just past the 'Max' value reading and STOP rotating the crankshaft (sample shows 2.850mm value decreasing).

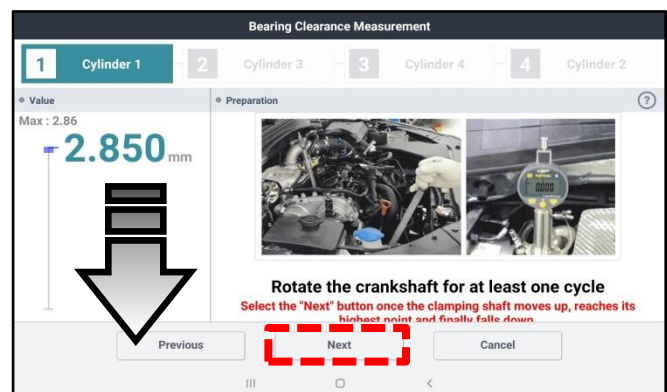
Note: The KDS may prompt to rotate the crankshaft 'counterclockwise' if needed.

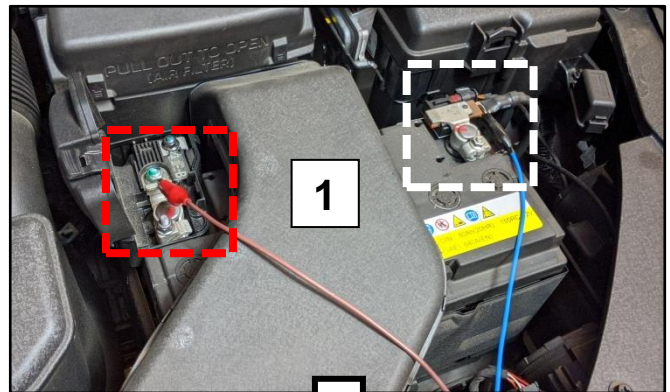
1. Power Cable (12V)
2. Air Compressor Hose
3. Test Hose

Note: The 12V power cable has red (+) and black (-) connector clamp ends.

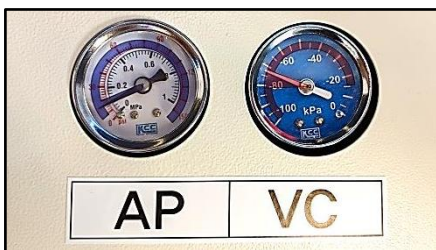
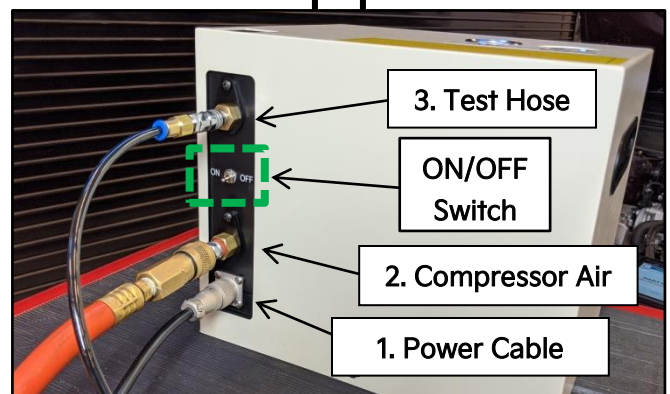
18. Turn the Bearing Clearance Tester power switch to the 'ON' position. Gauges should read as follows:

AP (Pressure) Gauge: (0.1 ~ .011MPa)

VC (Vacuum) Gauge: (-73 ~ -83kPa)

If the gauges do not read within specification, calibration of the SST box is required. Refer to [TSB SST067](#) for details.

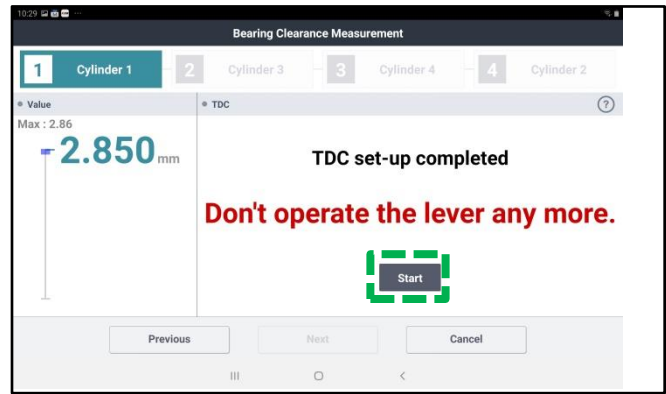
21. Locate the 'AP/VC' switch on top of the Bearing Clearance Tester Box and switch it to the 'AP' position. Select 'Next' to begin Cylinder 1 bearing clearance test.

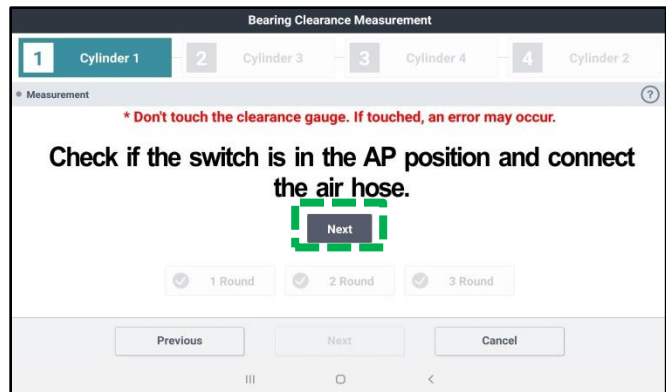
The toggle switch has a 3-way operation. The center is neutral. Always toggle past neutral.

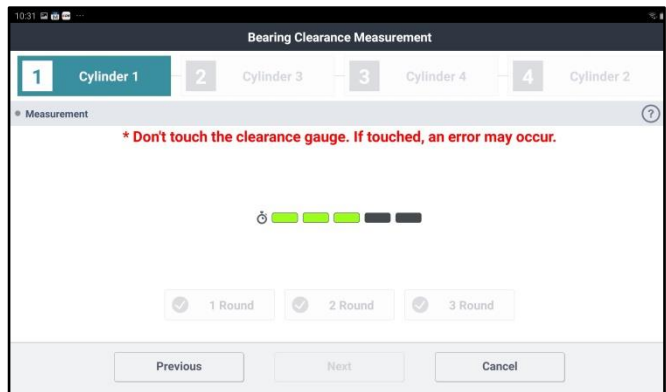
22. The KDS screen will prompt to change the 'AP/VC' switch to the 'VC' position.

Select 'Next' to complete. There are three (3x) rounds per cylinder to complete.

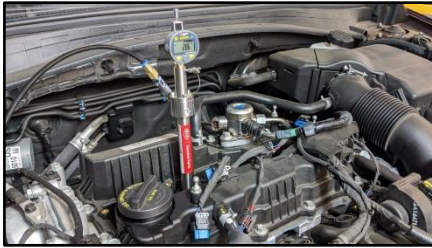
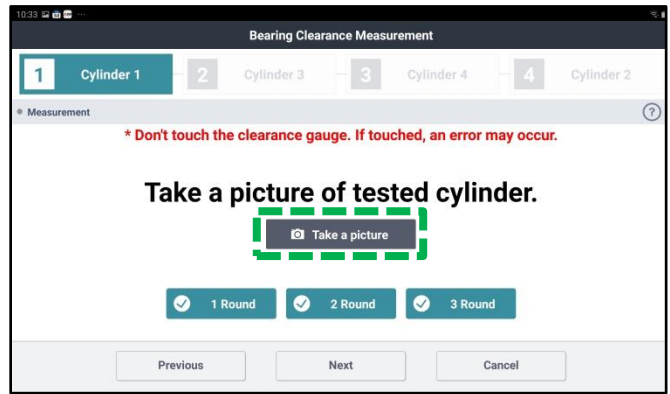
- Once Cylinder 1 test is completed, the KDS will prompt to take a picture of the tested cylinder. Select 'Take a picture'.

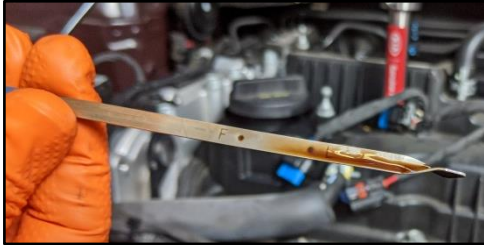
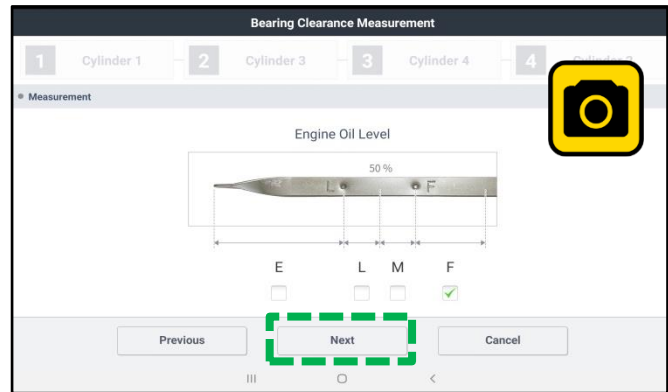
27. After completing the test of all four (4) cylinders, the KDS will prompt to check the crankcase oil level and to select the appropriate check box on the screen. Select 'Next'.

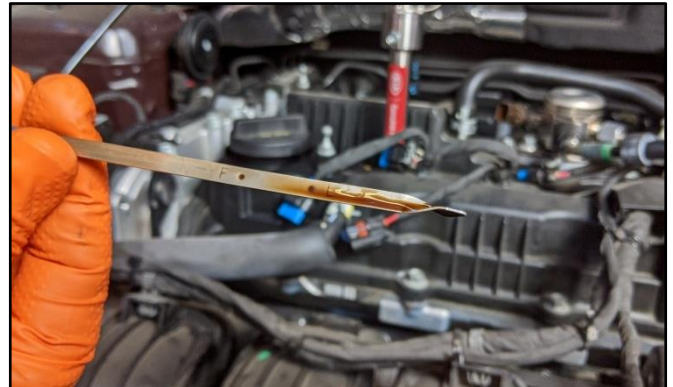
1. Measure and record oil dip stick level.
2. Note oil dip stick reading on the RO.

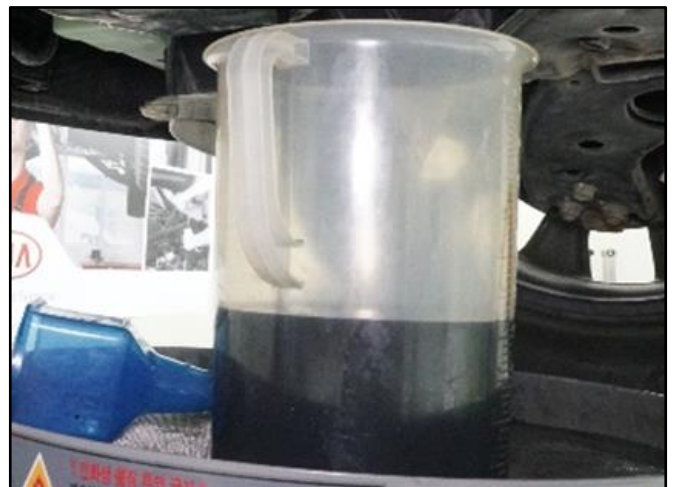
**Oil Level Measurement: (Flowchart C)**

1. Remove oil filler cap, remove oil drain plug and drain oil into the supplied measuring container SST067BUCK and check oil level.
2. Record oil level reading.
3. Take photo of the oil level using KDS.

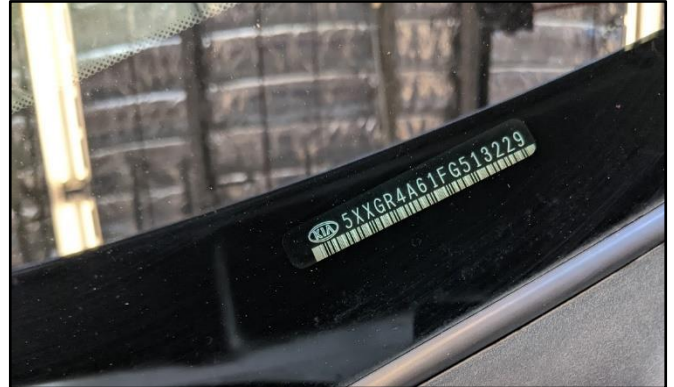
1. Start video showing vehicle and move in towards the dash VIN tag.

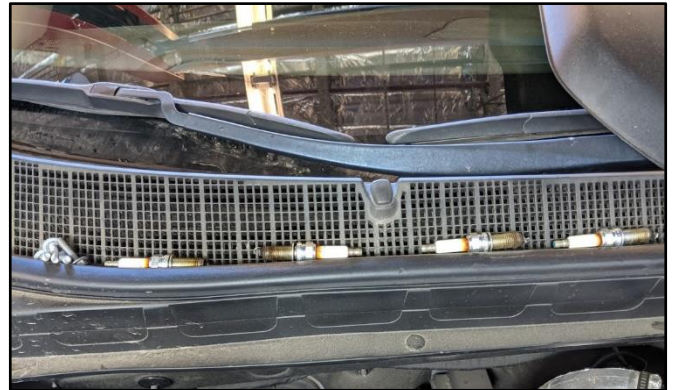
2. Show the removed spark plugs.

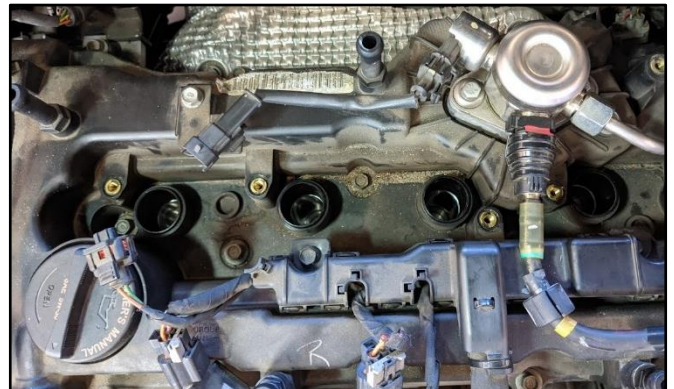
3. Show the empty spark plug holes from the engine.

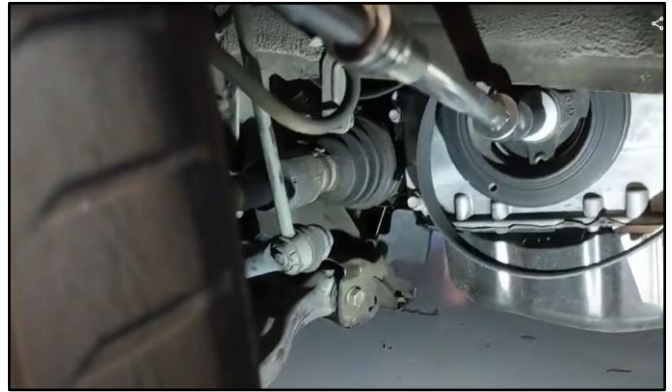
4. Show the removed drive belt and attached torque wrench to crank bolt.

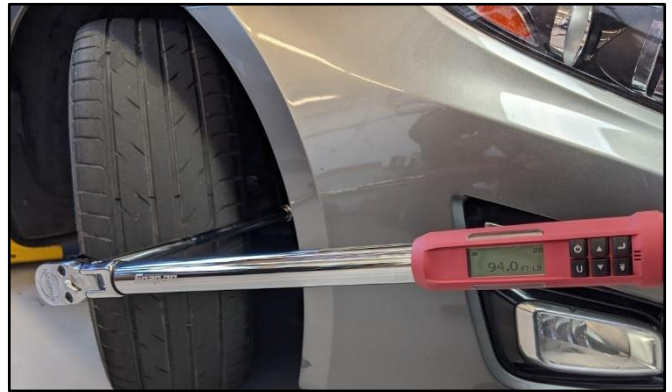
5. Show the engine being cranked and torque specification exceeding 94 lb.ft. torque.
