## Updated PM Sensor Removal Procedure - US17+OBD16 and Newer Emissions

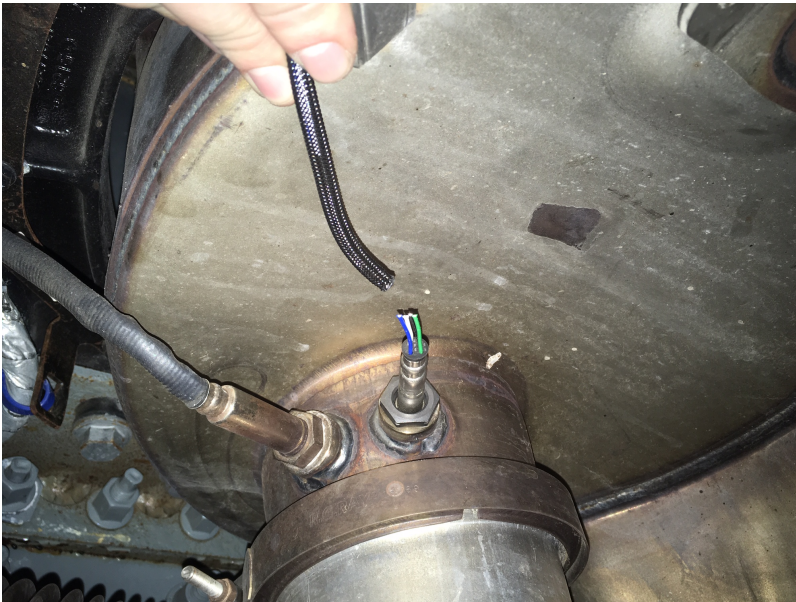
1. Cut the harness at the top of the sensor.

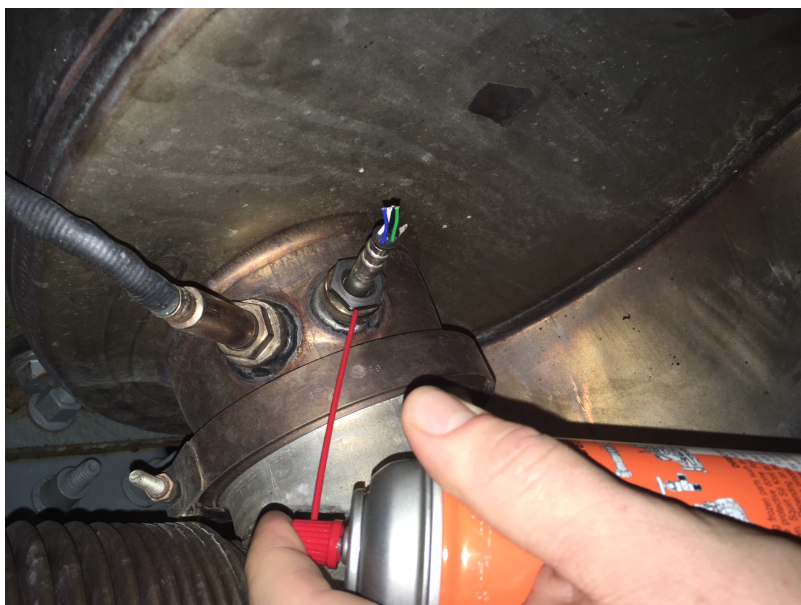
2. Spray the sensor nut with a suitable rust penetrant and let soak for approximately 5 minutes.

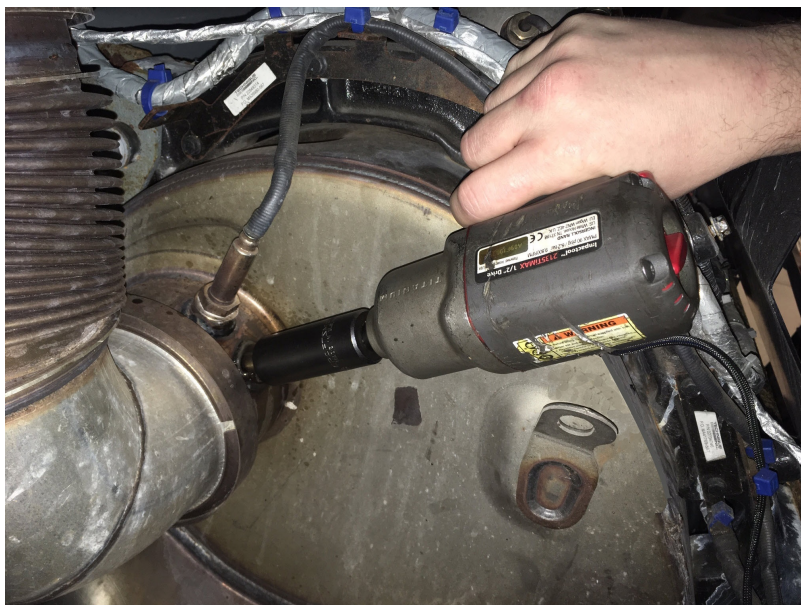
3. Remove the sensor with a ½" drive impact and appropriately sized deep socket.

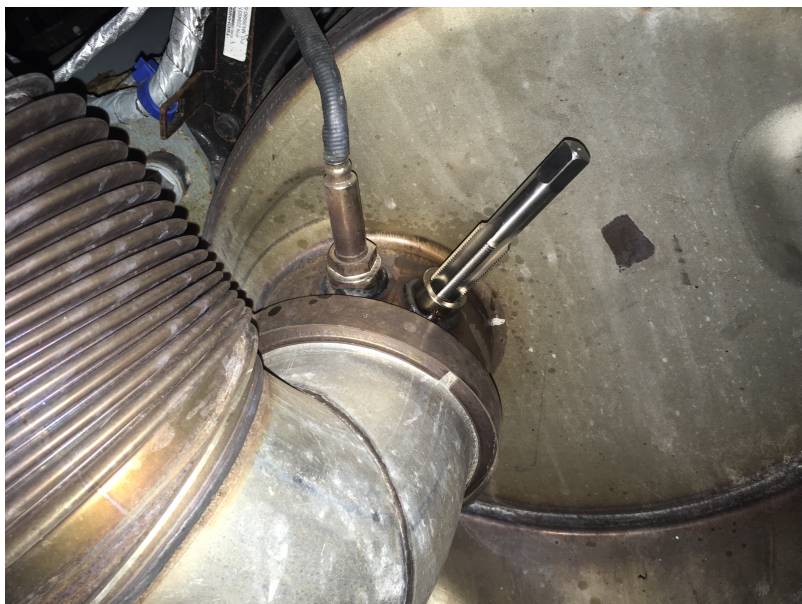
4. Use an M18 x 1.5mm **bottoming** tap to chase the SCR boss threads.

- Example bottoming tap – Grainger part # 2LWT5

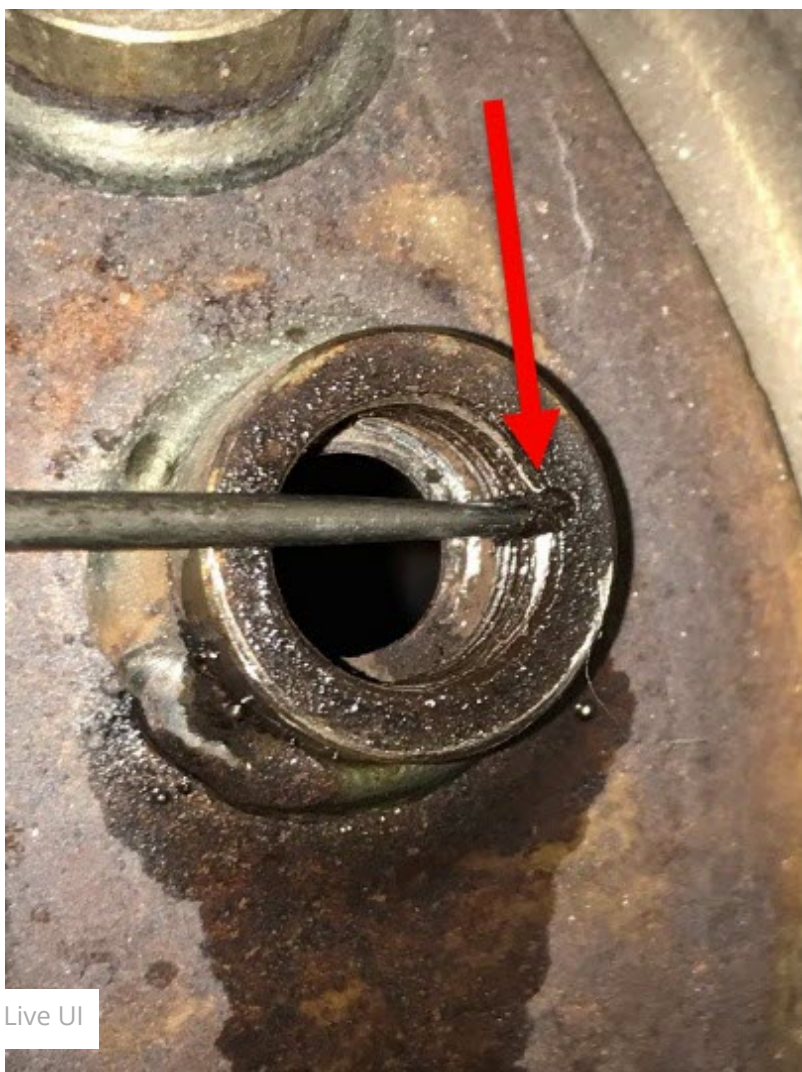
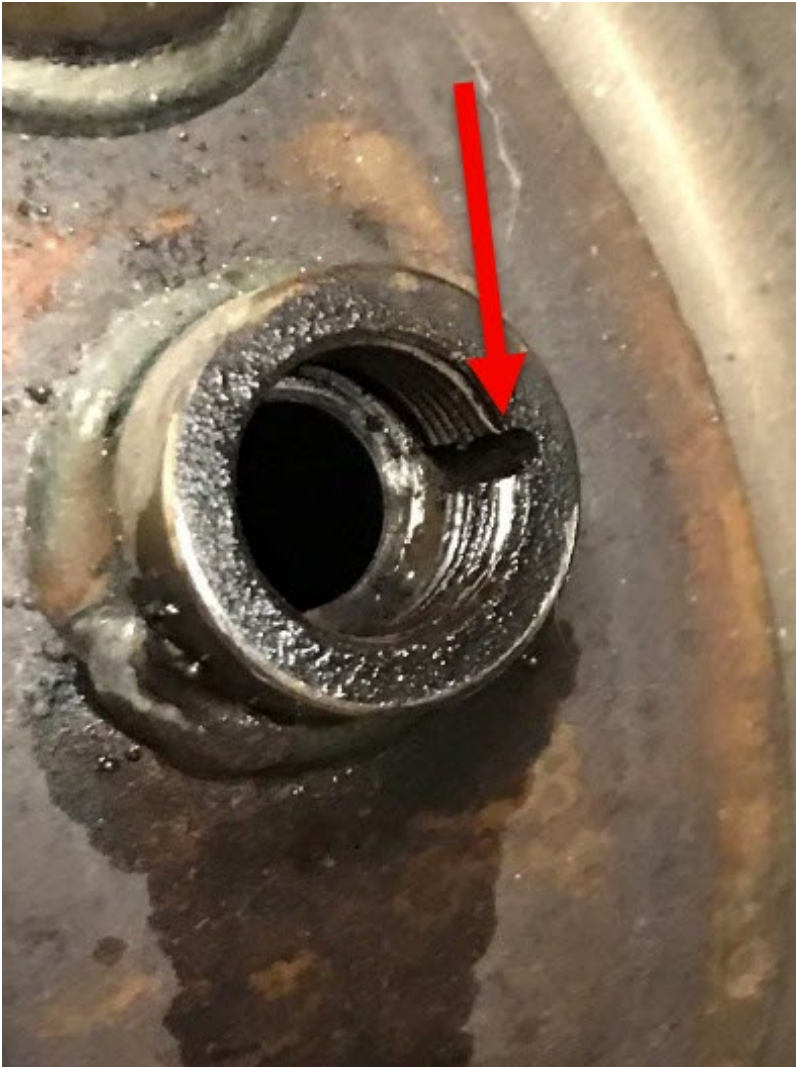
**5.** Inspect the boss threads and PM Sensor alignment notch for debris and clean if necessary.
