## Leese Neville Alternator Stud Cable Arrangement

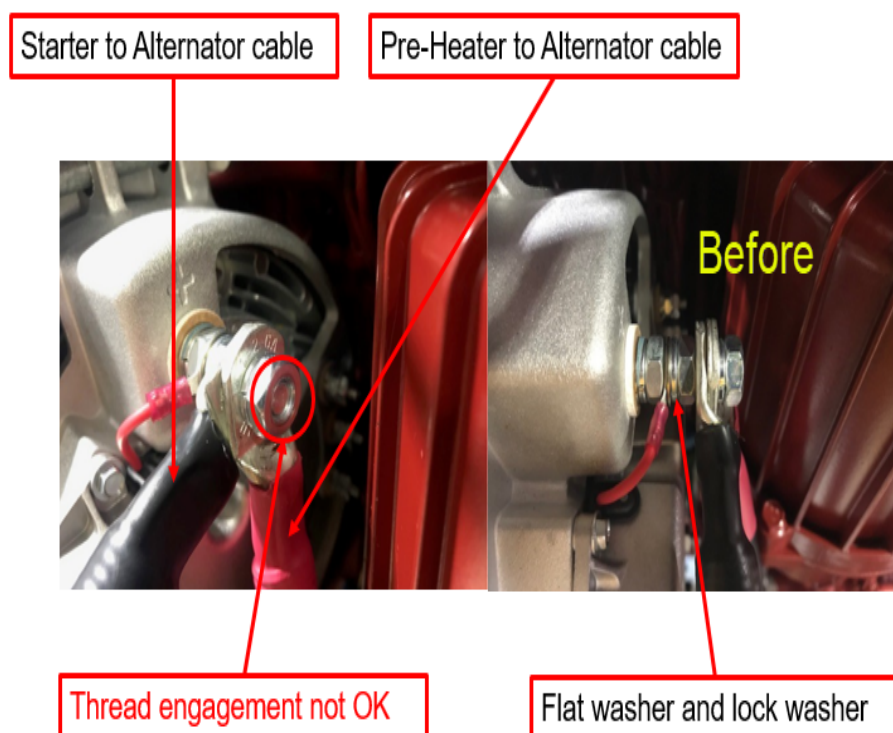
For Volvo and Mack trucks equipped with the Leese Neville Alternator and an engine pre-heater, the arrangement of the cables may result in not having full engagement of the fastening nut on the mounting stud.

Remove the lock washer and flat washer seen below.

Ensure Starter to Alternator cable (Bottom cable. Keep it away from the alternator housing.) is spaced away from the alternator housing.

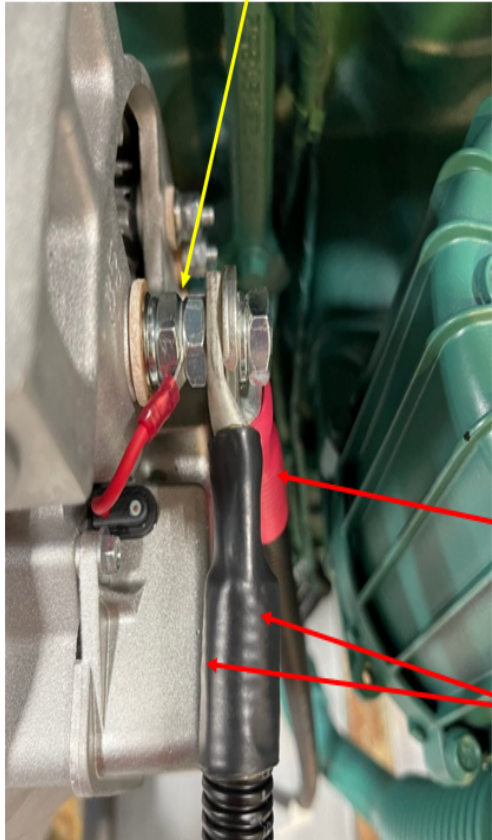
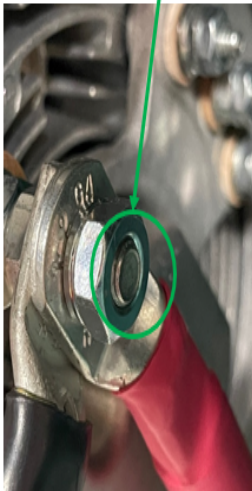
# Stack-up on Alternator terminal (After with pre-heater cables)

Thread engagement OK

Pre-Heater to Alternator cable (top cable)

Starter to Alternator cable (bottom cable keep it away from Alternator housing)

Remove flat washer and lock washer from middle assembly keeping the rest of the hardware and torque the same.
