SERVICE BULLETIN

APPLICABILITY: 2019-21MY Forester
 2020-22MY Outback & Legacy
 2018-21MY Crosstrek

SUBJECT: 6/8-way and Driver's Seat Hinge Cover-
 Design Change

NUMBER: 12-299-20R
DATE: 09/04/2020
REVISED: 09/20/2021

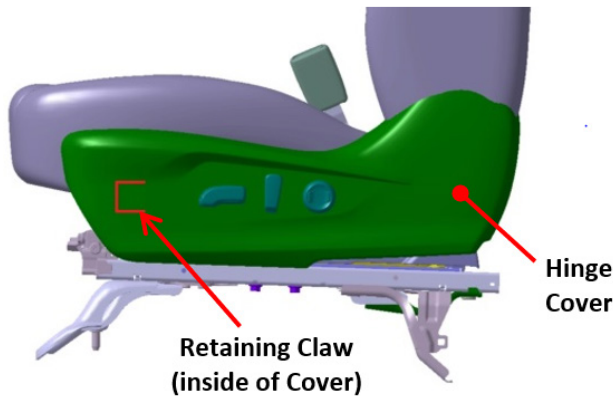
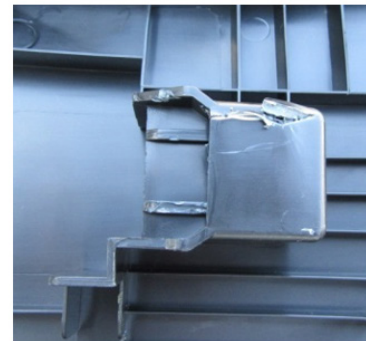
This bulletin announces a design change made to the outer hinge cover on the driver's 10-way adjustable power seats. The change has been made to address several reports about the cover coming loose over time as a result of getting into and out of the driver's seat. The retaining claw portion securing the cover to the seat frame has been changed to improve its strength and durability.

Enlarged View of Damaged Claw

The new Hinge Cover was incorporated into production as listed below:

- Forester: MH408966
- Crosstrek: M8251680
- Outback & Legacy: TBD

Description	Part Number	Application
COVER-HINGE FRONT SEAT OUTER LEFT	64115SJ231VH	For 10-way power seat
	64115AN15B	
	64115FL311VH	For 6/8-way power seat
COVER-HINGE FRONT SEAT OUTER RIGHT	64115SJ201VH	For 8-way power seat
	64115AN16B
