**FT5191 Coolant Pipe Leaks at Solder Joint**

# Interim Action Plan

## Hybrid Engine Coolant Leak Test

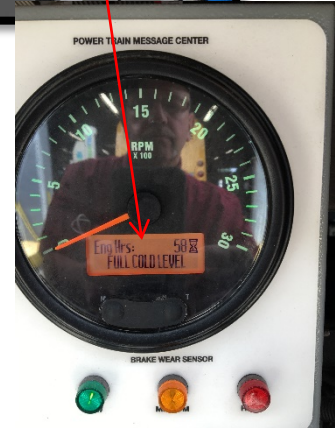
3. **Validate** the engine cooling system level using **ACTIA**. The display screen will display the Engine coolant level state it will state **Low Cold Level**.

Full Cold Level  
Or  
Low Cold Level

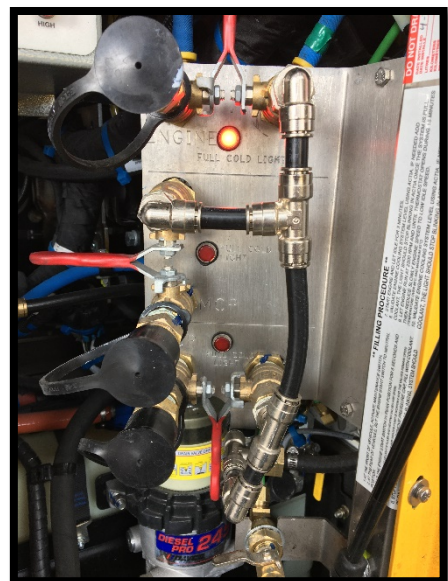
Also by looking at the **Fill Port Console** these lights are used for full and low signals:

If coolant level is on or under the low level, the light illuminates

If coolant level is on full level, the light extinguishes

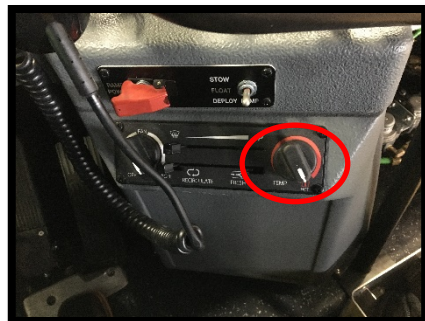
5. **Place** the Heater Defroster Control valve in the fully open position.

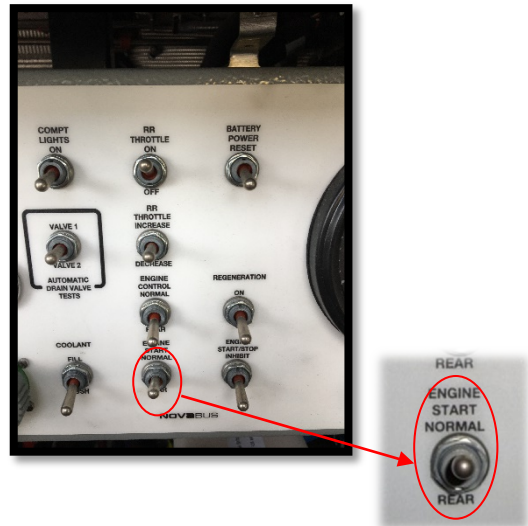
8. **Press down** the engine start switch on the rear engine control box for **5 seconds** and **release**. **Press down** again on engine start switch for **1 second** and release.

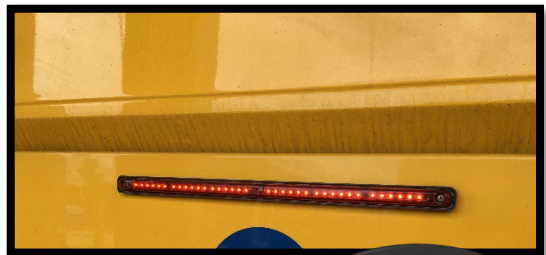
**Check** the backup lights and center stop light for blink (every 4 seconds) to confirm that the sequence has been activated.

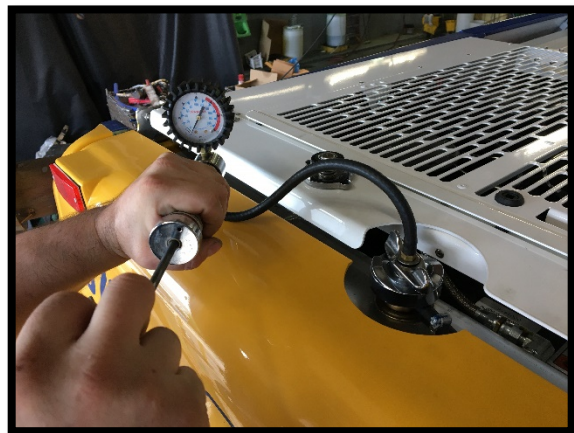
Now that the defroster heating valve and the floor heater valves are fully open move to the radiator surge tank located on the left/rear side of radiator to perform the Pressure test.

- 9. Remove** Engine surge tanks cap and install Pressure tester.

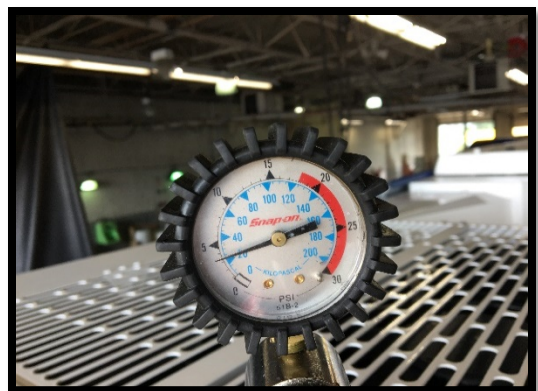
- 10. Pump** the pressure up to 20 to 21 psi and check to see if pressure holds. Check for leaks.

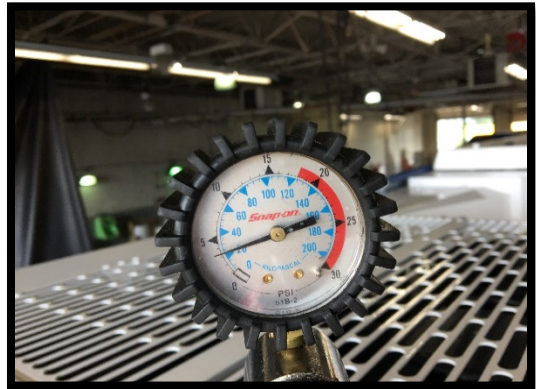
11. **Wait** 20 minutes and **Check** whether the pressure regulator gauge shows a decrease in pressure. If there is a decrease in pressure a leak check must be performed (see leak checking below)

**A decrease in the gauge pressure indicates a leak in the engine coolant system. If there is no decrease in pressure indicated on the gauge, the engine cooling system is good and possible air was trapped in the system**

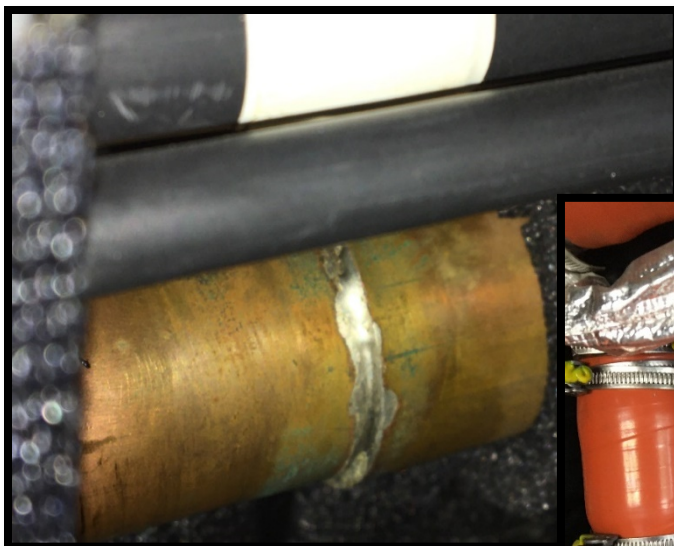
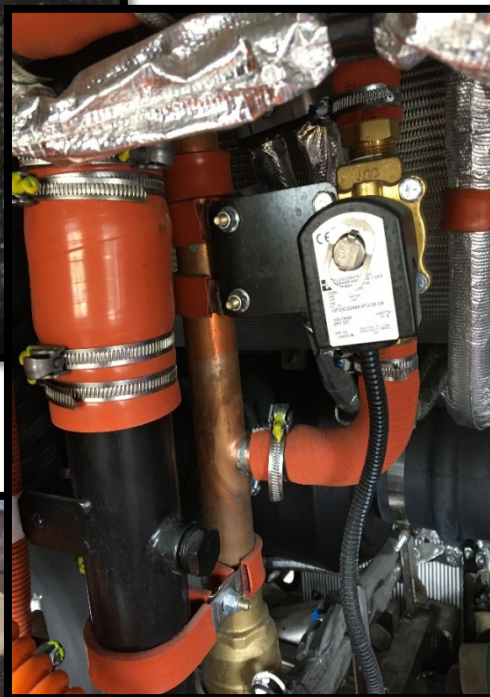
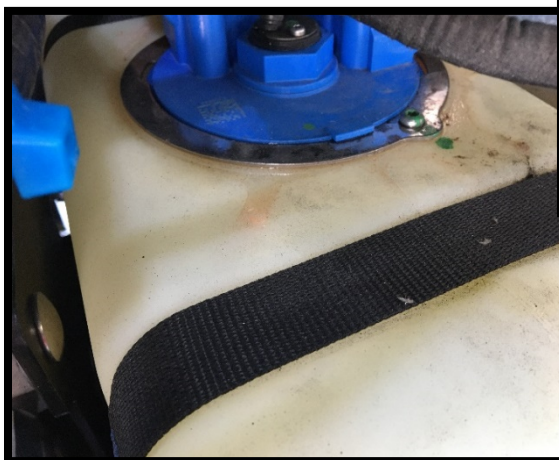
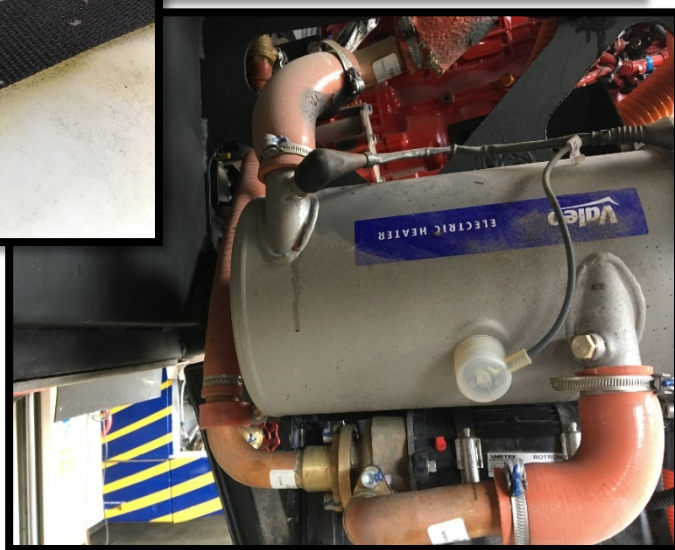
## Leak Check Location

For system with coolant still in the system look for a coolant leaking from the fitting and hose's.
