INSTRUCTION TO SERVICE

ITS: 59266		09/21/2021
SECTION:	400 - Structure	
WRITTEN BY:	Jeff Kosheluk	
SUBJECT:	Rework to mechanically fasten support bracket to existing upper bulkhead structure. This will include inspecting center pivot bolt at center hoop top bracket and EGS support bracket.	
ISSUE:	Current mounting bracket that holds upper bulkhead plate on front coach is breaking.	
SUMMARY:	Apply support by fastening mounting brackets, this is for buses showing no cracks.

ITS59266

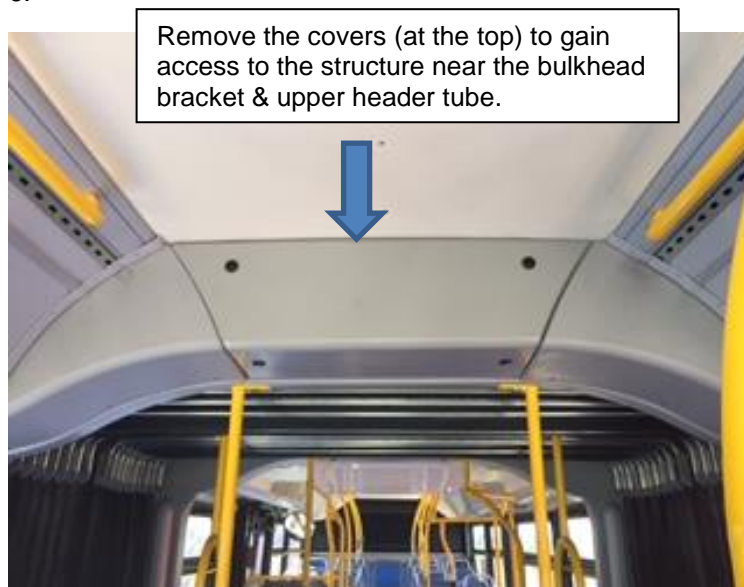
FIGURE 6: SHOWN INTERIOR COVERS TO BE REMOVED TO GAIN ACCESS

10. Remove the top section of the artic joint covers on the rear section at artic joint on the front coach. See Figure 6.

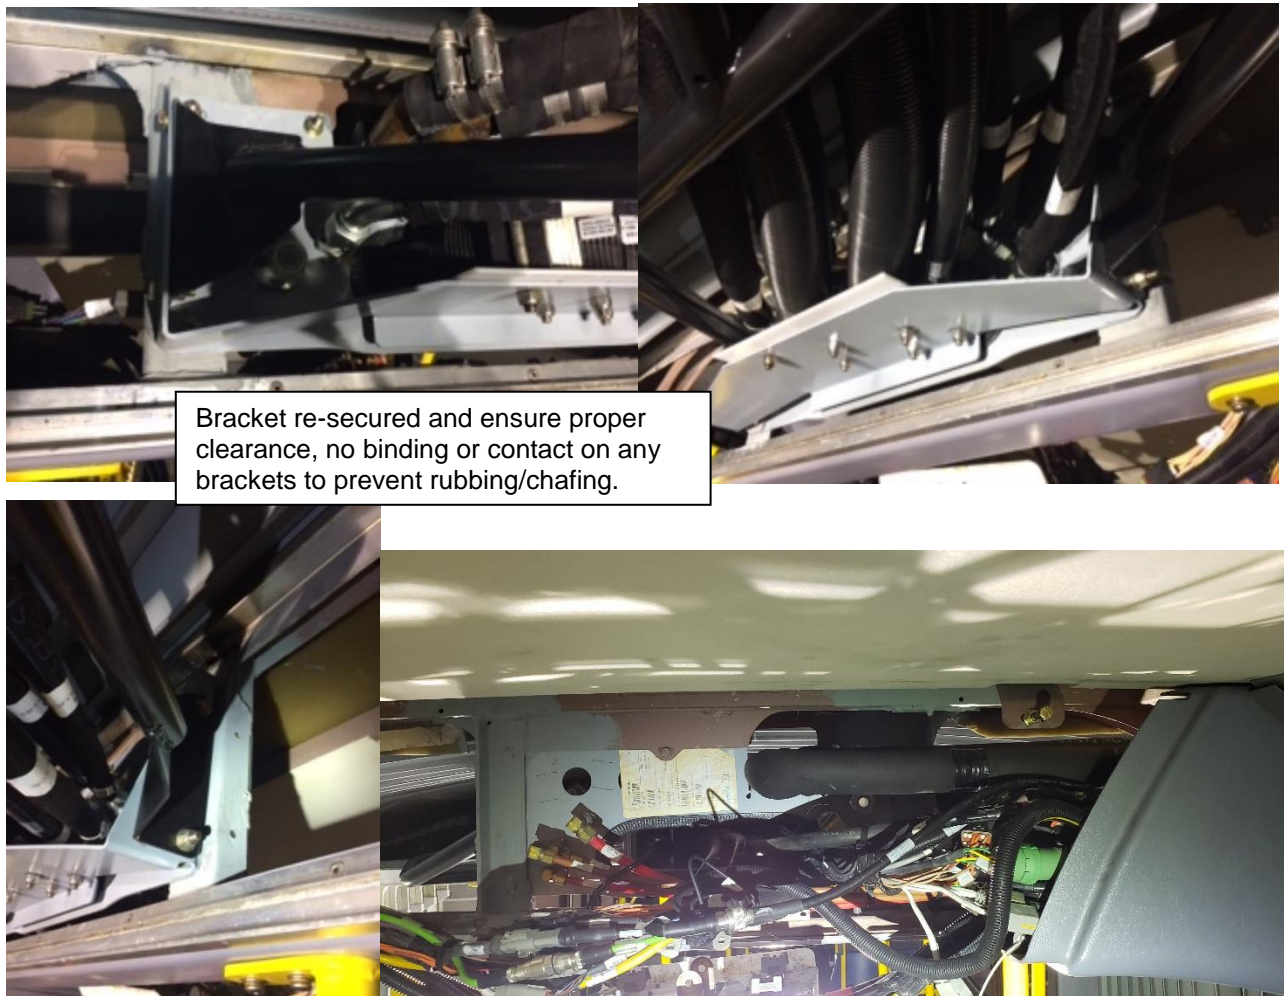
FIGURE 14: VIEWS OF HARNESS SUPPORT BRACKET

23. Re-install harness support bracket that was disconnected in step 9. Re-use hardware and torque 18-20 ft-lbs.

Note: With bus straight and on a flat surface, adjust position of assy-hose support to assure approximately 1" clearance between supports and false ceiling. Ensure no binding/rubbing or contact on any brackets.
