## Technical product information

<b>Topic</b>	Fluid leak from front air spring
<b>Market area</b>	Bentley: worldwide (2WBE),Hongkong-Macau (5HK)
<b>Brand</b>	Bentley
<b>Transaction No.</b>	2054635/6
<b>Level</b>	EH
<b>Status</b>	Approval
<b>Release date</b>

### New Continental GT and New Continental GTC

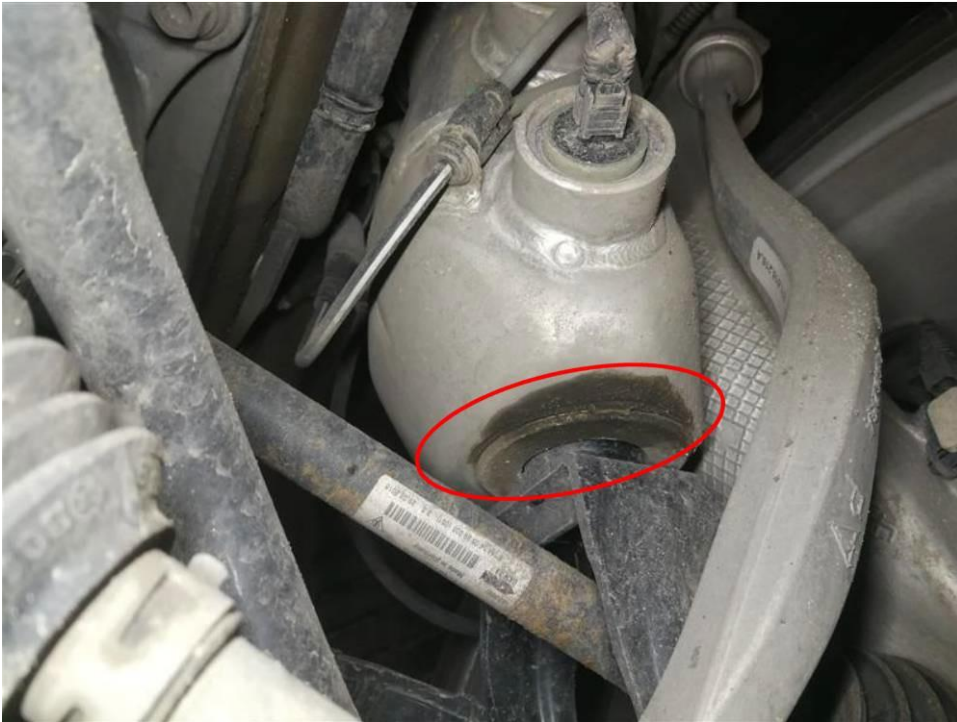
Figure 1

- Fluid leak from the base (Figure 1) and/or the top (Figure 2) of the front air spring/s

The fluid shown in Figures 1 and 2 is assembly fluid residue. The fluid is applied to various internal components of the air spring during manufacture.

1) Take a photograph of the applicable air spring in which the residue is evident

- Clean the residue from the air spring

2) Conduct a road test

3) On return from road test - Conduct a further inspection to check/confirm the residue is no longer evident

- Should the residue no longer be evident – No further action is required, parts must not be replaced for this concern
- Should the residue be evident on return from the road test – Raise a DISS query and await feedback before carrying out any further work  
*NOTE: Please ensure photographs of the residue are attached within the DISS query clearly showing the residue prior to cleaning/road test and post road test*
