# HYUNDAI Technical Service Bulletin

GROUP <b>Campaign</b>	NUMBER <b>21-01-059H</b>
DATE <b>September, 2021</b>	MODEL(S) <b>Palisade (LX2)</b>

**SUBJECT:** C-PILLAR GARNISH INSPECTION AND REPLACEMENT  
(SERVICE CAMPAIGN T6W)

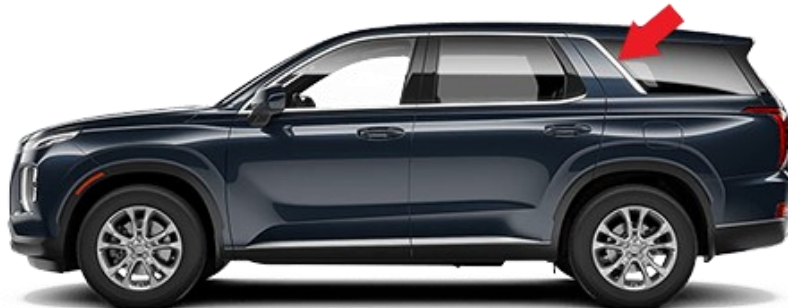
**Description:** Certain 2021MY Palisade (LX2) vehicles may exhibit separation between the C-pillar garnish and the rubber molding. Follow the procedure outlined in this bulletin to inspect the C-pillar garnish, and if necessary, replace it with a new part.
