HYUNDAI

Technical Service Bulletin

GROUP	NUMBER
Engine	21-EM-010H
DATE	MODEL(S)
September, 2021	Sonata (DN8a)

SUBJECT:	DN8A 1.6L TGDI MISFIRE HIGH PRESSURE INJECTOR REPLACEMENT
-----------------	--

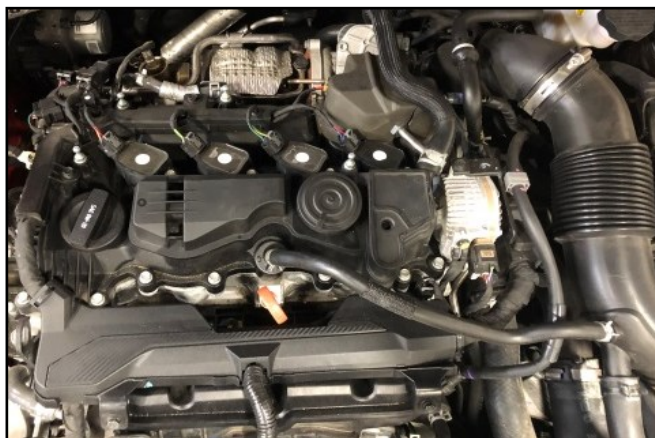
1. If the vehicle is diagnosed with having a misfire and the ignition coil, spark plug, and associated connections are identified to be operating as designed, proceed to diagnose as follows in step 2.

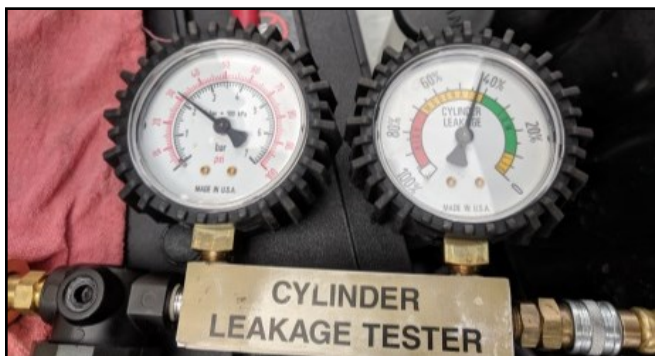
2. Complete a leakdown test on the affected cylinder exhibiting a misfire. If leakdown is 15% or greater, locate the source of escaping air.

One possible source of a leak can be a GDI injector underneath the intake manifold. If no leak is found in this location, proceed further for continued diagnosis.

One method to help determine the source of an air leak is to use the open end of a stethoscope.

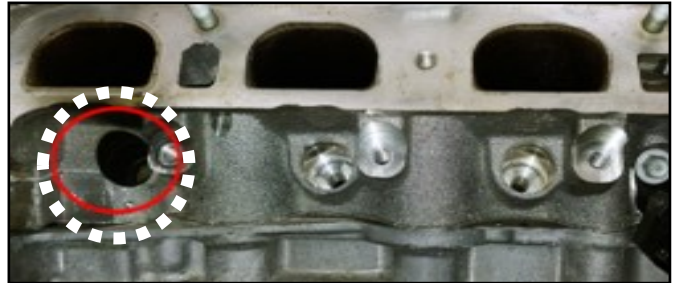
3. Upon removal of the injector associated with the engine's misfire, the following conditions may be shown on the right.

Conditions of burnt-out injector tip seals can be soot deposits around affected injector area and cylinder boss.
