# Technical Service Bulletin

## 70 Buzzing noise heard from the midrange speaker trim cover

70 21 73 2064546/1 October 8, 2021.

Model(s)	Year	VIN Range	Vehicle-Specific Equipment
Audi e-tron GT	2022	000001 - 003853	Not Applicable
Audi RS e-tron GT	2022	900000 - 902247	Not Applicable

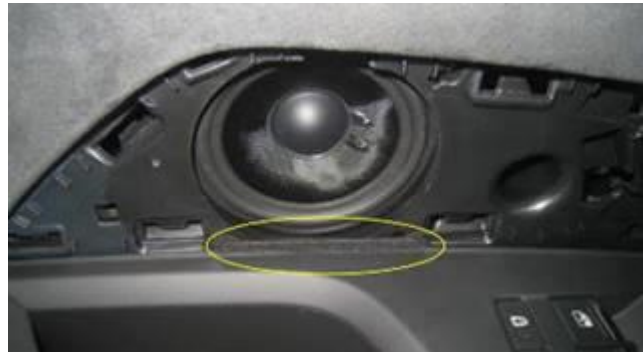
**Figure 1.** Felt strip section applied to opening in door panel.

1. Remove the midrange speaker trim. Using self-adhesive felt strip material (533 867 910 A), apply a section to the lower part of the opening for the trim in the door panel.

Ensure that this section of felt will not be visible when the speaker trim is reinstalled (Figure 1).

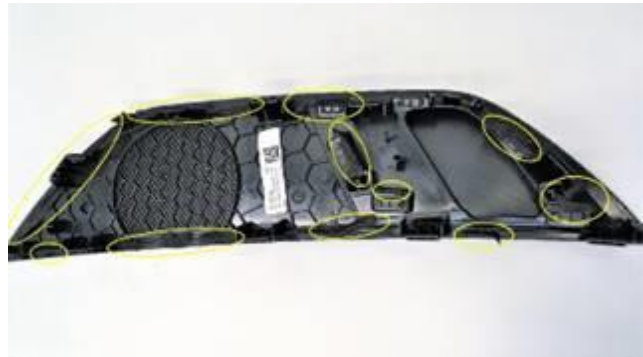
**Figure 2.** All tabs on the midrange speaker trim that require felt strip material.

2. All of the tabs on the speaker trim that engage the opening in the door panel will need to have felt strip material applied to each of them (Figure 2).

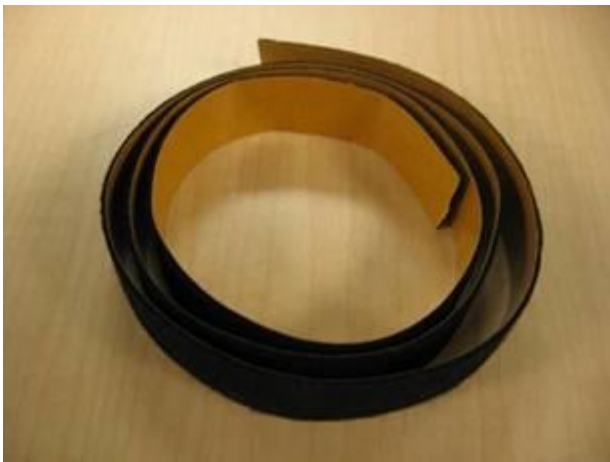
Always check with your Parts Department and/or ETKA for the latest information and parts bulletins.		
Part Number	Part Description	Quantity
533867910A

Self-adhesive felt strip	01
See ETKA	Fasteners, Bolts, Nuts, and Screws as needed per the Repair Manual	See ETKA/ELSA
