SERVICE BULLETIN

Classification: AT19-002G	Reference: NTB19-040G	Date: September 29, 2021
------------------------------	--------------------------	-----------------------------

DTC P0741/4/6, P0776, P0841, P0875, P0965, P2857/8/9, P17F0/1/2/4 AND/OR P285A STORED IN THE TCM, AND MAY HAVE HESITATION AND/OR REDUCED POWER

APPLIED VEHICLES: 2018-2021 Kicks (P15)
2020-2021 Versa Sedan (N18)

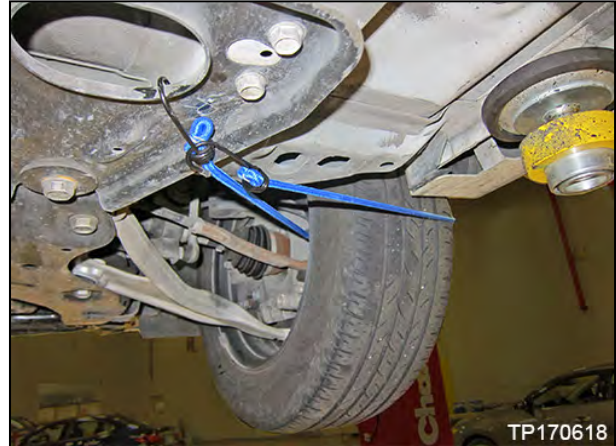
Figure 7

13. Secure the front right tire with a suitable strap.
 - This will assist in making the belt turn during the borescope belt inspection step.
14. Mark the front left tire with a suitable marking.
 - This will assure all 360° of the belt is inspected.

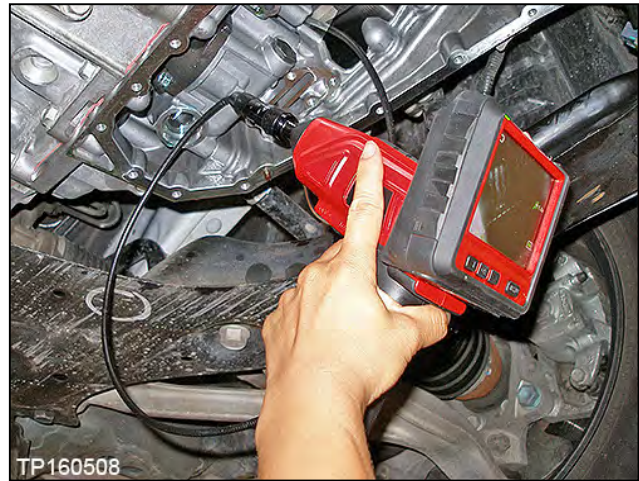
Figure 12

- c. Using the mark applied to the left front tire for reference, slowly and carefully rotate the front left tire one full turn in either direction to view all of the belt.
- Holding the borescope (camera flexible tube) with one hand allows rotation of the tire with the other hand (see Figure 12).

- d. Using the mark applied to the left front tire for reference, slowly and carefully rotate the front left tire one full turn in either direction to view all of the belt.
 - Holding the borescope (camera flexible tube) with one hand allows rotation of the tire with the other hand (see Figure 12).

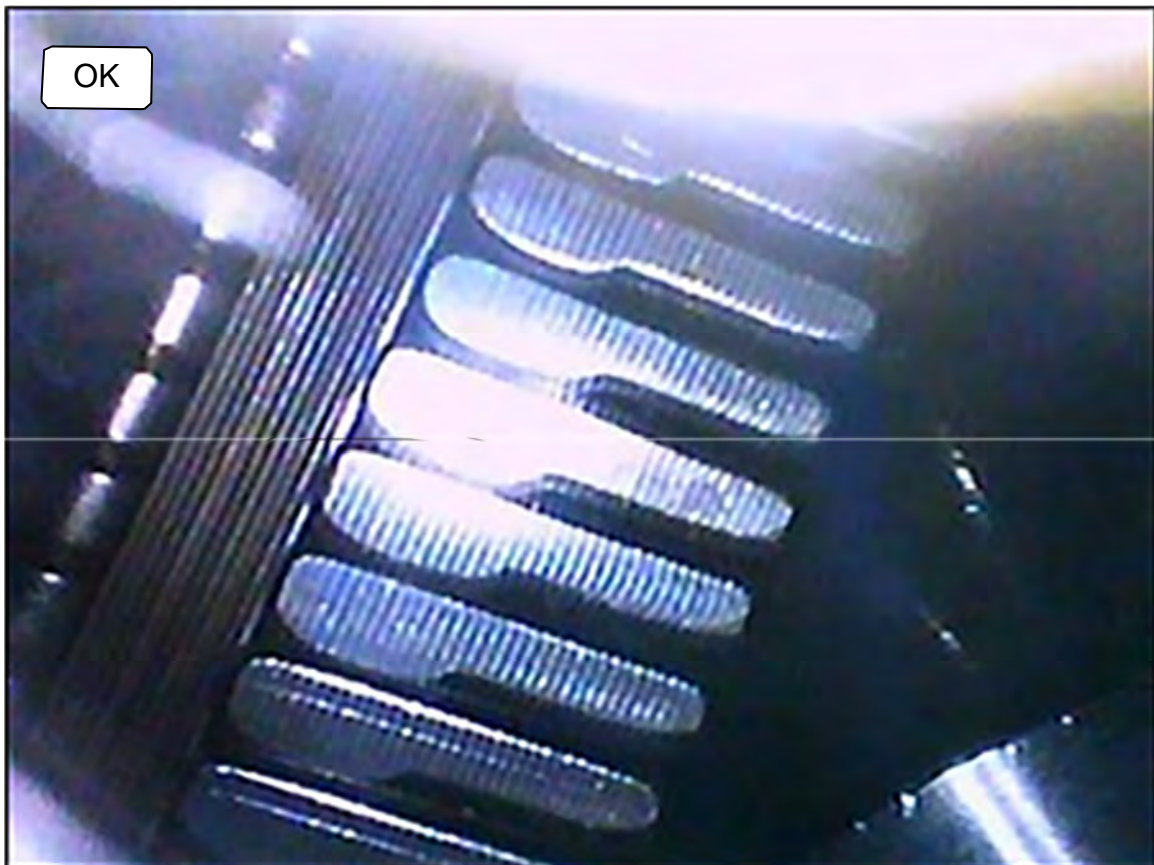
Pictures in Figure 16 and Figure 17 were taken with borescope J-51951.

- If no evidence of belt slip is found, proceed to step 19 on page 11.
- If evidence of belt slip is identified as shown on pages 13-16, skip to step 22 on page 17.
- If the belt does not move when rotating the front left tire, return to step 17 on page 8.

- Look for evidence of belt slip as shown on pages 13-16.

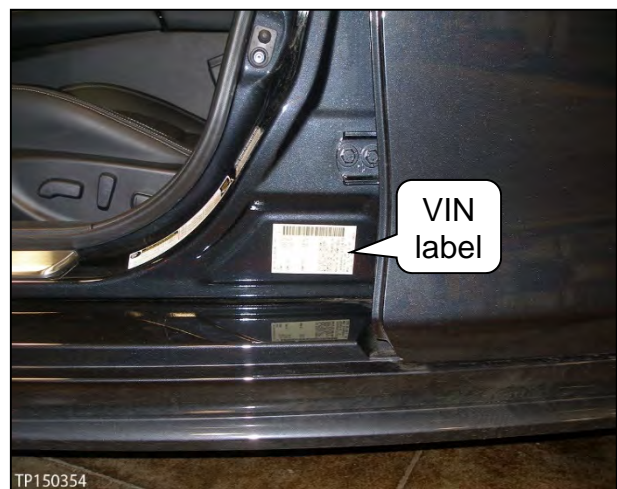
Figure 23

24. If CVT replacement is required based on the inspection results from steps 18 and 19, use borescope J-51951 to record a continuous video, 15 seconds or less, of the most severe evidence of belt slip and the VIN on the F.M.V.S.S. certification label (VIN label). See Figure 23.

NOTE: This required video must be attached to the Powertrain Call Center CVT Preauthorization Form (in ASIST) prior to calling for authorization. Failure to submit a continuous video will cause immediate denial of request for replacement.

- Before starting to record, make sure the camera handle's AA batteries are charged and the LCD monitor's battery is charged.
 - The video will show a backward or reversed image when the mirror end is used; this is okay.
 - The required video must show clear evidence of belt slippage and be 15 seconds or less.
25. Call the PCC for authorization at 800-973-9992 (opt 2).
