# SERVICE CAMPAIGN BULLETIN

Classification: BT21-015	Reference: NTB21-091	Date: September 23, 2021
-----------------------------	-------------------------	-----------------------------

## VOLUNTARY SERVICE CAMPAIGN 2022 PATHFINDER; REAR DOOR HINGE BOLT

**CAMPAIGN ID #:** PC841  
**APPLIED VEHICLES:** 2022 Pathfinder (R53)

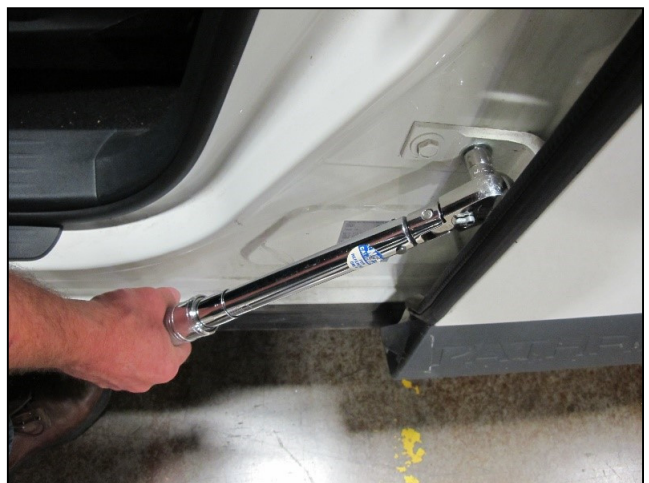
Figure 5

6. Torque the hinge bolt to 29.4 N•m (3.0 kg-m, 22 ft-lbs).

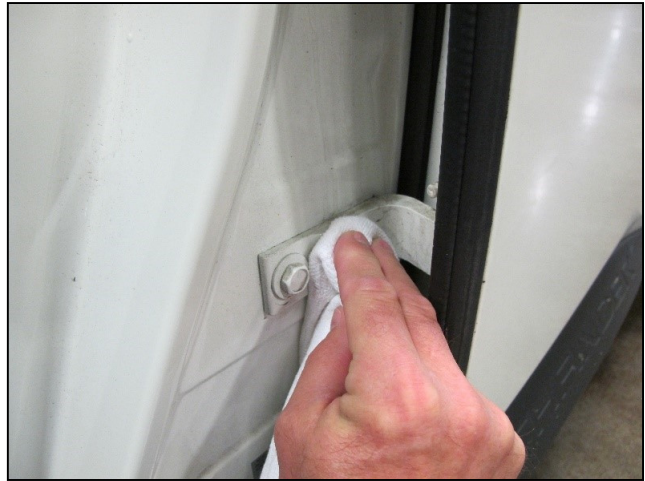
Figure 6

7. Using a clean lint free cloth, clean the replacement hinge bolt head and washer with isopropyl alcohol (Figure 6).

- Allow the isopropyl alcohol to dry before proceeding to step 8.

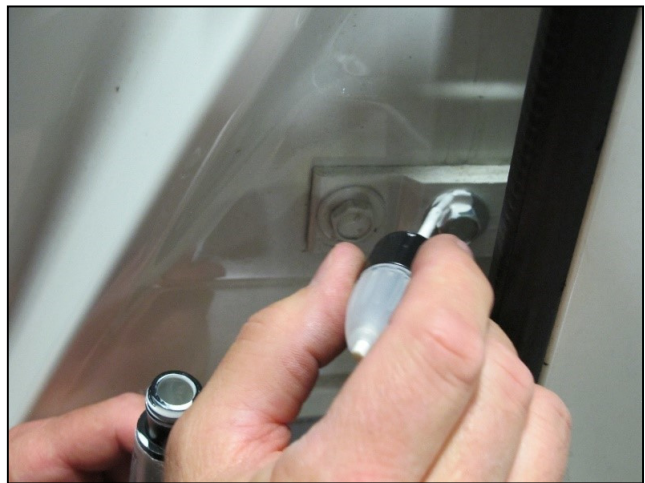
Figure 7

8. Once the isopropyl alcohol is dry, apply matching color touch-up paint and top coat to the hinge bolt head and washer (Figure 7).

- Follow all instructions included with the touch-up paint and the top coat.
- Allow the color coat to dry for 30 minutes before applying the top coat to the replacement bolt.
- Be careful to not get touch-up paint on the door or the door weather-strip surfaces.
- Make sure to cover all of the replacement hinge bolt head and washer with the paint and top coat.
