**SIB 61 01 21**

48 VOLT BATTERY MAINTENANCE

This Service Information Bulletin (Revision 2) replaces SI B61 01 21 **dated February 2021**.

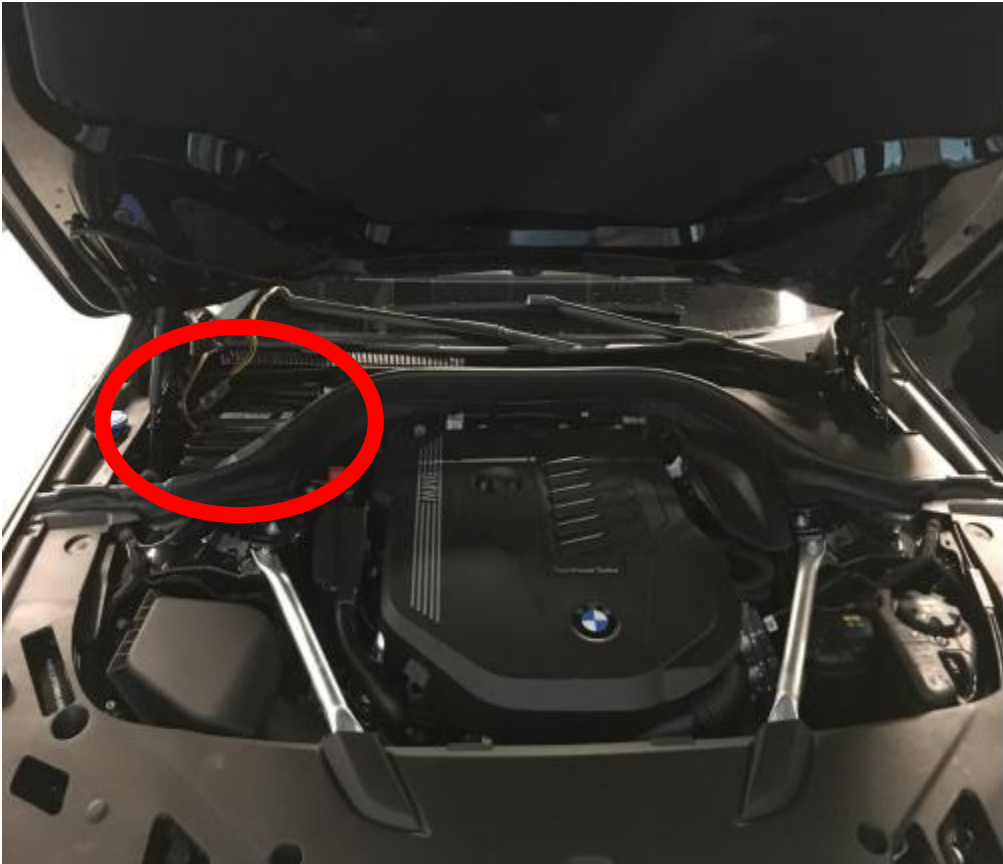
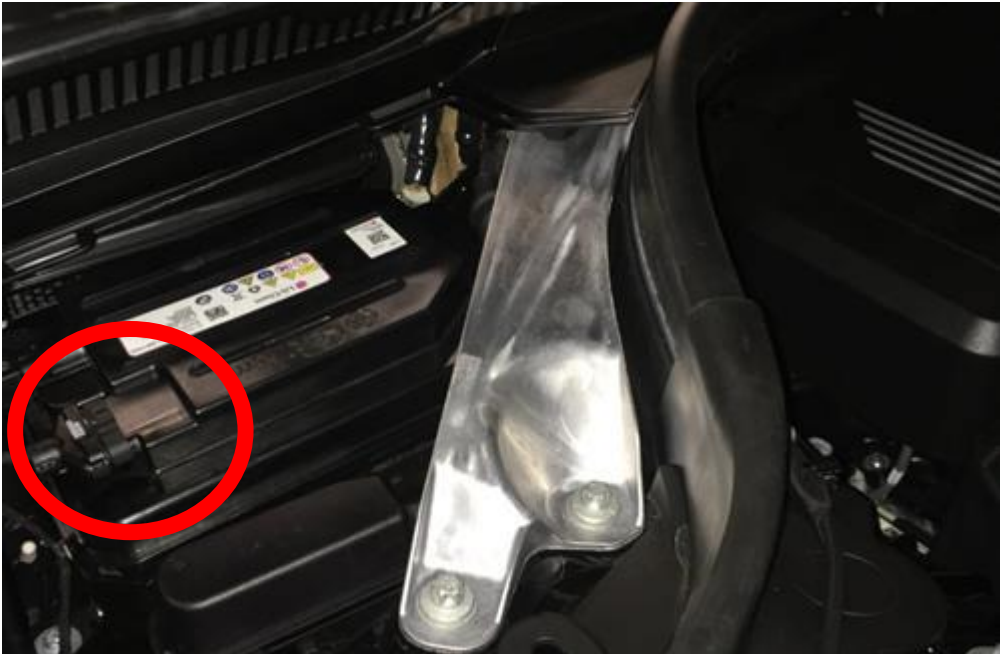
[picture_as_pdf B61 01 21 Attachment.pdf](#)

Disconnect the mains/signal connector **G14*1B** of the BATT48 (see attachment).

The 12V battery must be fully charged before unplugging the 48V signal connector.

Subsequently the hood can be closed.

Before the vehicle is driven again on the road, it is important to plug in the connector delete the fault memory using ISTA.
