# Spartan Fire, LLC

Campaign Service Bulletin  
CSB21-350-001

**CONDITION:** Rear Neway ADZ-127 suspension label has incorrect weight rating

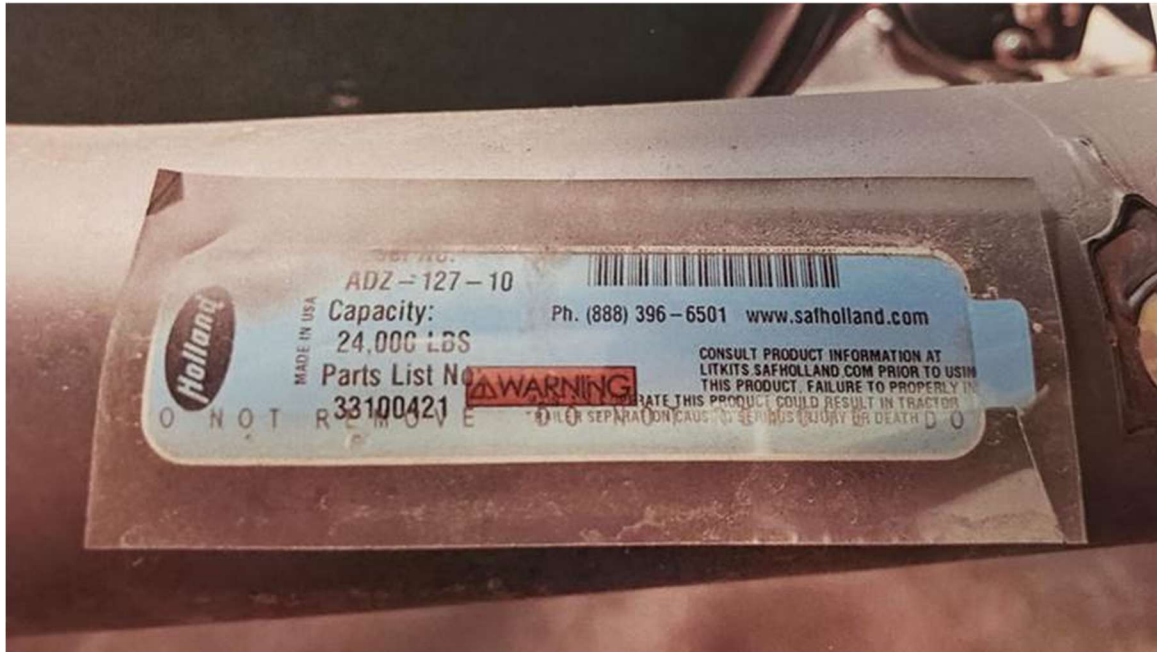
**FIG. 2.1**

1. Locate suspension label on rear suspension lower control arm. *See Figure 2.1*

**CORRECTION:** Replace incorrect 24,000 lb labels with 27,000 lb labels.

2. Examine label capacity on original label.
  - a. If capacity indicates 27,000 lbs, no further action is needed. The label is correct.
  - b. If capacity indicates 24,000 lbs as shown in figure 2.1, then proceed to step 3.
3. Identify if original label contains a part number 33100421 or 33100426
4. Select the new label with the same part number as the original label.
5. Remove original label from control arm and dispose of properly.
6. Clean area with a wax and grease remover to ensure proper adhesion of the new correct label.
7. Remove adhesive backing from new label and carefully apply to the clean region, pressing firmly to ensure proper adhesion.
