Technical Service Bulletin

69 Front seat belt is twisted

69 21 71 2058455/5 October 12, 2021. Supersedes Technical Service Bulletin Group 69 number 21-65 dated May 17, 2021 for reasons listed below.

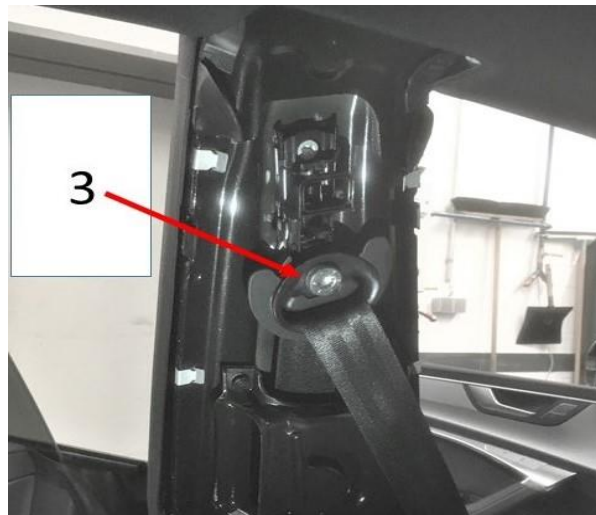
Figure 1. Seat belt deflector at height adjuster with B-Pillar trim removed.

1. Remove the upper B-Pillar trim on the affected side according to the Elsa Repair Manual.
2. Remove the bolt of the seat belt deflector (Figure 1, Pos. 3).

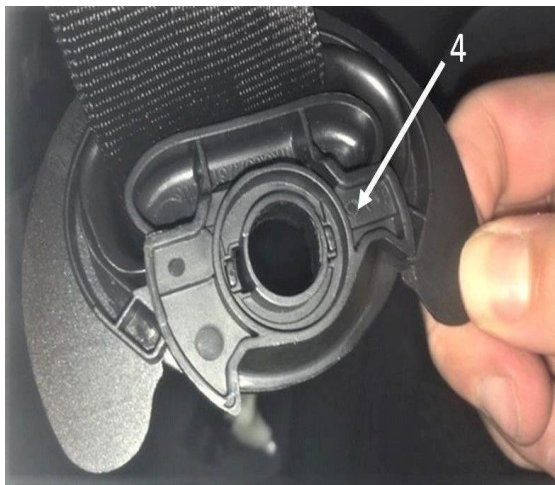
Figure 2. Backside of seat belt deflector. Deflector trim tabs engaged in the old belt guide.

3. Use your thumb to remove the old belt guide (plastic part) from the steel deflector. Start by detaching the guide from the bolt hole, then press out the lower section covering the metal tab (Figures 2 -3).

5. Install the modified belt guide 4K8 857 799 on the front driver side and 4K8 857 800 on the front passenger side (Figure 2, Pos. 4).
6. Start installing the modified seat belt guide at the deflector metal tab (Figure 5).

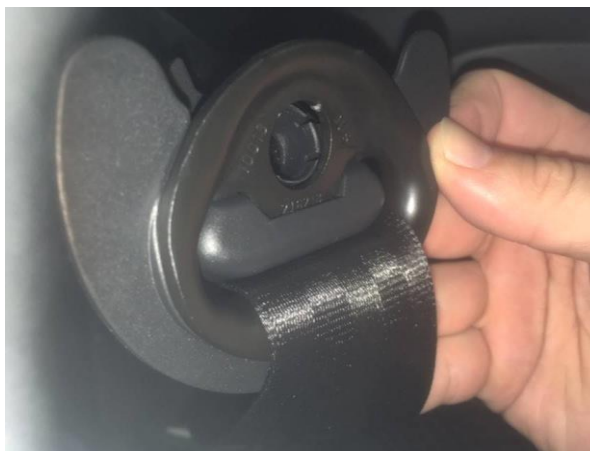
Figure 3. Removing old seat belt guide starting at the bolt hole.

Do not use sharp objects to remove the old belt guide to avoid damaging the seat belt webbing.

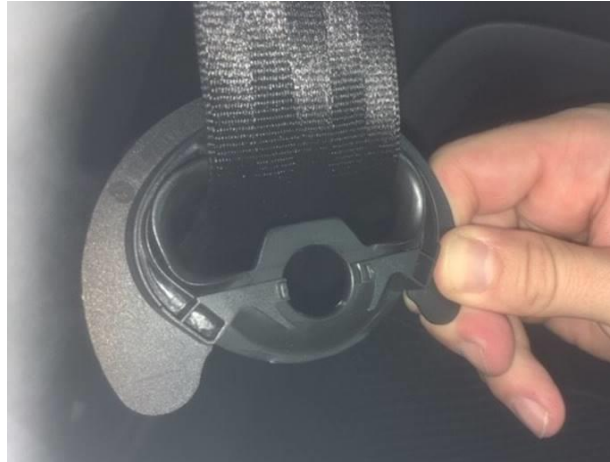
Figure 4. Old seat belt guide removed. The seat belt twist is corrected.

4. With the old belt guide removed, turn the seat belt webbing to remove the twist (Figure 4).

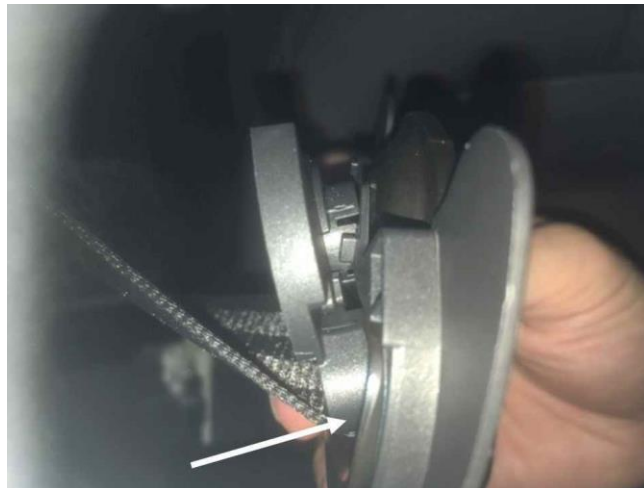
Figure 5. Installing modified seat belt guide starting with the metal tab on the bottom.

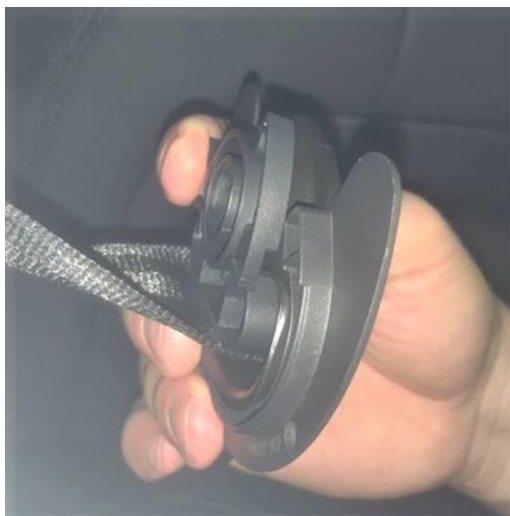
Figure 6. Seat belt deflector with the new guide installed.

7. Push the new guide into the bolt hole until you can hear the plastic retainers snap into place (Figure 6).

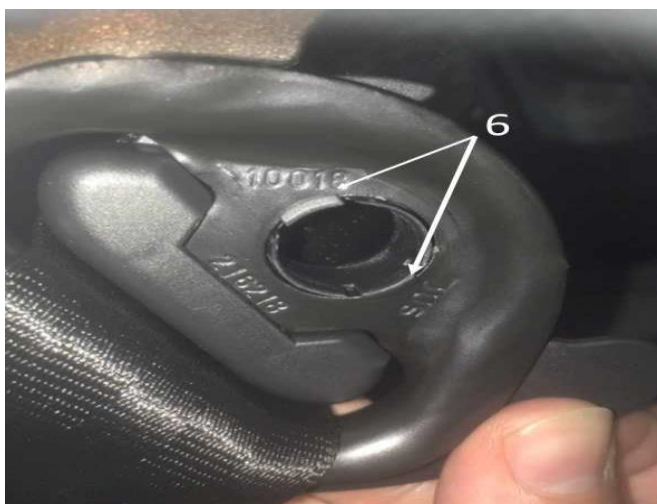
Figure 7. Belt guide locking tabs correctly secured at the bolt hole.

8. Inspect the front of the deflector for proper installation of the guide locking tabs at the bolt hole (Figure 7, Pos. 6).

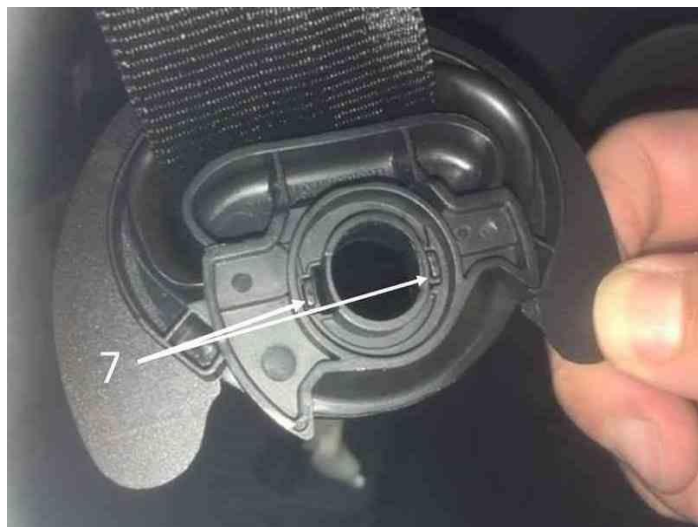
Figure 8. Seat belt deflector trim locking tabs properly secured to the seat belt guide.

9. Inspect the back of the deflector for proper installation of the deflector trim locking tabs to the seat belt guide (Figure 8, Pos. 7).
